VISUAL EFFECTS OF STRUCTURING ON COASTAL LANDSCAPE: EVALUATION FROM ÇANAKKALE-GÜZELYALI CASE

Onur KIZILARSLAN¹, Kardelen ŞENGÜL², Mehmet İlkan BAYRAK³, Alper SAĞLIK^{4*}

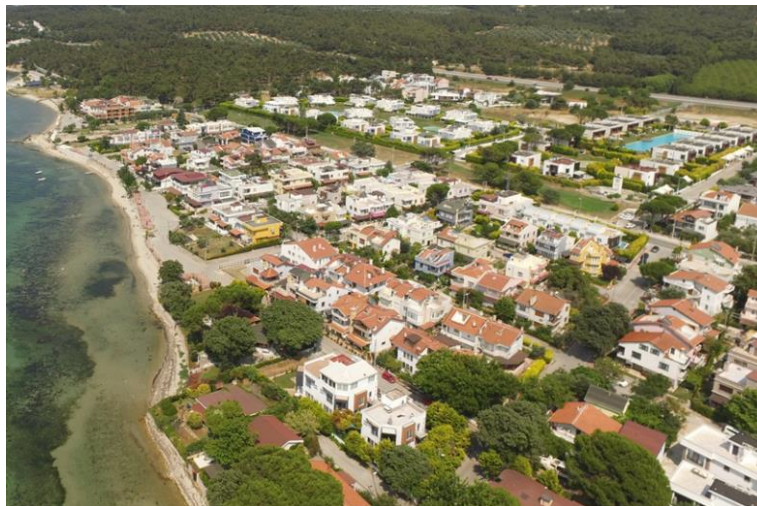
It is observed that the exterior paints of the buildings in Güzelyalı are not selected in accordance with a certain order and standard, the worn-out buildings are not repaired, and their colours are incompatible with each other. While only a few buildings have exterior cladding, other buildings have incompatible colours and worn-out facade paints, creating a bad appearance. This situation has a negative impact on visual quality by disrupting the city silhouette (Figure 5).

Figure 5. General Facade Views (Original. 2023)

- It is recommended to prefer white or light tones close to white as exterior paint or exterior cladding of buildings to create integrity.
- It is recommended that window and door joinery should be of appropriate size, compatible with each other and selected from appropriate materials.
- It is recommended that incompatible and worn-out advertisement boards be removed from these areas.
- It is recommended to repair the worn-out piers on the coastline.
- It is recommended that recreational areas, which in small numbers in some parts of the coastline, be placed along the entire coastline to create integrity and to enable recreational activities to be carried out.
- It is recommended to remove the worn-out structures and equipment that spoil the silhouette on the coastline. Green business parks provide significant environmental, social, and economic benefits.

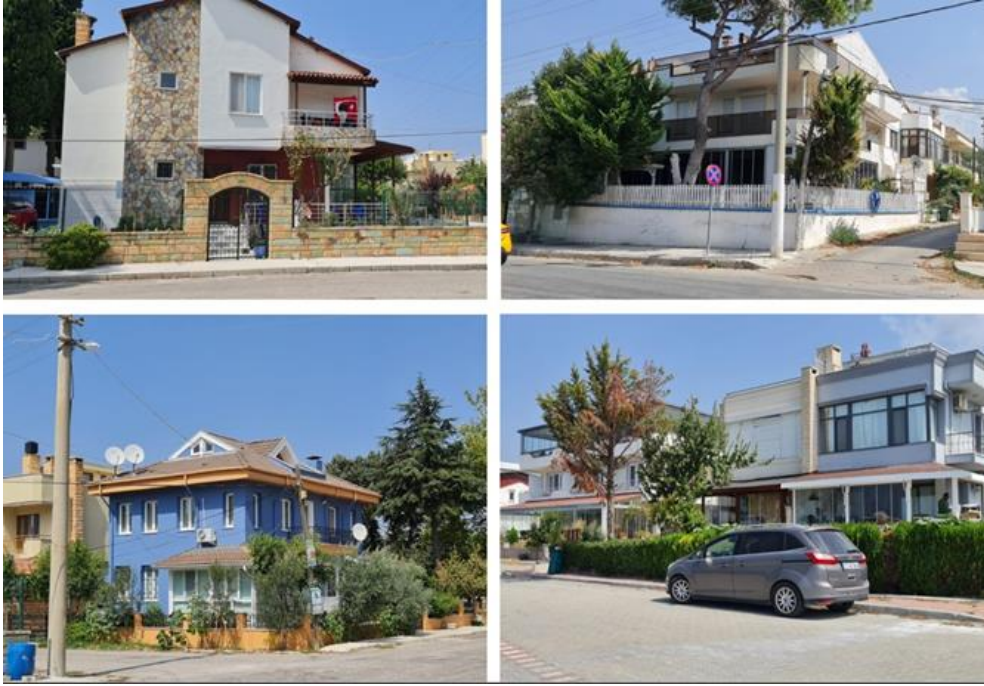
As a result of the examination of the research area, it has been observed that disproportionate, incompatible window and door joinery are used in many buildings to benefit more from the view. This disproportionate situation disrupts the overall harmony and affects the visual quality negatively by affecting the space-occupancy ratio. Likewise, balconies covered with different materials and colours to obtain more closed and shaded areas disrupt the mass to space ratio of the buildings, creating an incompatible shading element and negatively affecting the appearance (Figure 6). In addition, the irregular use of elements such as garden walls and railings can also create a negative appearance (Figure 7).

Figure 6. Facade Views (Original. 2023)

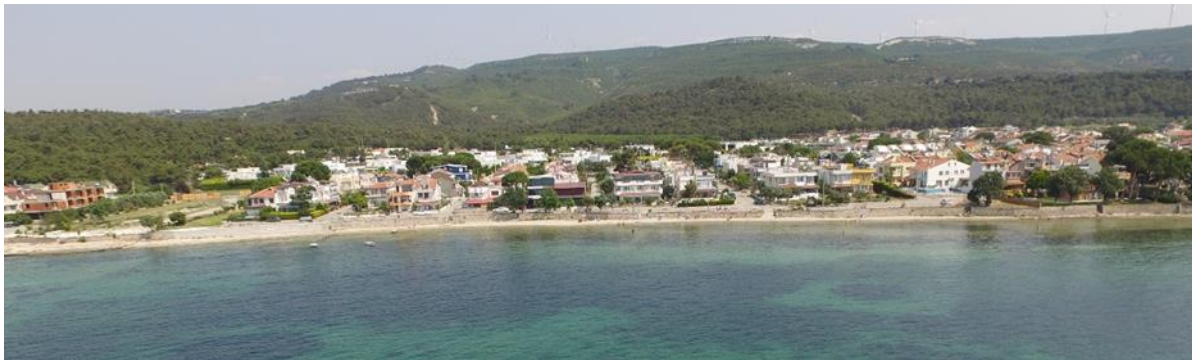
Figure 7. Coastal View (Original. 2023)

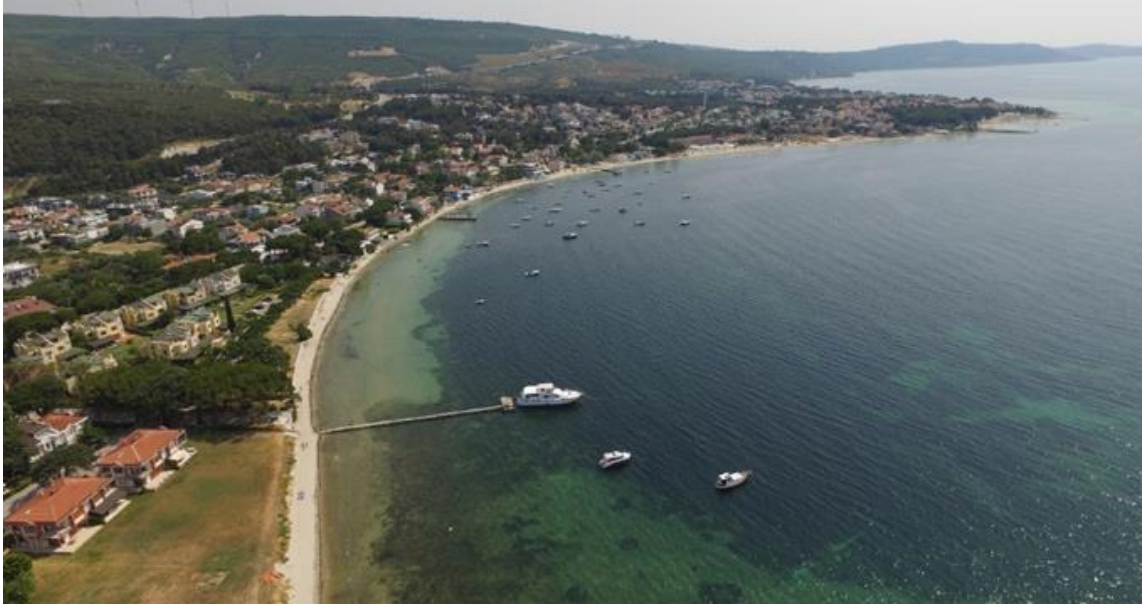
In the study area, it has been determined that there are no arrangement where recreational activities can be carried out in a way to cover the integrity of the coastline. It has been determined that the piers in some parts of the coastline are worn out and create a bad appearance (Figure 8).

Figure 8. Coastline View (Original, 2023)
