**Impact of Glazing on Thermal Comfort, Relative Humidity, and Lighting Level in Office Spaces**

**Abstract**

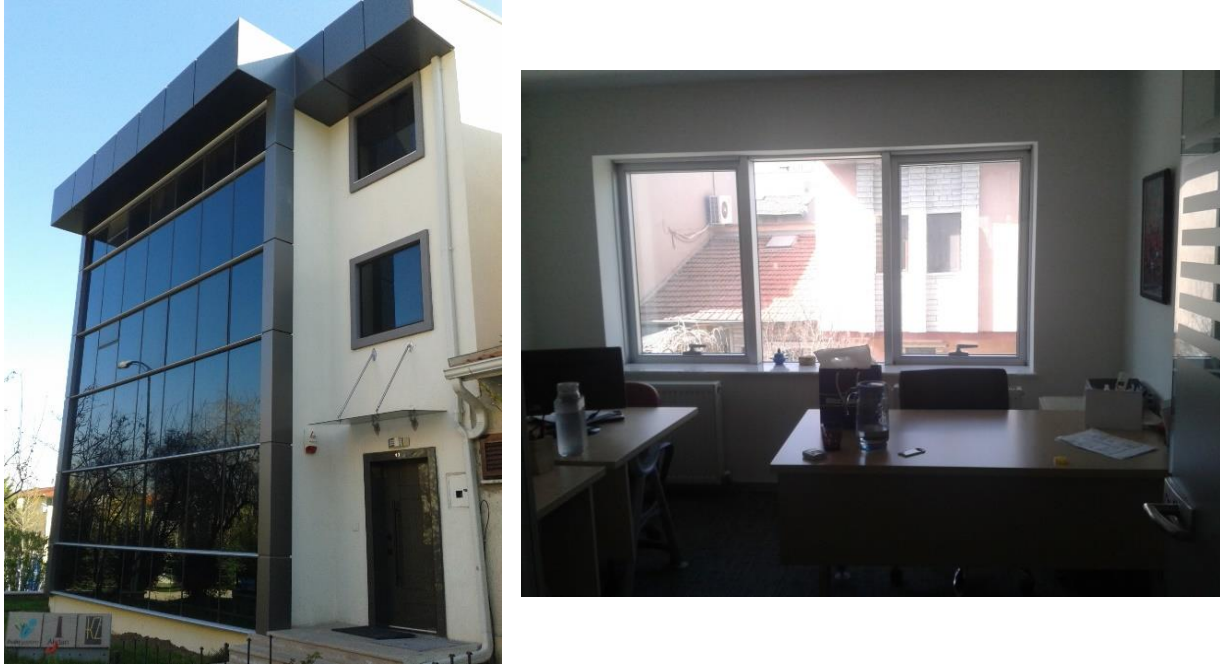
**Figure 2** At left Building 1 exterior picture that examinations were mainly went on. Photo was shot at 21st April, 2015. At right, an interior image of Building 1 showing the exterior walls adjacent to the curtain wall. The photo was shot at 27th April, 2015.

The building has an aluminum curtain wall at attributed façade where measurements are taken. Glazing type is reflective glass.

Heating system of the building is regular combi boiler. However, it was turned off during measurement. Although the facade is curtain wall glazing from outside, interior part has also the exterior walls adjacent to curtain wall, which can be seen in an interior picture given in Figure 2.

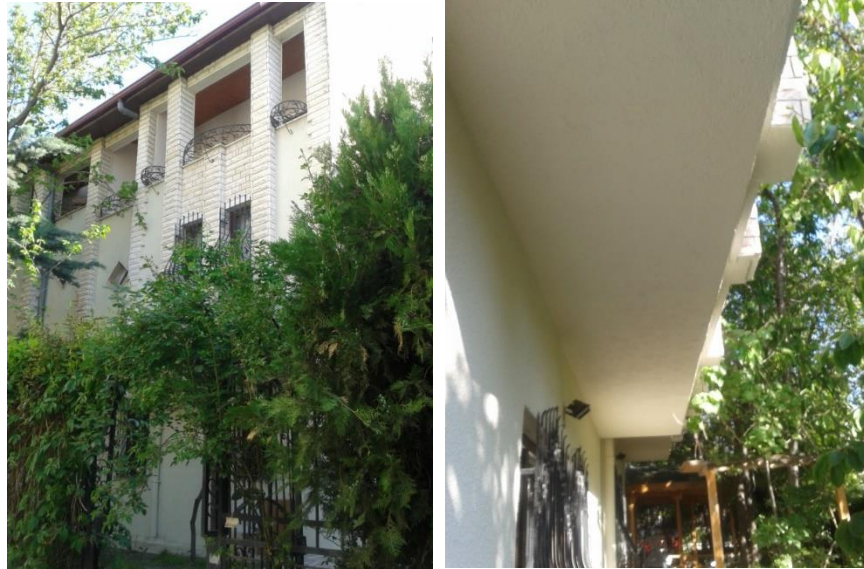
**Figure 4** (Left) An exterior picture of Building 2. Photo was shot at 21st April, 2015. (Right) Building 02 exterior picture (examinations were done in the rooms on this facade). Projection of 1st floor can be identified. Photo was shot at 21st April, 2015.

Building 2 is used by an architecture company. Loggers were placed 3 different levels in place, and all of the rooms where loggers placed are located on southwest facade. Glazing system is timber frame joinery. General outlook of the facade is indicated in Figure 4. Measurements were taken from the southwest facade. There are several possible sun-blockers (trees and shrubs) at the close surrounding of the building.

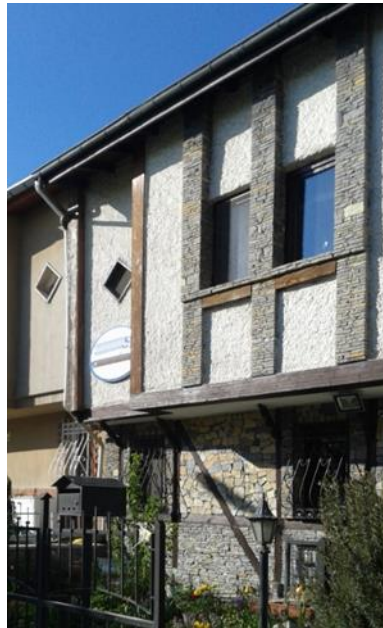
**Figure 6** Building 3 exterior picture representing northeast façade. Examinations were done in the rooms on opposite façade. Projection of 1st floor can be identified. Photo was shot at April 21, 2015, at 8:30 am.

Building 3 is used as an office of a law company. Loggers were placed 3 different levels in place, and all of the rooms where loggers placed are located on southwest facade. Glazing system is timber frame casework. General outlook of the northeast facade is indicated in Figure 6. Measurements were related with the opposite face.

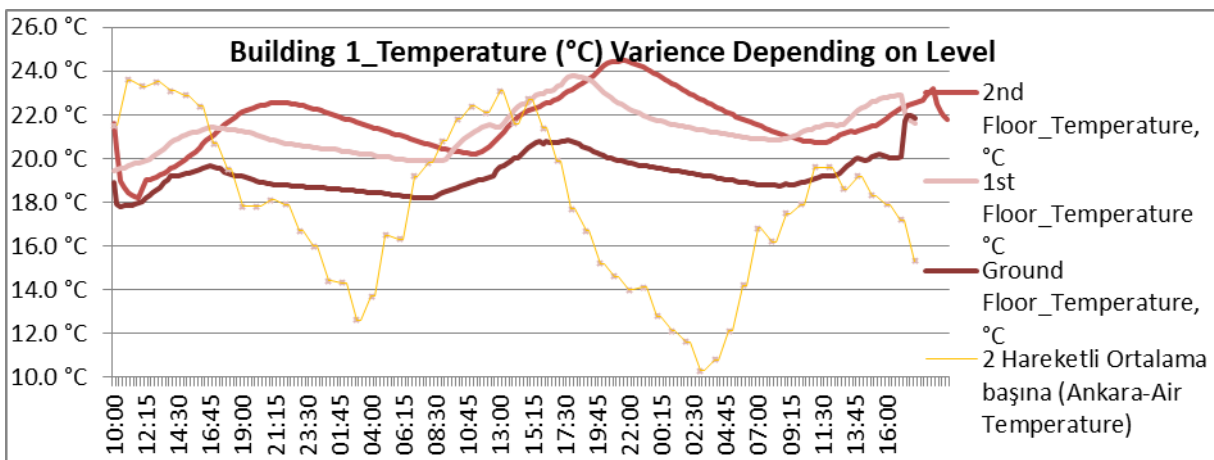
Table 1 represents the temperature measurement of Building 01 in 28th, 29th and 30th of April, 2015. According to the results, the temperature of the ground level is the lowest, and second floor has the highest in general term. In other words, as the level of the room rises, amount of temperature that penetrates inside is increases. Mean values for each floor are 19.27, 21.31, and 21.83°C respectively. The rise of values from ground floor to first floor is greater than first floor to second floor. The reason behind this might be the position of the logger in 2nd floor. The facade of the room where logger put does not have curtain wall façade that is indicated in Figure 1. Highest and lowest values in this building are 24.476°C at second floor and 17.796°C at ground floor. The reference values of ASHRAE (1982) for effective temperature interval office environments is between 22.5 and 25.3 °C.

There are two major peaks at Table 1, between 4-7 pm at first and second measurement day. It is quite likely this movement is related to the orientation (southwest) of the facade. The heating system was closed during measurement, that's why there is no observable effect of it on the curves.

First floor temperature line has a couple of several more minor peaks comparing with other two temperature lines. This can be explained by the user activity. As it is seen in Figure 02, room capacity is for 4 people while others are private rooms. The number of inhabitants plays a role in this regard.

**Table 1** Temperature (°C) graphic of building 1 depending on level / height.

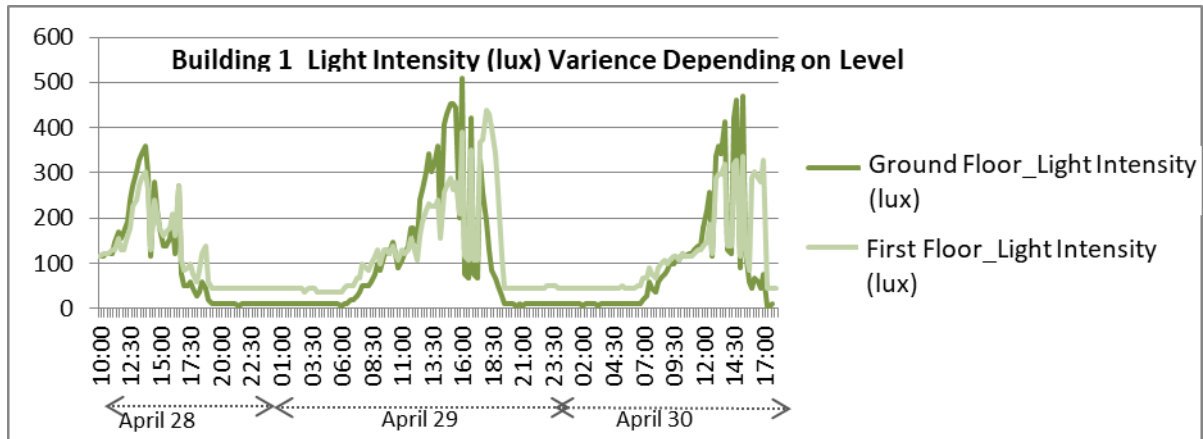
Table 3 shows the light intensity value. HOBO data loggers calculate the light intensity that falls on it rather than average light intensity in the room. The table represents the level of light intensity level in first floor is slightly greater than ground floor as might be expected. Mean values 99.02 and 118.04 lux respectively. The reference values of National Optical Astronomy Observatory (n.d.) in the United States are located between 250-500 lux for various office types, while IESNA recommended 300 lux for computer tasks and the measured mean light intensity level located below this interval. There are several peak points in each floors light intensity curve. There might be several reasons behind this, one of them could be switching on the artificial lighting during the cloudy hours can cause these differences. All three days that measurements took place are weekdays, Tuesday, Wednesday, and Thursday respectively.

**Table 3** Light intensity (lux) graphic of building 1 depending on level / height.

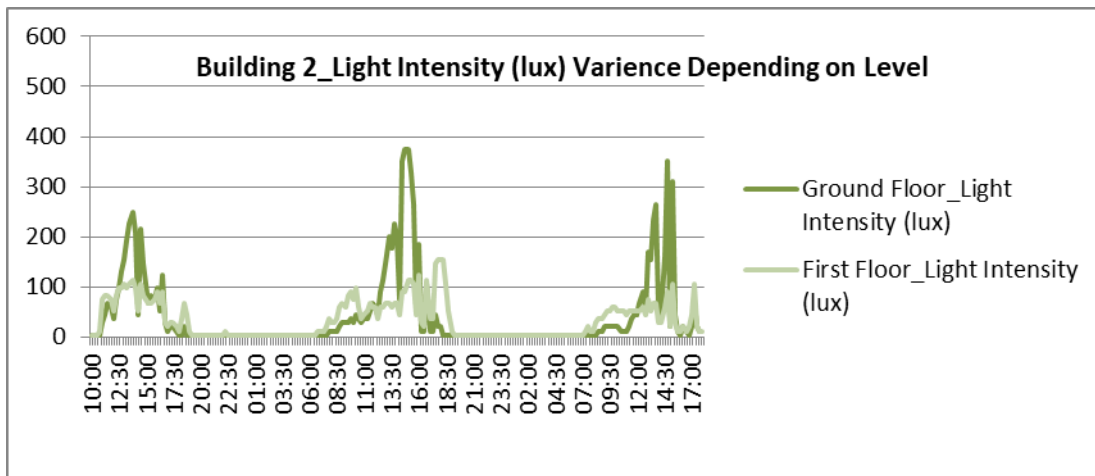
Table 6 shows the light intensity graphic of building 2. The table represents ground floor light intensity level is a little bit greater than first floors. Mean values 42.68 and 34.64 lux respectively. It is an uncommon condition that light intensity level is getting lower by the level is getting higher. The reason for this might be the 10-20 year-old trees in the backyard, the height of them reaches the first floor and this could be blocking the sunlight. There are several peak points in each floors light intensity curve. Switching on the artificial lighting during the cloudy hours can cause these differences, regarding lack of space utilization in first floor. The reference values of National Optical Astronomy Observatory (n.d.) in the United States are located between 250-500 lux for various office types and the measured mean light intensity level located dramatically below this interval in building 2.

**Table 6** Light Intensity (lx) graphic of building 2 depending on level / height.

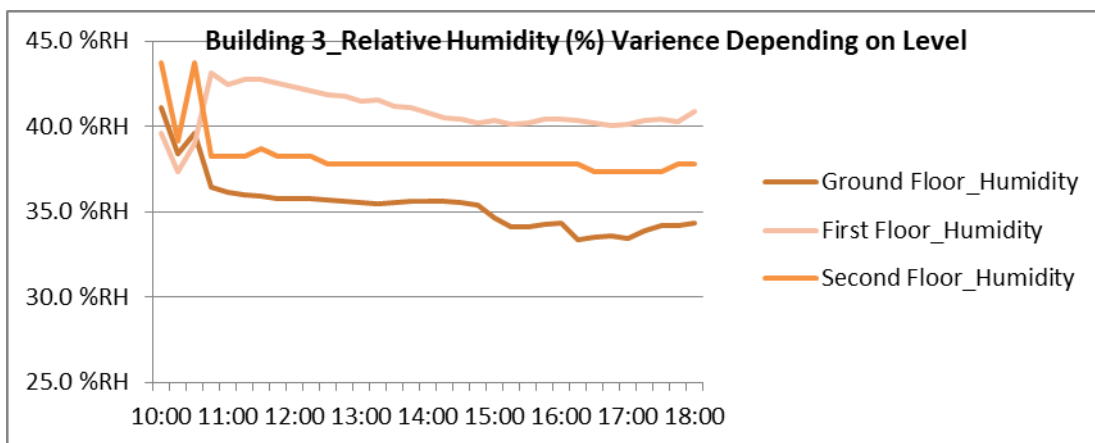
Table 8 depicts the relative humidity measurement of building 3 in April 27. The overall progression of graph shows there is a fluctuation between 10-11 am. Afterward the values of all three floors remain constant. Similar reasons with temperature curves could have influence on. Mean values for each floor are 35.4, 40.87 and 38.22% respectively. Highest and lowest values in this building are 43.7% at first floor and 33.36% at ground floor.

**Table 8** Relative humidity (%) graphic of building 3 depending on level / height.

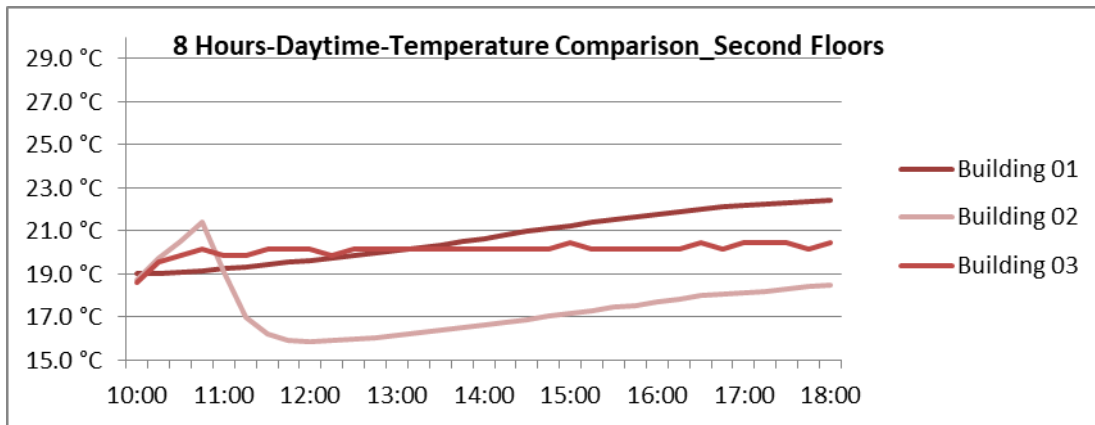
**Table 11** Temperature (°C) values of Building 1, 2 and 3 depending on first floor level.

Building 1 has slightly highest values regarding temperature measurements taken from second floor that is the highest floor level. Mean values for Table 11 are 20.69, 17.9, and 20.11 °C respectively. These values and progression of graph demonstrate Building 1 temperature has greater than others. It should be taken into account that the room of third floor of Building 1 has no curtain wall glazing.

Considering the orientation of the buildings was the same, it can be interpreted as this type of curtain wall has no significant effect on heating as a result of this study. Besides the mean values of three buildings are appeared similar in short-term measurements, there is also no significant fluctuation in day time, from 10:00 to 18:00. Secondly, building 3 is the only building that roof used as an attic, and configured as a pitched roof. This type of variation has no considerable effect on temperature values of the building. Lastly, the height has clear positive effect on heat gain.

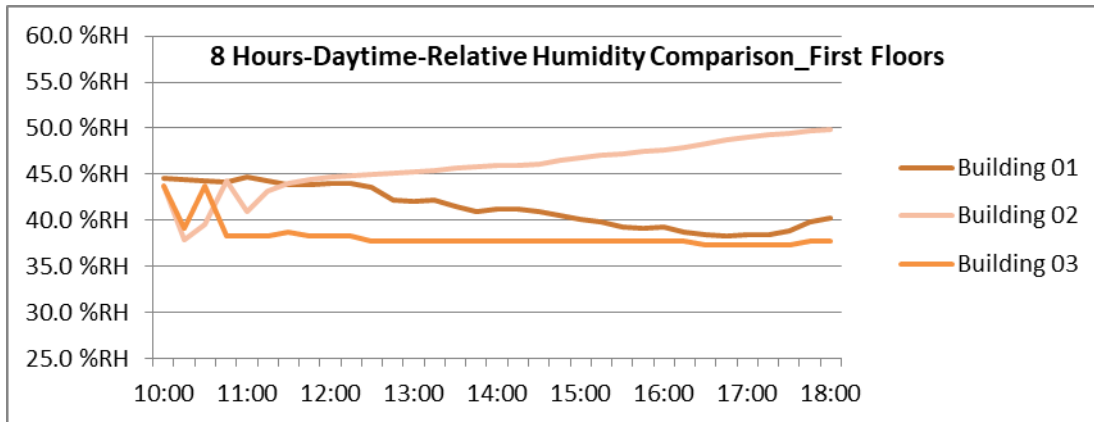
Table 12, 13 and 14 represent the daytime temperature measurement of related subjects on April 28. The overall progression of these three graph shows that RH values of building 02 are greater than other two while Building 03 has the lowest values in general. Considering the ranking, similar reasons with temperature of curves could be influential. Mean values of the ground floor are 49.87, 52.32, and 35.4% respectively while first floors are 41.43, 45.84, and 38.22 and second floors are 40.47, 58.67, 40.87.

**Table 12** Relative Humidity (%) values of Building 1, 2 and 3 depending on ground floor level.

**Table 13** Relative Humidity (%) values of Building 1, 2 and 3 depending on first floor level.

**Table 14** Relative Humidity (%) values of Building 1, 2 and 3 depending on second floor level.

According to ASHRAE standards (1999), relative humidity percentage of a space should be in between 30-60%. Values greater than 70% can cause fungal contamination (i.e. mold, mildew, etc.). Highest value among all is belonging to Building 2 second floor (see Table 05), 64.7%. This slightly exceeds the limits of ASHRAE. The reason behind this might be misinterpretation in insulation layers of roof. Lowest value belongs to Building 1 second floor (see Table 02), 29.4%. This is slightly lower than mentioned standard values.

At overall, it can be seen in three of the buildings that RH has inverse proportion although it is a proved information. That is why, most of the peaks (lowest or highest points) in relative humidity corresponds with the inverse peaks of temperature.

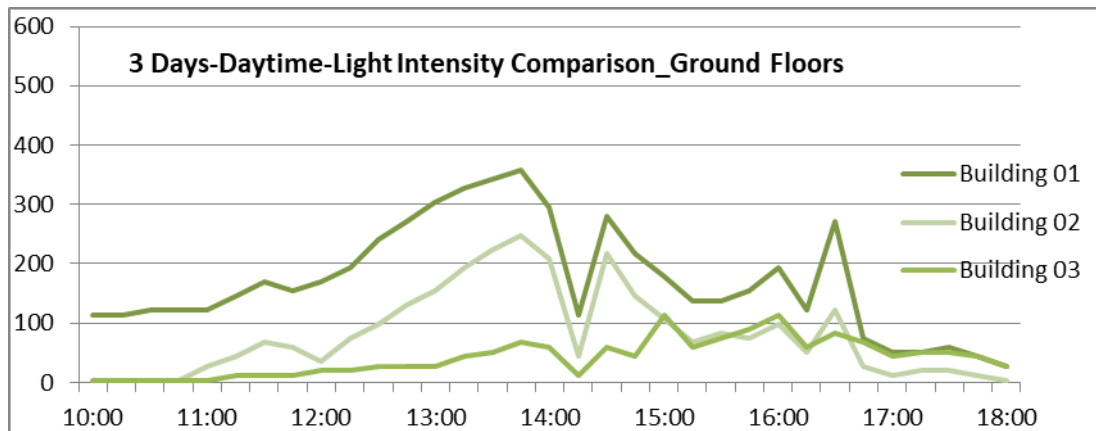
Comparative chart of light intensity at ground floor level is indicated below. Table 15 demonstrates the daytime temperature measurement of related subjects on April 28. Mean values of Table 15 for each floor are 172.12, 81.33, and 42.15 lux, respectively. Considering the graph and mean values, indoor light level is highest in building 1. Curtain wall glazing type and lack of small vegetation's at ground floor level affect light intensity level of the at building 1 positively. Wooden framework, which is used for decorative purposes, may cause the scarcity in light intensity level of building 3.

**Table 15** Light Intensity (Lux) values of Building 1, 2 and 3 depending on second floor level.

During 3-day measurements, occasional lighting level peaks are observed at some points. The reason behind this might be the sudden changes in weather conditions. Especially in 29th and

30th of April, this can be observed more frequently. This means natural lighting and façade articulation is not sufficient for a working environment so that occupants need artificial lighting. The reference values of IESNA (2004) for computer-related tasks is 300 lux, and according to Table 15, natural lighting performance of all three building is low.
