Surrounding Wall of Mimar Sinan's Mosques: Components and Construction Techniques

Nil Orbeyi^{*}

Abstract

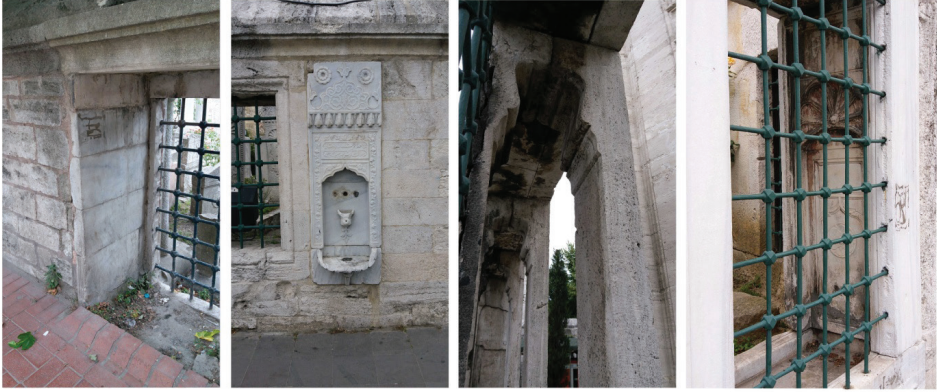
F. 3. The window details of Şehzade Mehmed Mosque; a) Safiye Sultan window *sebil*, b) twins fountains, c) the arcades in the wall thickness of the quadruple windows, d) Gevher Sultan window *sebil* (Author, 2018)

In addition to these common components, some walls have different elements such as fountains, sebils, columns, and arched passages for various purposes (Fig. 3). Orman¹⁷ and Egemen¹⁸ stated that, on the surrounding walls of the Şehzade Mosque, these elements were constructed to the sides or wall thickness of the windows (*hacet penceresi*) which were added in later periods for viewing tombs (Fig. 3). Furthermore, according to Erzen, these additions provided a connection between the structure and the city.¹⁹

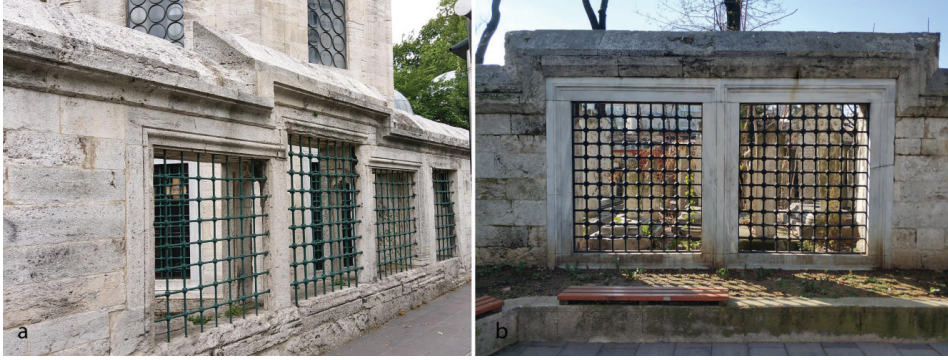
F. 4. a) Şehzade Mehmed Mosque, b) Zal Mahmud Pasha Mosque (Author, 2018)

Visual concern: The positioning of the surrounding wall near a landscape, a main road or an important structure such as a tomb has caused the wall heights to be differentiated at these points. Two such examples of this are the increases in wall height in the Sehzade Mehmed Mosque’s western wall’s windows and Zal Mahmud Pasha’s eastern wall’s windows, which are both located in front of a tomb (Fig. 4). Another example is the surrounding wall in the north-east direction of Süleymaniye Mosque. The wall’s height was reduced in this direction in order to see the Golden Horn.

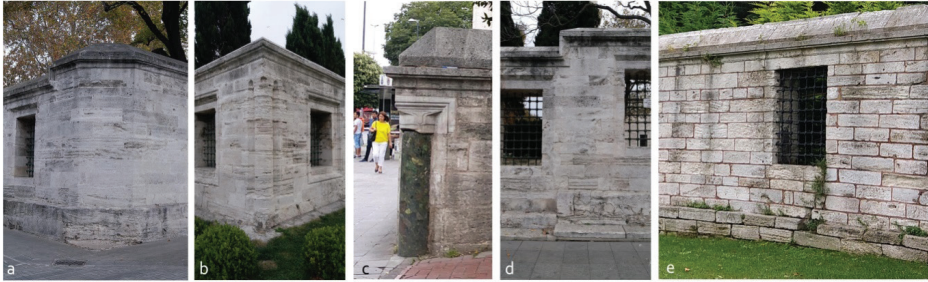
F. 5. The corner turns (*çal köşe*); a, b) Süleymaniye Mosque, c) Şehzade Mehmed Mosque, and the wall base (*duvar pabucu*); d) Süleymaniye Mosque' west surrounding wall, e) Şehzade Mehmed Mosque's north surrounding wall (Author, 2018)

On some walls, it is seen that different elements have been used in order to soften corner turns called "*duvar pahu*, *köşe pahu*, or *çal köşe*"²⁴ (Fig. 5a-b). However, some of them have made an impression in the urban memory with their decorative features. For example, there are assumptions that the green porphyry (*somaki*) column located at the intersection of Dede Efendi and Şehzadebaşı Streets (*Divanyolu*) of the Şehzade Mehmed Mosque pointed to the geographic centre of the city rather than softening

the corner²⁵ (Fig. 5c). The corners of the western and northern surrounding walls of Süleymaniye Mosque are chamfered (Fig. 5a). On the other hand, there are columns at the corners of the southern surrounding wall of the mosque (Fig. 5b). In addition, in some walls, a wall base (*duvar pabucu*) was used at the bottom²⁶. This formation is seen in the Süleymaniye, Kılıç Ali Pasha, and Şehzade Mosques (Fig. 5d, e).

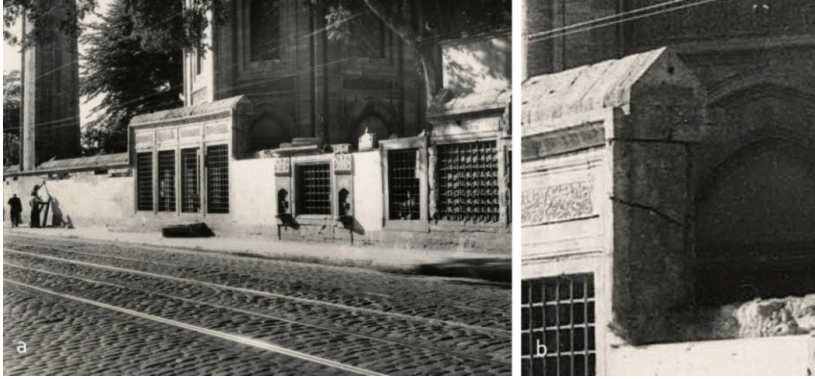
F. 8. Şehzade Mehmed Mosque, 1958; a) Şehzadebaşı Street view; b) the corner detail of coping (Source: <https://saltonline.org/>, TASUH3937 Ülgen Family Archives Access Date: 02.10.2019)

Figure 8 and 9 show that the roof parts, which are missing or standing in an irregular manner, are monolithic and have been constructed independently from the cornice.

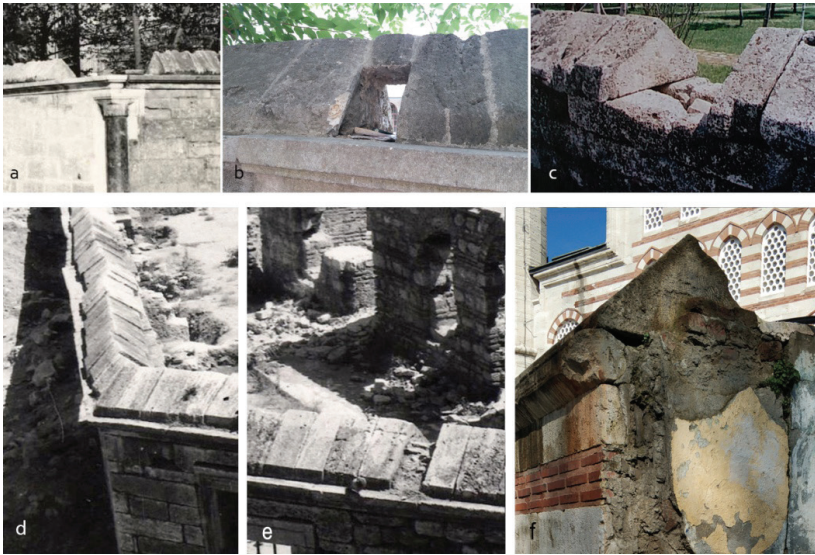
F. 9. a) Şehzade Mehmed Mosque, the coping in the intersection of Şehzadebaşı Street and Dedeefendi Street, 1958 (<https://saltonline.org/>, TASUDOC0190 Ülgen Family Archives Access Date: 02.10.2019),

b) Şehzade Mehmed Mosque, coping detail in Dedeefendi Sokağı, 2018 (Source: Author), c)

Edirne Beyazıt II Complex, coping detail in surrounding wall, 2000 (Source: Tayla, 2007),

d,e) restoration photo of a wall in Süleymaniye Mosque, 1957-1961 (Source: <https://saltonline.org/> Ülgen Archives Access Date: 02.10.2019),

f) Zal Mahmud Pasha Mosque, 2018 (Source: Author)

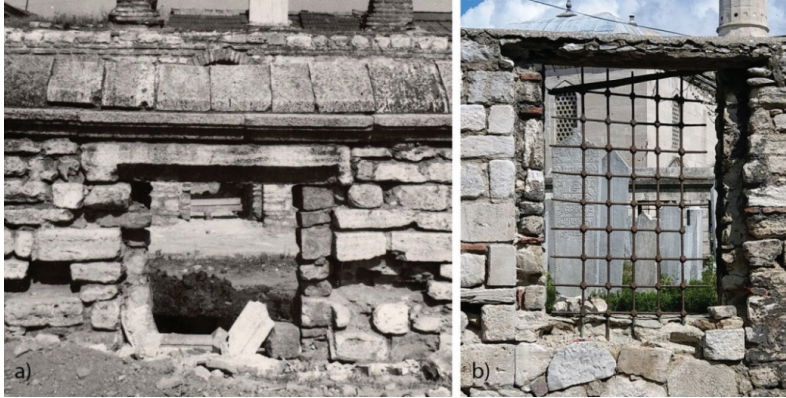
F. 11. Connection details of the jambs with the wall;

a) A restoration photograph of a wall in Süleymaniye Mosque, 1957-1961 ([https://saltonline.org/Ülgen Archive](https://saltonline.org/Ülgen_Archive) Access Date: 02.10.2019), b) The south-western wall of Kara Ahmed Pasha Mosque, 2018 (Author)

- a. The windows with jambs:** All of the windows of the Çatalca Ferhad Pasha and Zal Mahmud Pasha Mosques, some of the windows of the Şehzade Mosque and the Kara Ahmed Pasha Mosque have jambs. The thicknesses of the jambs are in the 18 cm to 28 cm range. Marble and limestone were used as materials. The moldings were generally made of bead, fillet, and hollow sections in different sizes and forms (Table 3, Table 4). Because some windows jambs of the Kara Ahmed Pasha Mosque are missing, junction details of the jambs and walls can be seen (Fig. 10a, Fig. 11b). A similar situation can be seen on restoration photographs dated 1957-61 of the Süleymaniye Complex. The jamb sits in the groove that was made on the edges of the window opening. However, connection details cannot be seen on-site examinations.
