DETERIORATION PROBLEMS AND PIGMENT ANALYSES OF THE QAJAR PERIOD WALL PAINTINGS FROM SHAH BATH IN ISFAHAN

Negin Derakhshan HOUREH¹

Ali Akın AKYOL²

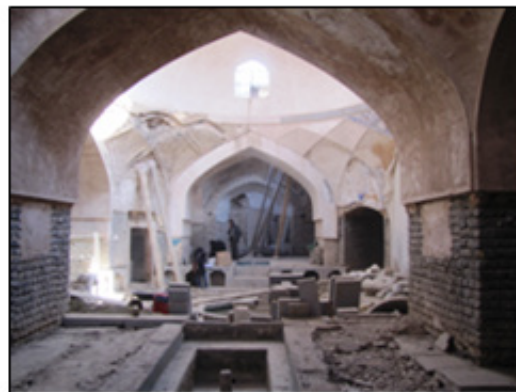
Various decorations have been used in the Shah bath (Fig. 2a-2g). These decorations are related to different historical periods. In the Hashti part of the bath that leads to the Sarbineh, there are two decorative layers: the later layer is painting and the older layer is decoration with lime (Fig. 2c). This decoration with lime belongs to the Safavid era. It has flowers and bush motifs and is made of dark blue (Fig. 2e). On this decoration with lime there is another layer of painting on the gypsum that shows a sitting hero who is related to the Qajar period (Haji Ghasemi, 2004, p.5).

In the western part of the Shahneshtin, there are also three layers of painting (Fig. 2d). The latest layer is related to the Qajar period and depicts heroes. It cannot specifically be determined which period the two older layers are related to. However, since this bath was built during the Safavid period, it can be said that

the older layers may be related to the Safavid period. There is also a painting on the gypsum in the eastern side of Shahneshin, which was hidden behind a wall. This painting behind the wall was discovered during excavations and studies (Fig. 2g). The design of this painting is in Slimi motif which is drawn by arch lines and is similar to the paintings in Ali Gholi Agha bath (Fig. 2f).

There are carvings in the Sarbineh which is the place of shoes and dresses of those who took a shower in this bath. At the top of these carvings, there are tiles that are blue and yellow. Under the dome of the Sarbineh, there are also slimi motifs that most likely belong to the Safavid period. These slimi motifs are known as snake slimi. Beside these slimis, there are paintings which depict angels who have interconnected eyebrows. Interconnected eyebrows show that this painting is related to Qajar period. There were numerous decorations in the Shah Bath, some of which were repaired by Mr. Aqajan. On top of these Slimi, there are tangled motifs around the dome of the Sarbineh some of which have been restored (Fig. 2c).

Figure 2. Decoration of Shah Bath; general view (a), entrance (b), slimi motif (c), layers of the wall (d), decoration on gypsum plaster (e), figures on the gypsum plastered wall (f) and details of the wall paintings (g).

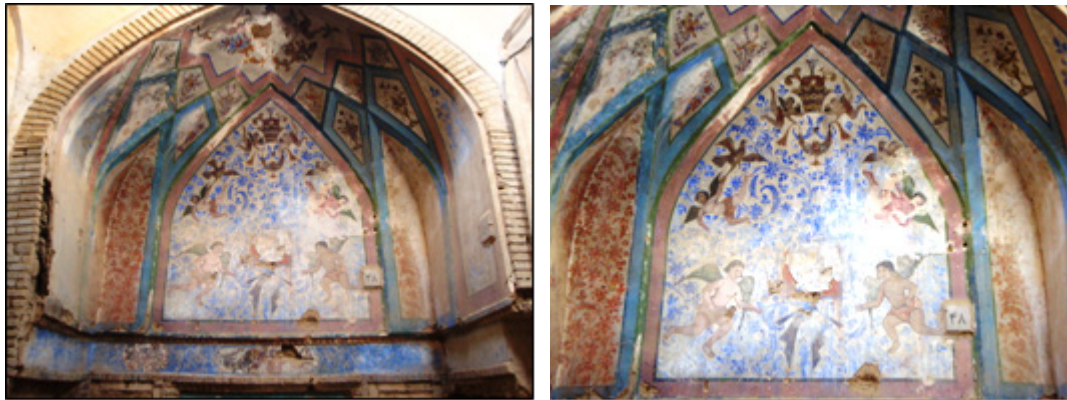
The design of this painting is a combination of blue Slimi motif, angel, and bird motifs. The angels are symmetrically arranged on both sides of the painting, creating a hypothetical square. One of the angels has been repaired in the past incorrectly (Fig. 4).

Figure 4. Paintings above Shah Bath entrance

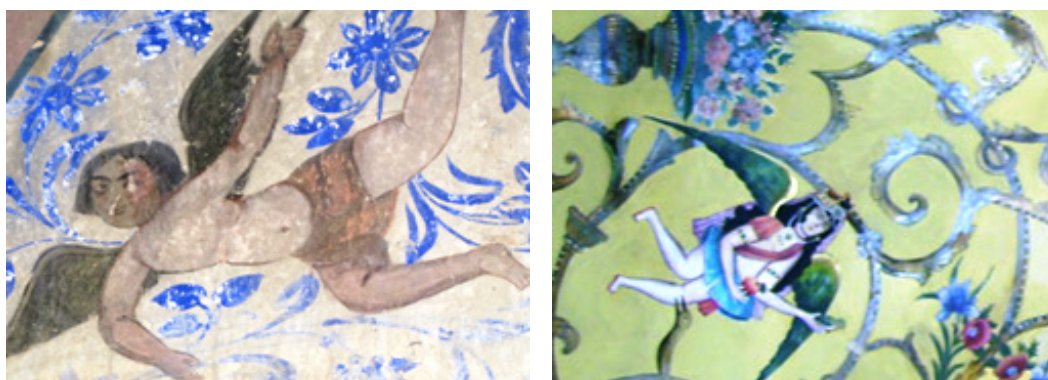
The common theme of these two paintings is the use of the angel motif in both. So, angel motifs which are used in these two paintings will be compared. The angels that have been painted on the roof of the Vasigh al-Dawleh house are females with long black hair and interconnected eyebrows. However, the angels that have been painted above Shah bath entrance are male. The wings of both angels are green, and the shape of their wings are roughly the same. Only the wings of angels in the Vasigh al-Dawleh house are bigger and the tip of these wings are narrower and sharper. The angel's wings of the painting in Shah Bath are smaller and the tip is wider. The angel's hands in the Vasigh al-Dawleh house are located on the same side of the body, but the angel's hands that have been drawn in Shah bath are open and express a flight condition. The shapes of the legs of both angels are slightly bent and apart. Only the angel's legs in the Shah bath are

more open than the other angel. Eventually, the form and motion of the angel in the Shah bath is smoother and more realistic than the angel in the house of Vasigh al-Dawleh (Fig. 5).

Figure 5. Paintings above Shah Bath entrance (on the left) and roof paintings of the Vasigh al-Dawleh house (on the right) in Isfahan.

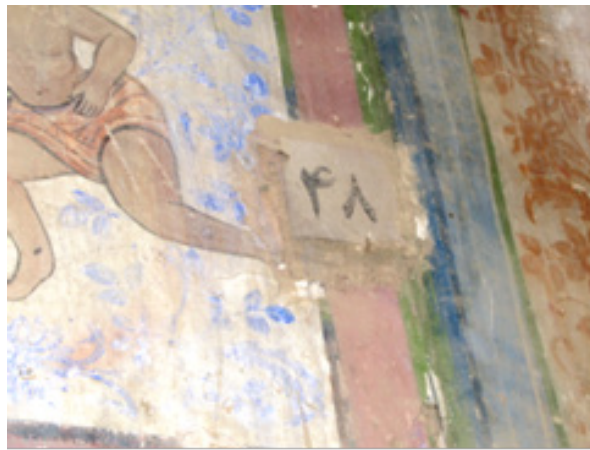
b)

The municipality has stuck a card plaque on the right side of the painting which caused damages and destruction. The card plaque was stuck to the painting with the gypsum mortar that initially caused part of the painting to be hidden under the card plaque, and secondly, the mortar on the painting damaged the paint layer. Even to remove the card plaque from the painting, part of the paint layer will be removed unwisely and damage the painting (Fig. 7b).

Figure 7. Deteriorations of the wall paintings; Knocking a nail on the painting (a), sticking a card plaque on painting (b), pouring the paint (c), improper restoration (d) and cracks (e).

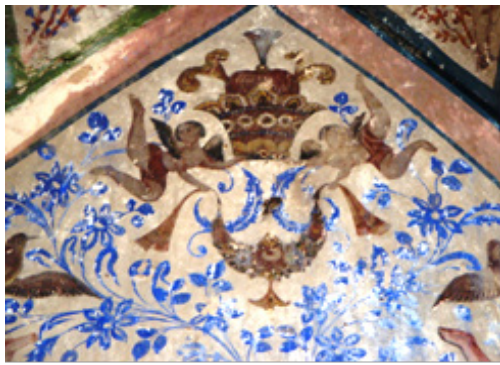
Figure 8. Deteriorations of the wall paintings; damages caused by atmospheric pollution (a and b), loosing paint layer (c) and loosing paint and substrate layers together (d)

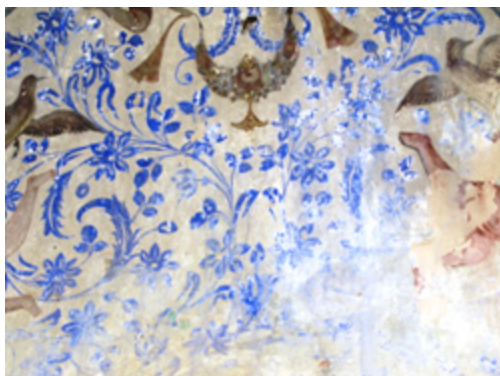
c)

Loss of pain binder results in loss of paint on the substrate layer. The binder causes the paint to stick to the paint layer, losing its adhesion to the substrate, and its removal from the surface of the substrate (Fig. 8c).

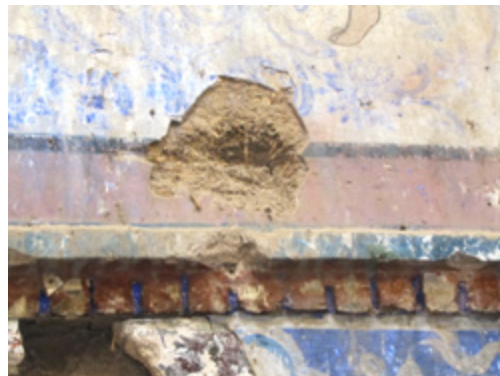
d)

Due to the absorption of moisture (ascending, descending and sweating) by the straw in the mortar, this layer is swollen and pushes the next layers of the painting like substrate and paint layers by internal mechanical pressure and causes the layers to drop. Drift of the earth causes a waste of the bond between the layers and, as a result, the layers are separated and fall. External mechanical pressure by humans, such as knocking down the nail, cause the layers to fall (Fig. 8d).
