## DETERMINATION OF THE DISTORTIONS OCCURRING IN THE ENTRANCE PATH OF THE NEMRUT CALDERA NATURAL MONUMENT AND THE PROPOSAL LANDSCAPE STUDIES

**Please cite this article as:** Alp, S., Yeler, O. and Mutlu, B. (2019). Determination of the distortions occurring in the entrance path of the nemrut caldera natural monument and the proposal landscape studies, *Turkish Journal of Forest Science*, 3(2), 149-158.

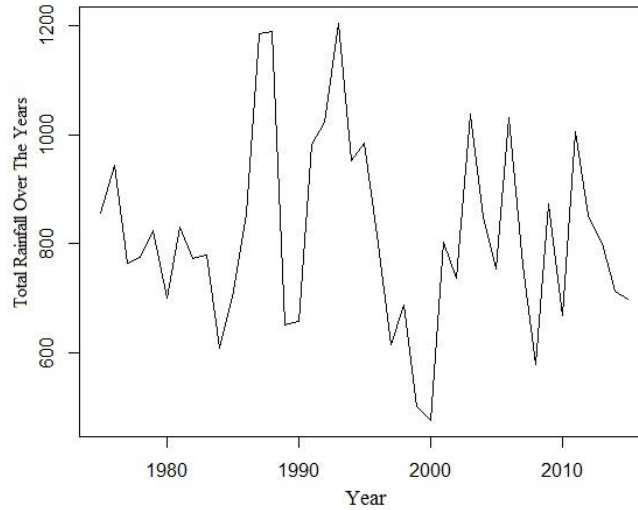
**Figure 2:** Total Rainfall Chart Of The Study Area By The Years (Anonymous, 2018).

The average annual temperature of Tatvan is 9.0 °C, and the average annual rainfall is 844 mm. The driest month is July, with 6 mm of rainfall. The most precipitation falls are in April, with an average of 124 mm of precipitation (Figure 2). In the region, July is the hottest month of the year with a temperature of 21.3 °C. The average temperature in January is -2.5° C, being the lowest average of the year. In the region, there are an absolute frost for three months and a likelihood of frost for five months, but also a moderate dry period until mid-June to early October (Anonymous, 2018).

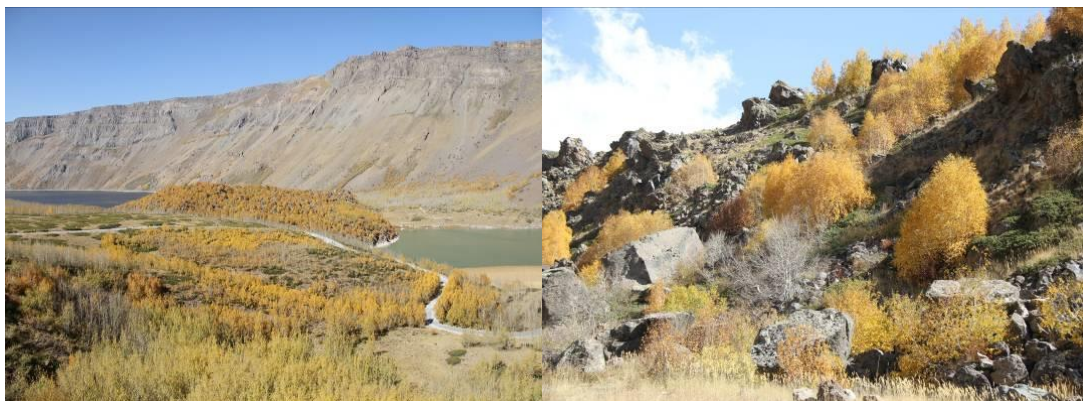
When the plant material in the area is examined, there is no forest formation in the research area (Figure 3). In Nemrut caldera, there are trees, shrubs and bush species that have been intensified around two lakes. Predominantly seen trees in the region are *Betula Paddy Roth* (huş), *Populus tremula* L. (quaking aspen), *Juniperus communis* L. subsp. *Nana* Syme (dwarf juniper), as well as, *Acer platanoids* (sycamore), *Sorbus* L. (rowan tree), *Frangula llnus* (alder

**Figure 3.** Image Of Existing Plants In The Workplace (2018)

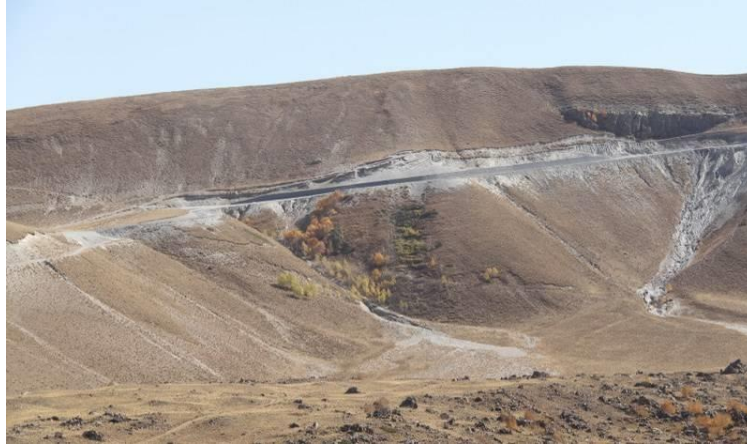
Due to the fact that pyroclastic rocks were not cohesive, the flows and slippages caused by surface waters were observed through the in situ investigation (Figure 4). These flows

continue along the slope surface towards the depths depending on the thickness of the mass and threaten the current path. The wedge surface formed in deeper was not observable.

**Figure 4.** The View Of The New Road In Nemrut Caldera Nature Monument From The Direction Of Tatvan (2017)

First of all, geotechnical design projects have to be created to prevent the slippage caused by the transportation road. To create geotechnical design projects, geotechnical parameters of the slippage surface must be produced. As a result of observational evaluations, it is necessary to perform drilling and geophysical studies starting from the entrance of Nemrut Crater for geotechnical purposes and to determine the thickness and physical properties of this loose-featured unit in the upper layer. To form geotechnical bearing structures (retainer, bored pile, etc.), it is necessary first to make a 1/1000 or 1/2000 scale map acquisition in the vicinity of the study area and then to determine the geological surface map, drilling locations and geophysical points on this map (Alp et al., 2017).

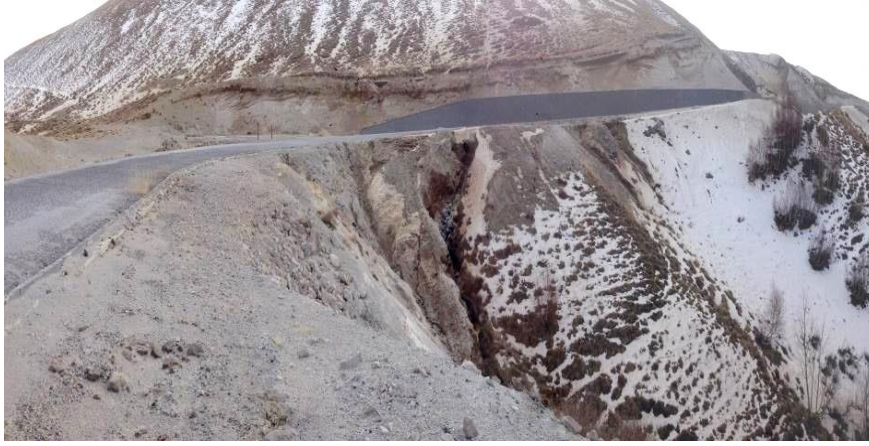
While designing the highway at the entrance of the Nemrut caldera, it was observed that the stabilization of the existing slopes was not made. These stabilization studies are one of the important issues that should take place in the first phase of the project. The applications of the road making work promote the formation of new slopes and current flows of the slopes. After all, the opened road leads to damage to the caldera (Figure 5)

**Figure 5.** An Image Of The Flows And Slippages Observed In Pyroclastic Rocks At The Entrance Of The Nemrut Caldera Natural Monument (2017)

- Local seeds should be used in the sodding of the sloped surfaces with the method of hydroseeding, sloped surfaces must be laid with stone, plastered with spray mortar.
