Ege Üniv. Ziraat Fak. Derg.,2020, 57 (4):
467-477 DOI: 10.20289/zfdergi.634651

**Examination in terms of accessibility and use of place of
Unimpeded Wellness Center: The Case of Ankara**

Engelsiz Yaşam Merkezinin Erişilebilirlik ve Mekan Kullanımı Açısından
İrdelenmesi: Ankara Örneği

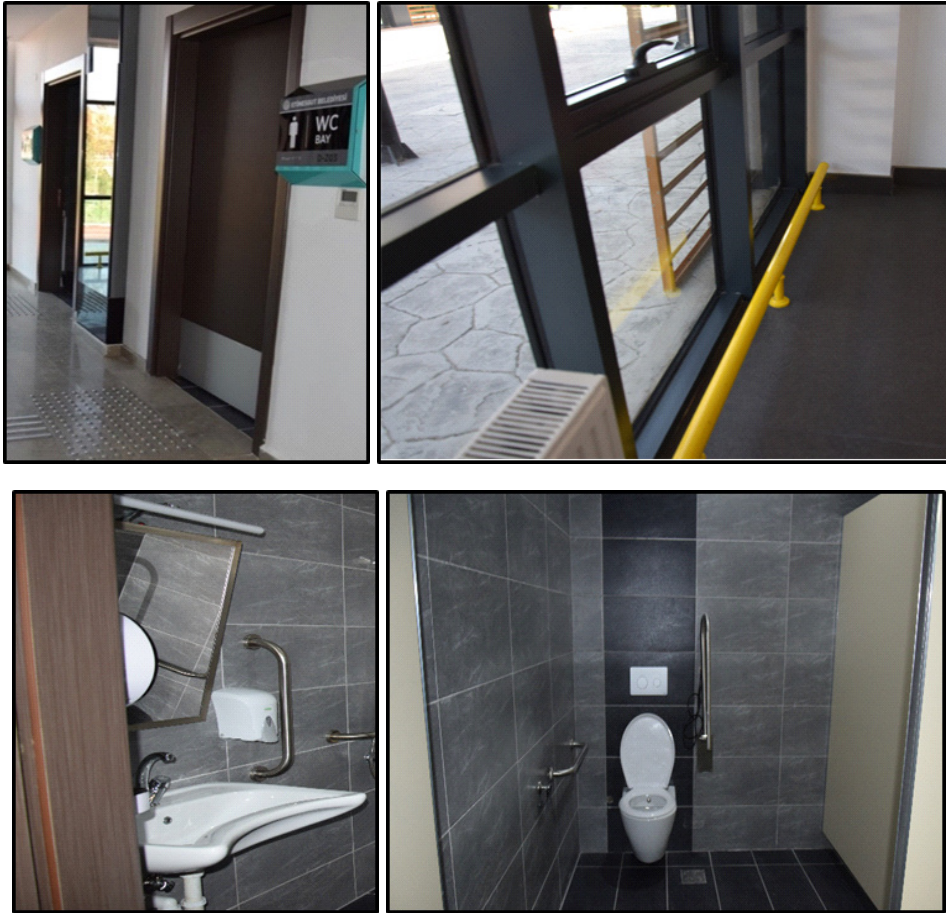
In the facility, the dimensions of the interior doors were 110 x 220 cm, and these measurements fit the TS 9111 standards that recommend at least 90 X 210 cm. proposed net is at least 90 x 210 cm. For easy opening, the door opening direction is organized in a way that is perpendicular to the corridor axis. Braille was used

on the doors' mechanisms, suitable for individuals with disabilities. On the interior doors, protective plates were used at the door slamming height and the door leaf width (Figure 2).

In TS 9111, the floor or floor area dimensions are specified as 76 x 122 cm. These measurements were met for the wheelchair user who were waiting or moving inside the building. In the windows used in the building, 15 cm high parapet was constructed according to the standards under the window to prevent the visually impaired individuals from being damaged by crashing into the glass. In order to prevent other collisions, the disabled barriers with distinct colors were placed at a height of 20 cm from the floor for the visually impaired (Figure 2).

Figure 2. Door protective plates, disabled barriers and restroom samples (Original, 2018)

The restrooms for the disabled individuals in the building were located on each floor next to the group and individual activity classes. This is important in terms of having an accessible route to the toilets. The size of the toilet cubicle was 200 x 220 cm. This meets the criterion of the TS 9111 which wants at least a minimum standard of 150 cm width around the toilet bowls. Toilet doors were opened to the outside, and designed to be opened from the outside in case of emergency. In the toilets, motion-sensitive lighting was preferred, and emergency call apparatus was installed. Double-sided holding tapes were used, which are positioned to allow easy passage from wheelchair to the toilet bowl. The toilet paper and siphon handles were installed for easy access and according to the standards. The use of pedestal sinks was avoided, and no cabinets were installed under the sinks. An empty floor surface in front of the sink was designed and a knee space under the sink was provided to create comfortable access to the sink with the wheelchair. For individuals who have difficulty in standing up, a holding band was used on one side of the sink. The liquid soap dispenser was installed at 80 cm high, and the towel holder was installed 100 cm high. The mirror was fixed for the eye level (110-130 cm) of the individuals sitting in wheelchairs. Fixed mirrors

but with an elevation of 10 were preferred. The toilets in the building were designed according to the standards given in TS 9111 (Figure 2).

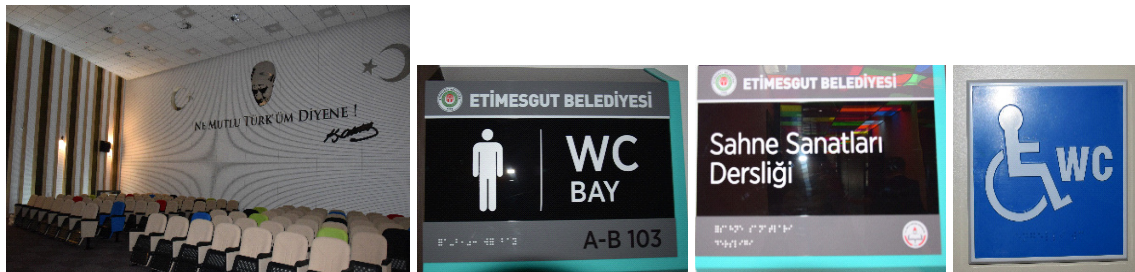
Indoor transportation was examined according to stairs, surface texture and signs specified in TS 9111 standards (Figure 3). During the indoor transportation, the width required for the 180° turn of a wheelchair in the corridors and halls is at least 150 cm. In the facility, in some places, this length was up to 170 cm. Disabled elevators were installed in each floor of the building and 150 x 150 cm space is left in front of the cabin for the usage purpose. The control panel buttons inside the elevator were placed so that they can be used by the visually impaired.

Floor and linoleum surfaces used indoors and outdoors were non-slip, stable, strong, fixed, hard and durable. In the center, no carpets were used outside the nursery and conference rooms. The carpet used was fixed on the ground, and placed in a way that does not impede wheelchair users. The signs used in the building were legible for the visually impaired and wheelchair users so that everyone could read. Symbols and written information supported by symbols were also used in places.

Figure 3. Indoor transportation, floor, linoleum surfaces, sign and symbol samples (Original, 2018)

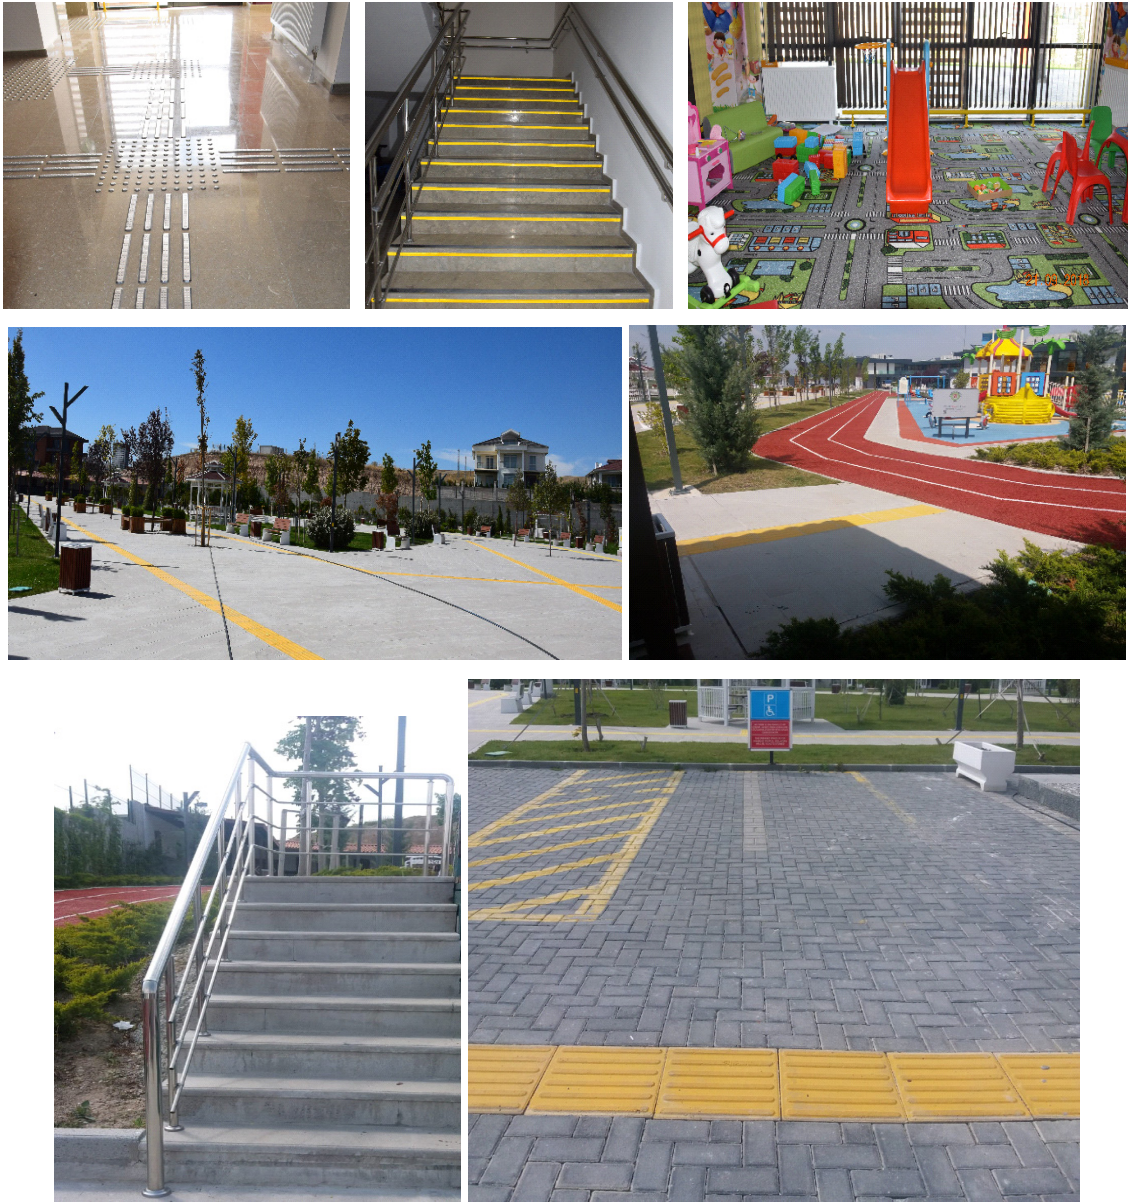
The width of the narrowest walkway in the open area of the center is 300 cm. This was found appropriate for the wheelchair users' maneuvers. TSI stated that the walkways should be at least 150 cm. In the open space of the center larger hard grounds were present.

Ramps are very important for the disabled people because they provide comfortable and safe passage for them. There are a couple of ramps in the open areas of the center. With a width of 250cm and a slope of 4%, one of them is in the parking space in the open area. There is another ramp to go down to the sports area. The width of this one is 300 cm and its slope is 1%. There is a ramp to go up to the exhibition area. The width of this one is 300 cm and the slope is 1%. Finally, there is an area within the walking track with a width of 250 cm and a slope of 6%. The ramps that were found were constructed appropriately for disabled

individuals. The area in the walking tract, the one area with the highest slope, is accepted as usable according to standards (Anonymous, 2015). In the open space of the center, the elevation difference between the children's playground and the activity area was solved by a railing staircase. The step sight of this staircase is 30 cm, and the step height is 15 cm. It is appropriate for double-sided transportation. With a width of 150 cm, the staircase has seven steps. The only staircase used in the open space is located here and it is in compliance with the TS 9111/TS 12576 standards' stair conditions (Figure 4).

Figure 4. Roads, ramps, stairs, car park and sign for disabled people in the field (Original, 2018)

There is a parking space in the center that hold a total of 69 cars and three buses. The car parks are distributed to the entrances and exits in different areas of the center. 20 of these parking spaces have been allocated for disabled people. TS 12576 standards state that the width of a parking space for disabled people should be at least 360 cm. The standards also state that for wheelchair users, there should be an appropriate access corridor between two standard parking spaces (250 cm wide). When the disabled parking spaces were examined, it was found that 100 cm wide access corridor was left between the two standard parks. Although this corridor is appropriate for people with disabilities to move freely, it is recommended that this width be 150 cm in some sources (Anonymous, 2010). There is also a parking sign for disabled people in the car parks.

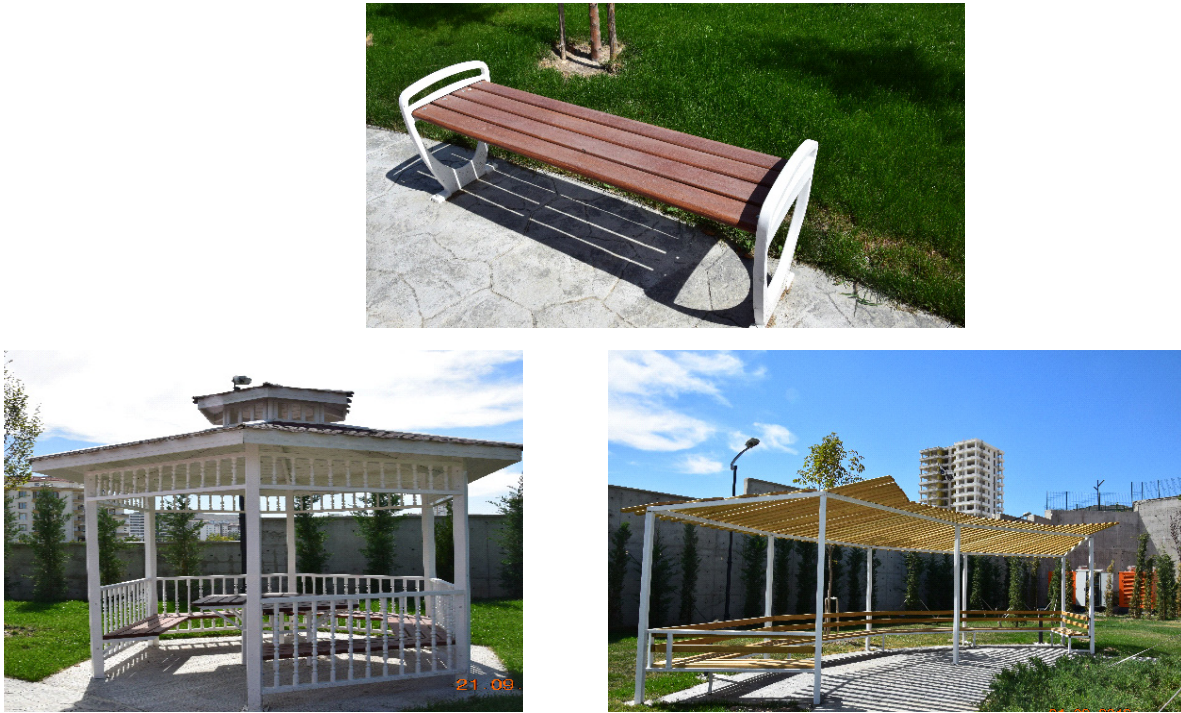
Having a large open space, the facility has created resting areas consisting of 133 benches, 10 camellias and a pergola. Although the benches are enough to meet the resting needs of the visitors, it was determined that they may prevent the pedestrian flow due to the fact that they are positioned in the open space without creating any resting areas for them. It was also revealed that some of the benches did not have backrests. Depending on the disability type, these kind of benches may not be ergonomic. TS

12576 seating unit standards state that in areas with seating units, there must be a horizontal free space with measurements of 75cm X 120 cm. In the open space of the center, there was no area that did not meet this criterion.

The camellias used in the area are at the same level with the pedestrian path. Therefore, this does not constitute a problem for wheelchair users while they enter and exit the facility. However, it was determined that the camellias used were not very appropriate for wheelchair users and that the table in the camellia could become an obstacle. When a wheelchair user uses the camellia, this may cause problems for other individuals while they enter and exit the camellias. The pergola in the area is preferred because it does not constitute a problem for the wheelchair users while they enter and exit the pergola (Figure 5). It was found that seating units under the trees found in the open area of the facility were not appropriate for disabled individuals. In the usage of this type of seating units, it is important for different user groups to use these units together and for these units to meet the needs. It is also important because the fact that users cannot be distinguished from each other will eliminating the feeling of isolation and contribute to disabled individuals' socialization.

Figure 5. Resting area and some equipment elements (Original, 2018)
Şekil 5. Dinlenme alanları ve kullanılan donatı elemanları örneği (Orijinal, 2018)

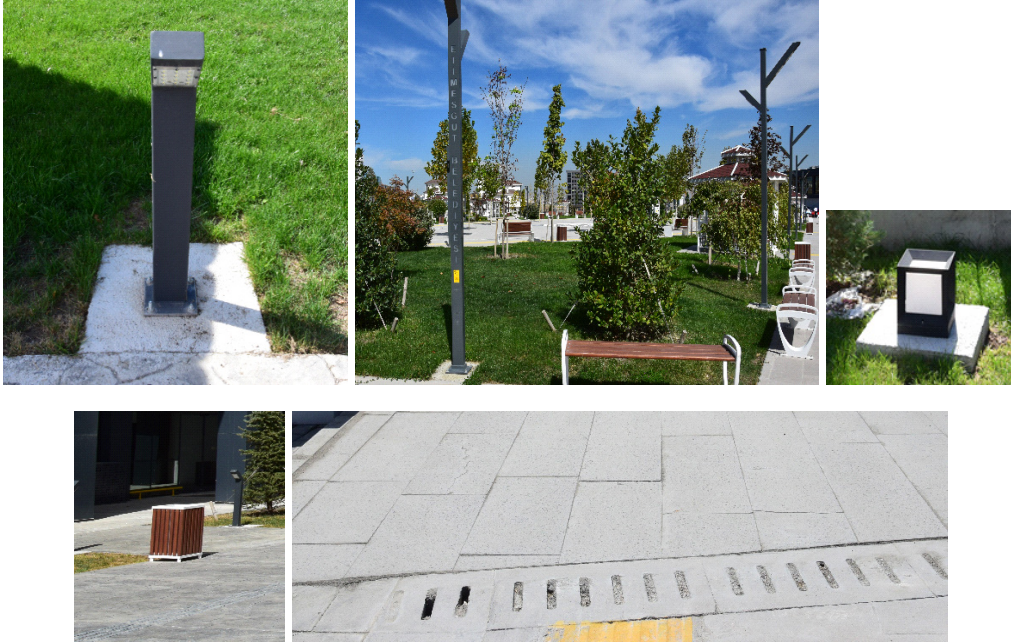
Amongst the equipment elements, lighting elements, trash cans and grates used in the field were evaluated according to TS 12576, Universal Standards Guide for USTAD for the Disabled, and Accessibility Basic Information Technical Manual for Local Administrations. It is stated that the height of the lighting elements should be at least 230 cm from the ground. In some studies, it was expressed that this height should be at least 210-230 cm for safe head distance (Anonymous, 2011b; Kuter & Çakmak, 2017; Yılmaz et al., 2017; Aygun et al., 2018). There were many different types of lighting in the center for individuals with visual problems. Thus, a complete and sufficient level of illumination of the area was ensured.

In these kind of areas, it is important to illuminate by taking anthropometry into consideration for wheelchair users. When the trash cans and grids are examined, it is an important factor not to place these so that they do not constitute obstacles on pedestrian roads. The trash cans that were used were placed on the sides of the pedestrian road. It is stated in the standards that the height should be at least 90 cm and not more than 120 cm. The trash cans used in the center are appropriate to the height standards. The width of the grates used in the center is below 13 mm as specified in the standards. Therefore, it does not pose a danger for wheelchair and cane users (Anonymous, 2015) (Figure 6).

Figure 6. Lighting elements, trash cans and grates used in the field (Original, 2018)

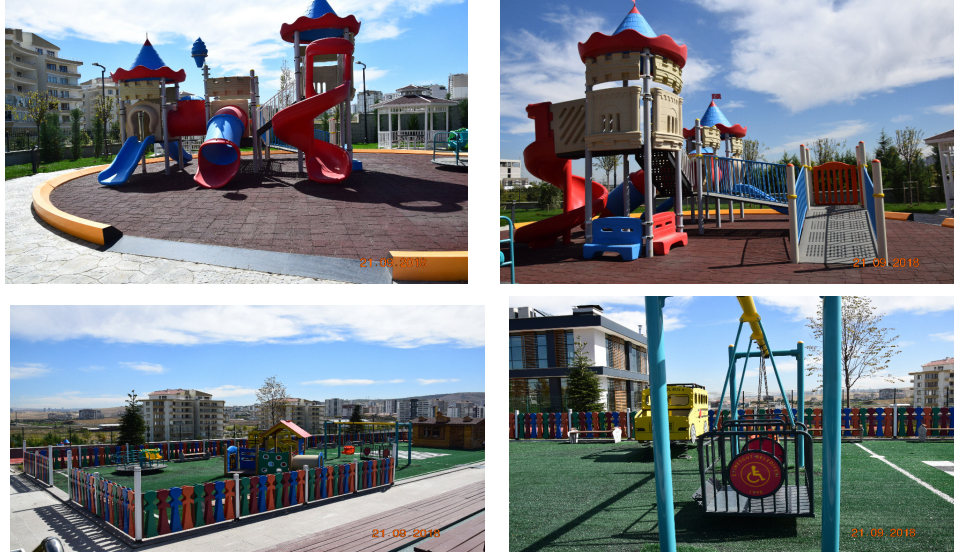
At the center's open area, there are two playgrounds and one activity area seen as a playground. One of the playgrounds is 375 m², the other is 134 m² and the activity area is 307 m². In the playground and activity area, appropriate play equipment is used for disabled children. The play equipment is placed so that all children can share the space. Artificial turf carpets and soft floor pavement were preferred to prevent for the ground so that the ground does not create an obstacle for the wheelchair using children and so that they do not create danger depending on the weather. Resting areas for the families were also built considering the fact that children will come to the center with their families (Figure 7).

Figure 7. Playgrounds and play equipment in the field (Original, 2018)

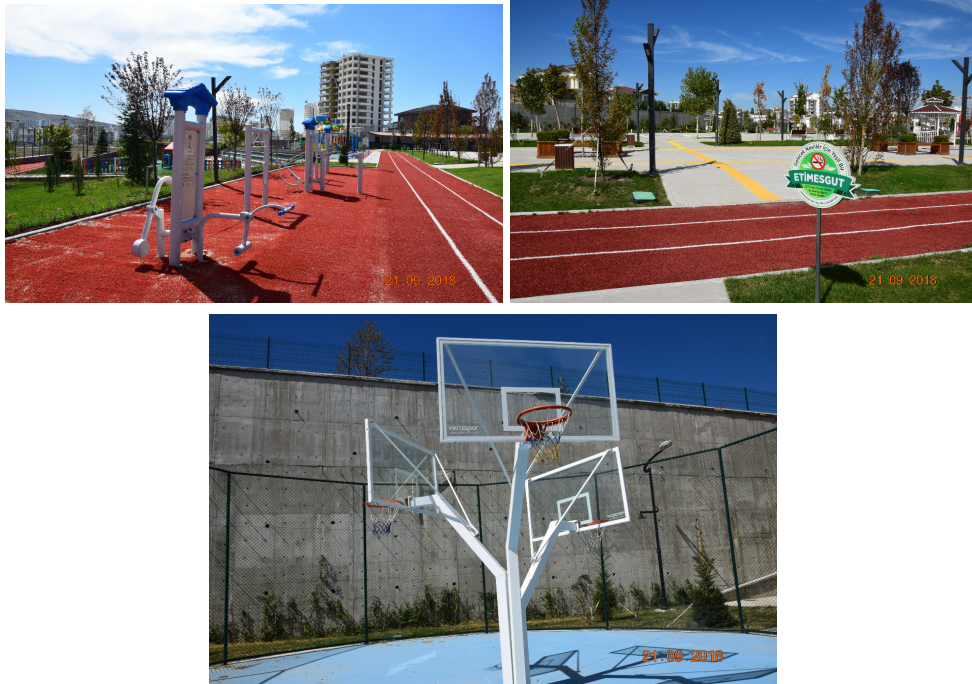
There is an exercise area and a walking tract appropriate for the use of abled and disabled individuals in the area and a 1333 m² basketball court with three baskets at the appropriate height standards, separated by a wire mesh. While providing physical, mental and physical empowerment, sports also allows the person to feel psychologically well by enabling him or her to socialize. It also has a therapeutic quality for disabled individuals. When appropriate conditions are created, disabled individuals can also take part in sports activities in which healthy individuals participate in. Exercise equipment used along this line should be preferred in different hand sizes for activities such as holding, bending and pulling. Floor coverings should be in such

a quality that they should not cause any injuries in case of fall or collision. Adequate space should be left in the sports field for the disabled people using vehicles or for their attendants. In addition, maintenance of the equipment elements in outdoor sports areas should be made regularly, and the site should always be clean and safe (Çelik et al., 2015). In accordance with

the aforementioned, nothing was found to prevent the disabled people using the sports field (Figure 8).

Figure 8. Samples of exercise equipment, walking tract and basketball court (Original, 2018)
