# WORK RELATED INJURIES AND EXPOSURES AMONG EMERGENCY MEDICAL SERVICE PERSONNEL DUE TO INTERIOR DESIGN OF AMBULANCE

**Keywords:** Ambulance, emergency medical services, work-related injuries, ambulance interior design, ergonomic design.

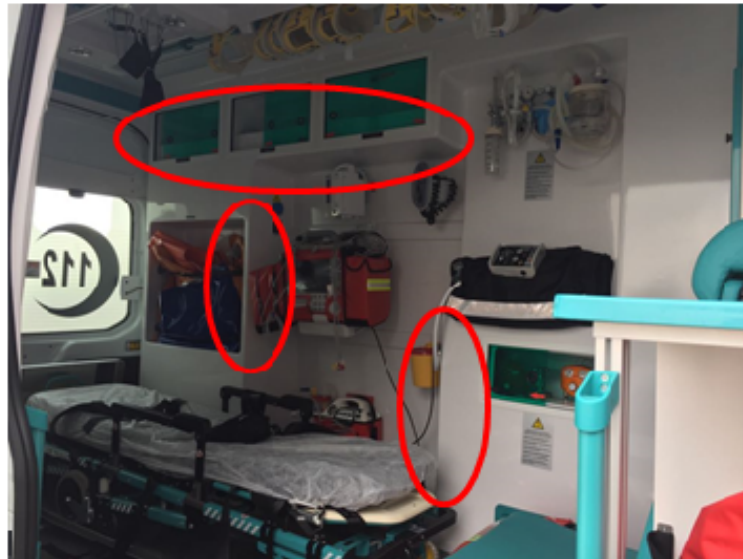
During treatment and transportation process, on active duty in the ambulance, medical staff hit their heads etc. on sharp corners such as cabinet edges, drawer edges, ambulance

side wall edges, device edges (Figure 2), which leads to physical injury.

**Figure 2:** Sharp corners in the cabin.

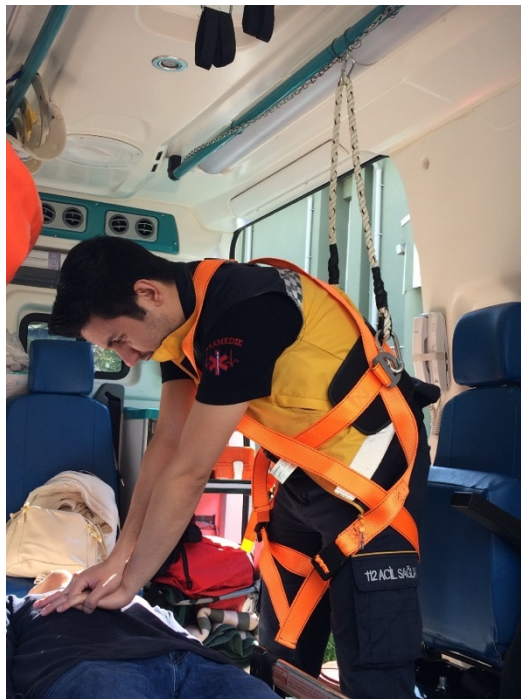
**Figure 3:** A waist belt in an ambulance.

The personnel fail to perform the treatment in the ambulance while the seat belt is fastened (%59). Since the internal capacity of the ambulances and the size of the stretcher is rigid, the seat width must be adjusted by taking anthropometric measurements while the staff are sitting on the seat. Thus, after the size of the seat is determined, the seat is adjusted to move to the right and to the left with the seat's pedals through the sliding mechanism installed in the ambulance for the treatment seat next to the patient and the seat becomes movable to lift up and down according to the size of the personnel. Staff can immobilize the seat to right-left and up-down when needed. However, it is necessary to unfasten the seat belt and probable stand up from the seat for treatments such as taking equipment from the shelf, inoculating and cardiac massage. In this case, since the ambulance is in motion, the personnel would most probably have an accident. In such a case, a waist belt (Figure 3) around 50-60 cm long should be used which is attached to the clasps on the roof of the ambulance to prevent skidding in the event of impact.
