The Abandoned Khan of Louroujina, Cyprus: A Case Study of a Vanishing Building Type

Marko KIESSEL – Sevinç KURT – Yasemin MESDA*

Metruk Lurucina Hanı (Akıncılar, Kuzey Kıbrıs): Yok Olan Bir Yapı Tipi Üzerine İncelemeler

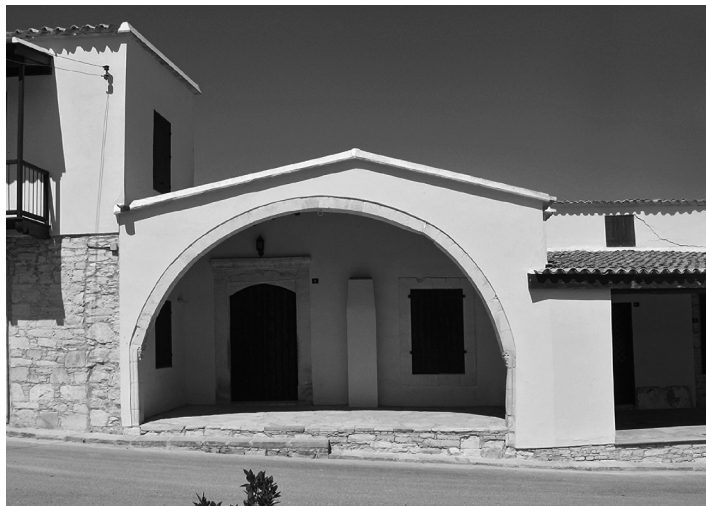
Fig. 4
Khan, east elevation of
Building G towards main square;
restored facades of Building F on
right (with later additions) and
group of Buildings H on left

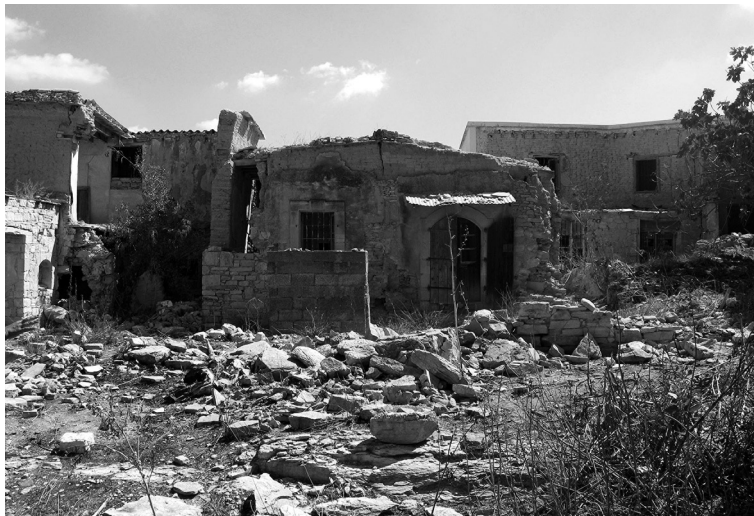
Fig. 7
Khan, view towards east,
over destroyed Building
B to unrestored facades
of Stable E (left in front),
Guesthouse F (two-storey,
with rests of door on first
floor), Coffee house
G (center), H (right).
In front of G unrelated
square structure

The western facade and the southern wall consist of stone up to an uneven line above the western door. They are completed with adobe up to the roof beams (Figs. 7-8). However, to the north stands an adobe wall on a stone foundation, which is partially shared with Building F and which still carries a lot of plaster. The left part of this wall is attached to or joined with the north-south-oriented eastern wall of F, the narrow side of the latter being visible on the photo documentation (Fig. 12). To the right, the adobe material of G's north wall looks different than on the left, but this impression might be deceptive. In any case, the tight connection between the two buildings suggests a parallel construction.

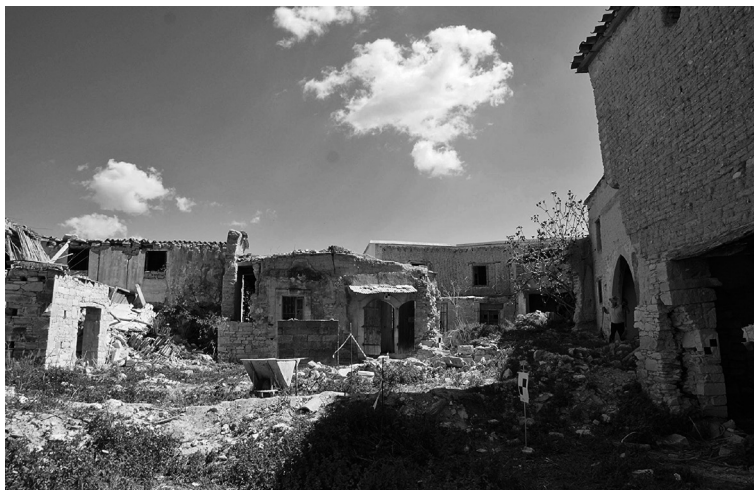
Fig. 8
Khan, view towards east over
destroyed Building B
and trench markers onto
unrestored facades of
Stable E (left in front),
Guesthouse F, Coffee house
G (center), H (right), A (far
right) and unassociated
passageway (far right/in front)

The buildings south of G are grouped around a small court. They are marked on the map of 1967 mainly as two-storied (Figs. 2-3, 8). Access to the courtyard of the khan is not verifiable, and it is therefore unclear if the buildings originally belonged to the khan. If a connection to the khan existed, a residential function for guests as in F was most likely. The original substance changed: the parts facing the courtyard by decay/collapse, the parts oriented to the street/square by (whitewashed) restoration.

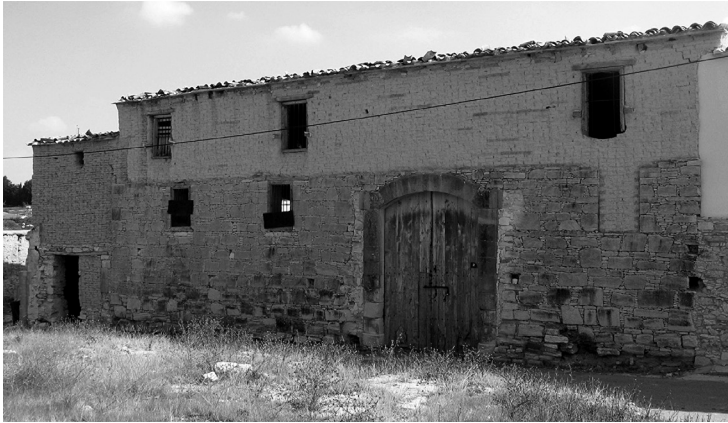
Fig. 11
Khan, Building A, south
elevation towards street;
left: unassociated passageway

roofing material (Figs. 5, 11)⁴⁰. The mortar contains a considerable amount of lime or consists of the same adobe mix like the mudbricks⁴¹.

Phase 1 included four bays of which the exterior walls of the ground floor consist of stone, whereas the 'first' floor and the dividing walls between Rooms 1, 2 and 3 consist of adobe (the latter on stone foundation). The eastern bay (Room 1) communicated to the courtyard with a single window. The three western bays (Rooms 2-3) are defined by pointed, about 3.40 m. wide stone arches which face the courtyard (Figs. 5, 9). They are carried by 0.38 m. wide ashlar pillars with sculpturally emphasized capitals on the western and eastern sides of the pillars (Fig. 15). The eastern arch is part of the passageway between the court and the street. The two western bays connect to the street via two windows, whereas the eastern bay originally was supposed to open to it with one window (Room 1). Instead the void was closed with mud brick while building up the first floor. The lintels of the street-oriented ground-floor windows correspond with the last layer of the stone wall (Fig. 11).

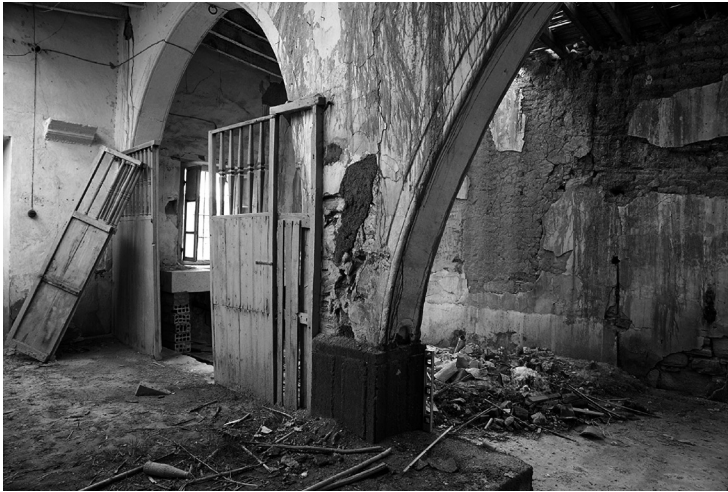
Fig. 12
Khan, Building G (coffee house),
view from southern bay towards
northern wall, *souventza*
(cornice) on wall to left,
middle pillar reinforced
by concrete cover

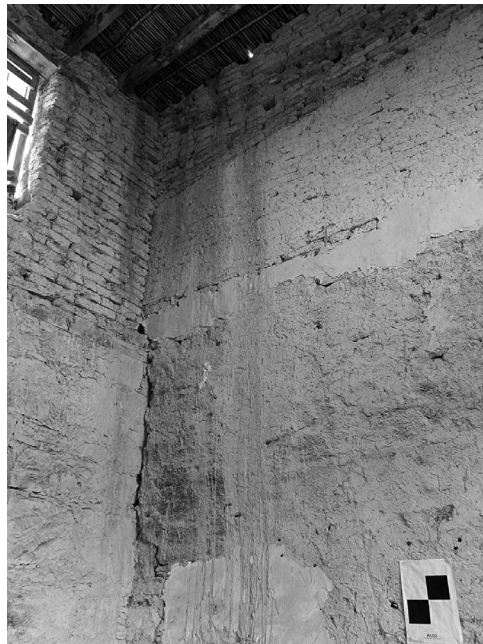
Fig. 13
Khan, Building A, view into
south-west corner and of
western wall of Room 3
shared with unassociated
passageway

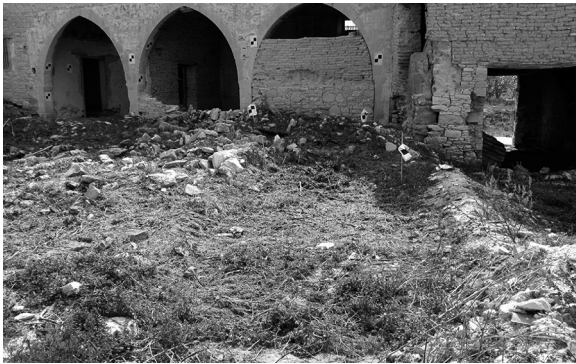
Fig. 14
Khan, destroyed Building B,
view towards south onto
north elevation of Building A;
right: unassociated passageway,
slight traces of walls of B
under debris and vegetation

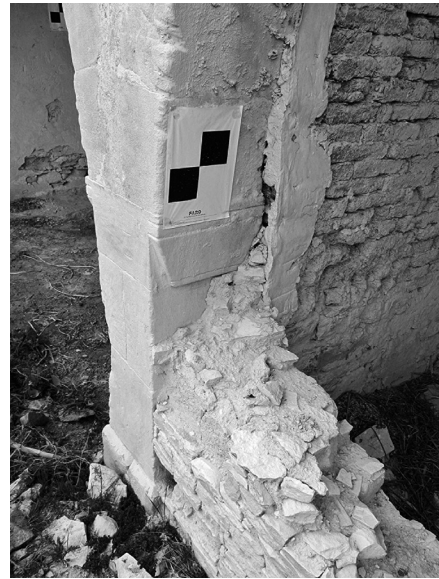
Fig. 15
Khan, Building A, rest
of filling of middle
arch and ashlar pillar
with capital

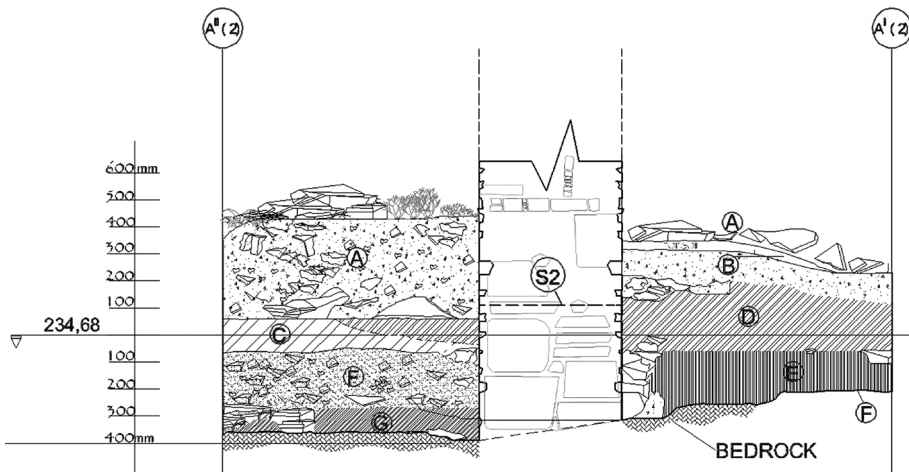
Fig. 16
Khan, Building B/
courtyard, Trench B-A,
detail; drawing of
south profile A'(2) –
A''(2) over east wall
of B, exterior and
inner levels C,
B and F

The eastern wall displayed traces of the southern ashlar frame of a door or gate in Trench B-A – 6.20 m. distant from the filling of the arch of Building A. The remaining cubic stone of this frame S2 is laid onto two blocks of foundation and is linked to the adjacent wall by horizontal layers of small stones (Figs. 18-20). This method of adjusting the ashlar frames to the adjacent walls is a typical feature in the vernacular building tradition and can be seen also on the gate of Building A (Fig. 11). The outer floor level, corresponding to Inner-floor B but being slightly lower than B, was C (Fig. 16). The iron handle of a bucket derived from the surface of C.

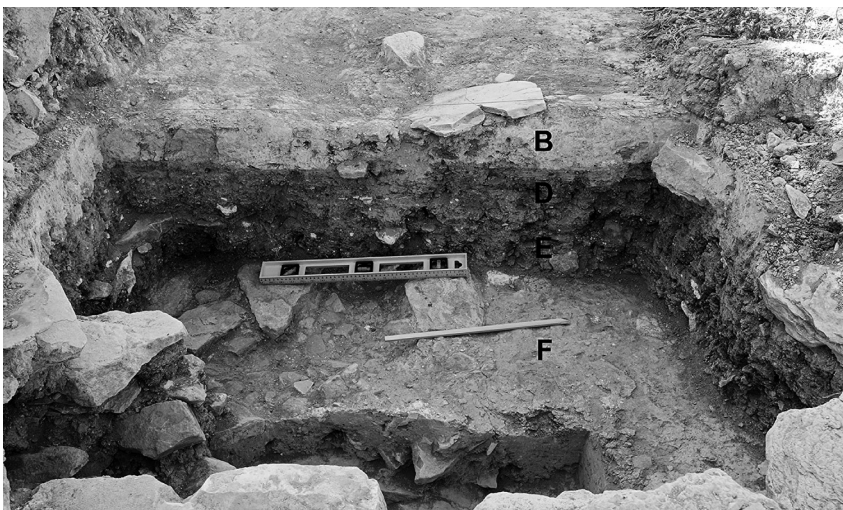
Fig. 17
Khan, Building B,
Trench B-A, view
towards west with
excavation next
to eastern wall,
until A'(2) - B'(2);
Inner floor
Levels B and F

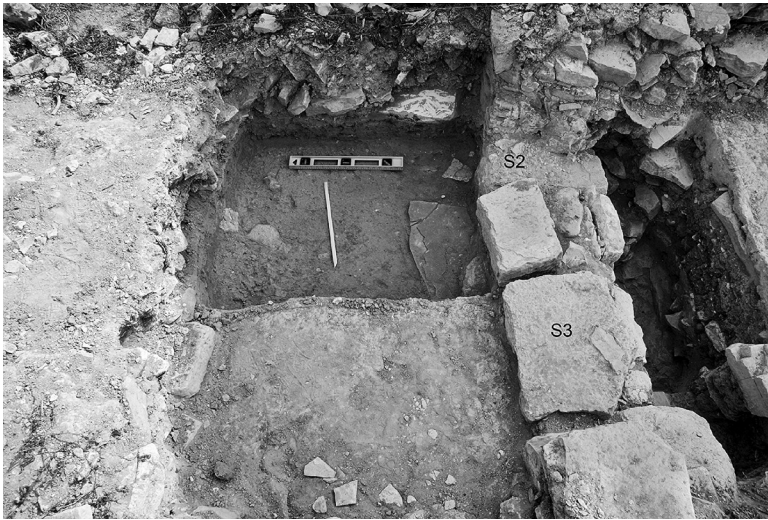
Fig. 18
Khan, Building B/courtyard,
Trench B-A, view towards
south; right: eastern wall of B,
far right: inner floor level B;
Left of ashlar Block S2 (rest of
frame of door/gate): exterior
floor level F with stone slab
next to the wall

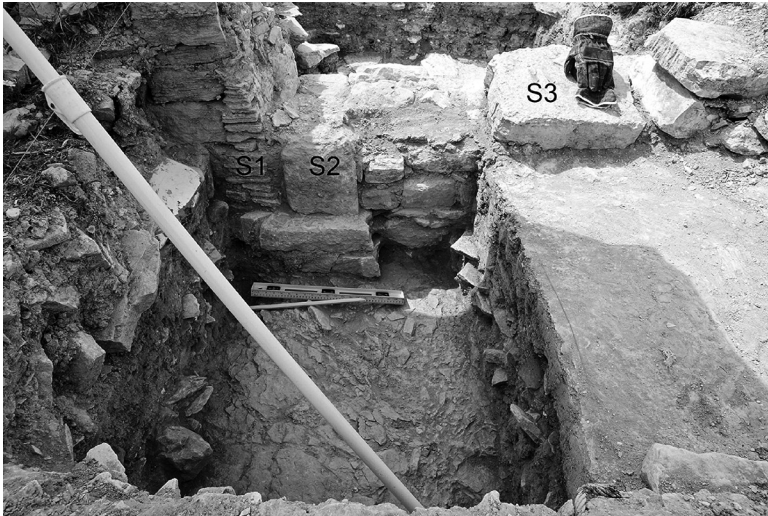
Fig. 19
Khan, Building B/courtyard,
Trench B-A, view towards
west onto eastern wall of B;
bottom: bedrock

Outside of the building, the surface of Layer F reaches to the upper surface of the foundation of S2 (Figs. 19, 21). Most probably the first and older threshold, belonging to Floor F, is to be found in the first layer of stones above the foundation of S2, north of S2 (Figs. 19-20). This layer of stones corresponds to the stone slab on the exterior Floor F which was placed immediately next to the wall (Fig. 18). Its level (ca. 234.40-50 m. above sea level) fits approximately to the floor level of the passageway north-west of A. A possible reason for laying the second Floor B is the development of moisture on the lower Floor F. The gate of Building B and its framework – the documented southern one and the assumed northern one – was used in both building phases, but the threshold as the floor were raised in phase 2.

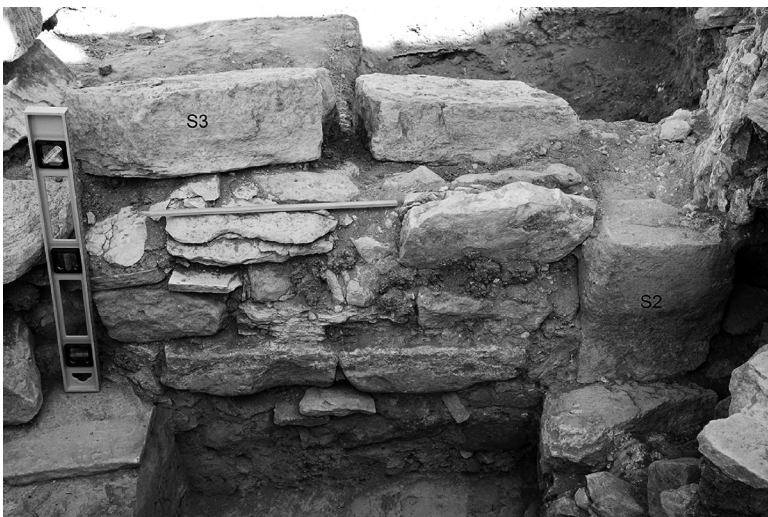
Fig. 20
Khan, Building B,
Trench B-A, view towards
east onto the east wall of B,
left: floor level F,
bottom: bedrock

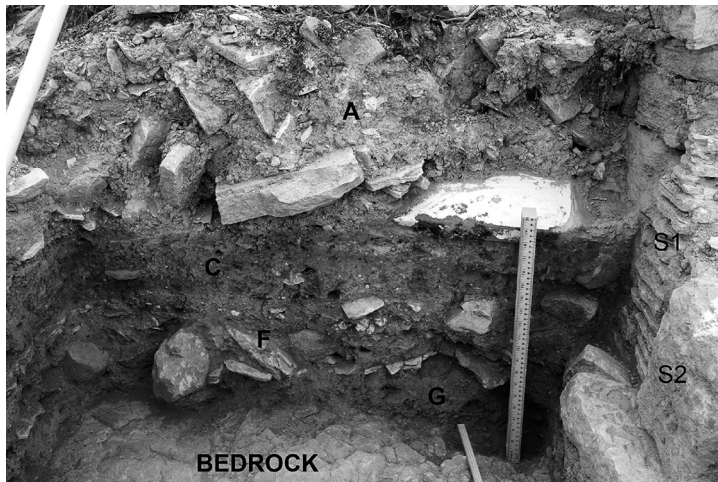
Fig. 21
Khan, courtyard/Building B,
Trench B-A, view towards south.
South profile B''(2) - A''(2) east of
eastern wall of B with floor levels
C and F; right: ashlar Block S2

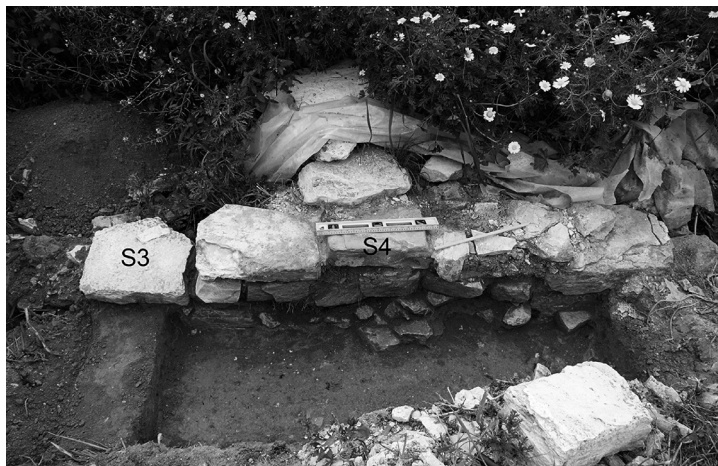
Fig. 22
Khan, courtyard/Building B,
Trench M-N next to eastern wall
of B, view towards west

Trench B-A due to lack of time (Figs. 6, 22). The only indicator of the northern frame could be the presence of an apparently stronger foundation underneath Stone S4. The width of the opening between S2 and S4 amounts to about 1.40 m. The discovery of the remains of an iron locker-system in Trench M-N, measuring 0.50 m. in length, and due to its size surely deriving from a gate⁵⁵, only generally proves the existence of an opening at this spot.

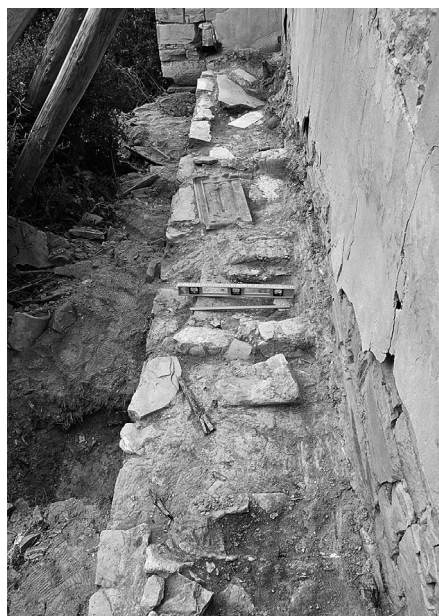
Fig. 23
Khan, Building E, Unearthed
remains of a manger along
northern wall, view towards west
