Rinore ile Başvuran Kalsifiye Ventriküloperitoneal Şantlı Bir Olgu

A Case With Calcified Ventriculoperitoneal Shunt Presenting With Rhinorrhea

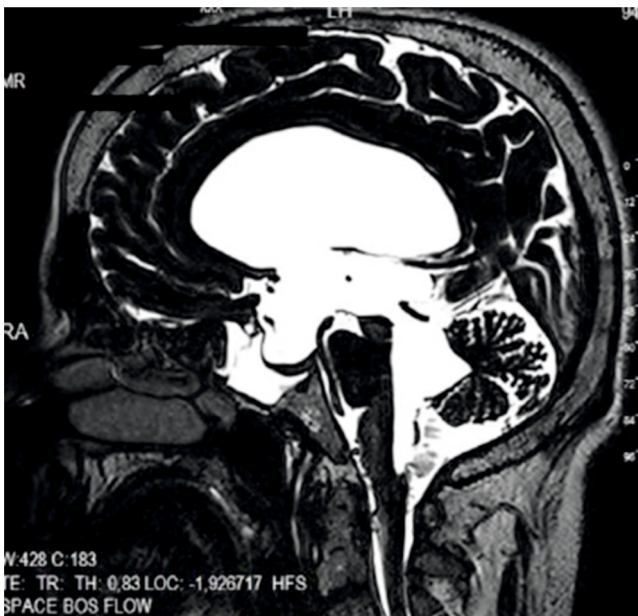
A 34-year-old male patient was referred to our clinic with complaints of serous nasal discharge for 10 days following a severe headache lasting for 3 days. The patient had undergone VP shunt operation by the senior author of this paper 22 years ago with the indication of secondary hydrocephalus due to meningitis. His neurological examination was unremarkable. On cranial computed tomography, tetraventricular hydrocephalus was observed. During magnetic resonance cisternography, radio-opaque substance (Magnevist®; Schering Diagnostics AG, Berlin, Germany) was administered intrathecally and CSF leak into sphenoid sinus was observed while the patient was in prone position (Figure 1).

Figure 1. Magnetic resonance cisternography showing cerebrospinal fluid leak into sphenoid sinus.

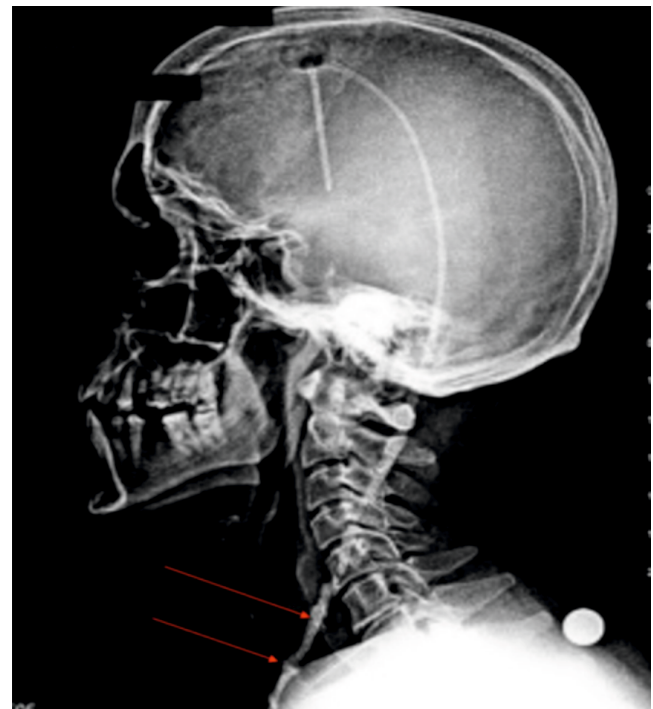
Palpation revealed non-functional dome of the shunt. Calcified shunt trace was observed in the plain radiograph (Figure 2). After evaluation of the patient reoperated for shunt revision was performed.

Figure 2. Preoperative plain radiograph showing the calcified shunt trace with arrow.

Microscopic calcification of the soft tissues adjacent to VP shunt tubes is a common finding; however, heavy calcification apparent on plain radiographs is extremely rare. Such a calcification seems to show VP shunt catheter degeneration and should be deeply investigated for a probable disconnection.

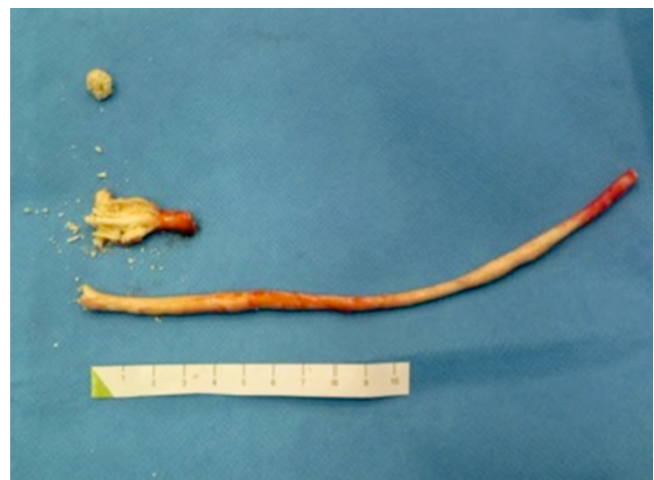
Perioperatively, CSF leak from the ventricular end was observed; however, calcification of the peritoneal part of the shunt was detected which necessitated removal of the shunt (Figure 3). A new shunt system with a moderate pressure was applied. During the postoperative period, rhinorrhea ceased and a second surgical intervention was not performed on sphenoid sinus. At his 1st year-follow-up visit, any medical or surgical problem was not encountered. Consent form was taken from the patient.

Figure 3. Calcification observed in the peritoneal part of the shunt.
