Preliminary application of space-based remote sensing and geospatial technology for investigation on the geo-environmental consequences of Cyclone Aila 2009 in the SW Bangladesh

Farhana Tazneen¹, Hafizur Rahman¹, Sajidur Rahman¹, Nasrin Sultana¹, B.M. Refat Faisal¹

¹ Bangladesh Space Research and Remote Sensing Organization (SPARRSO), Agargaon, Shere Bangla Nagar, Dhaka-1207, BANGLADESH

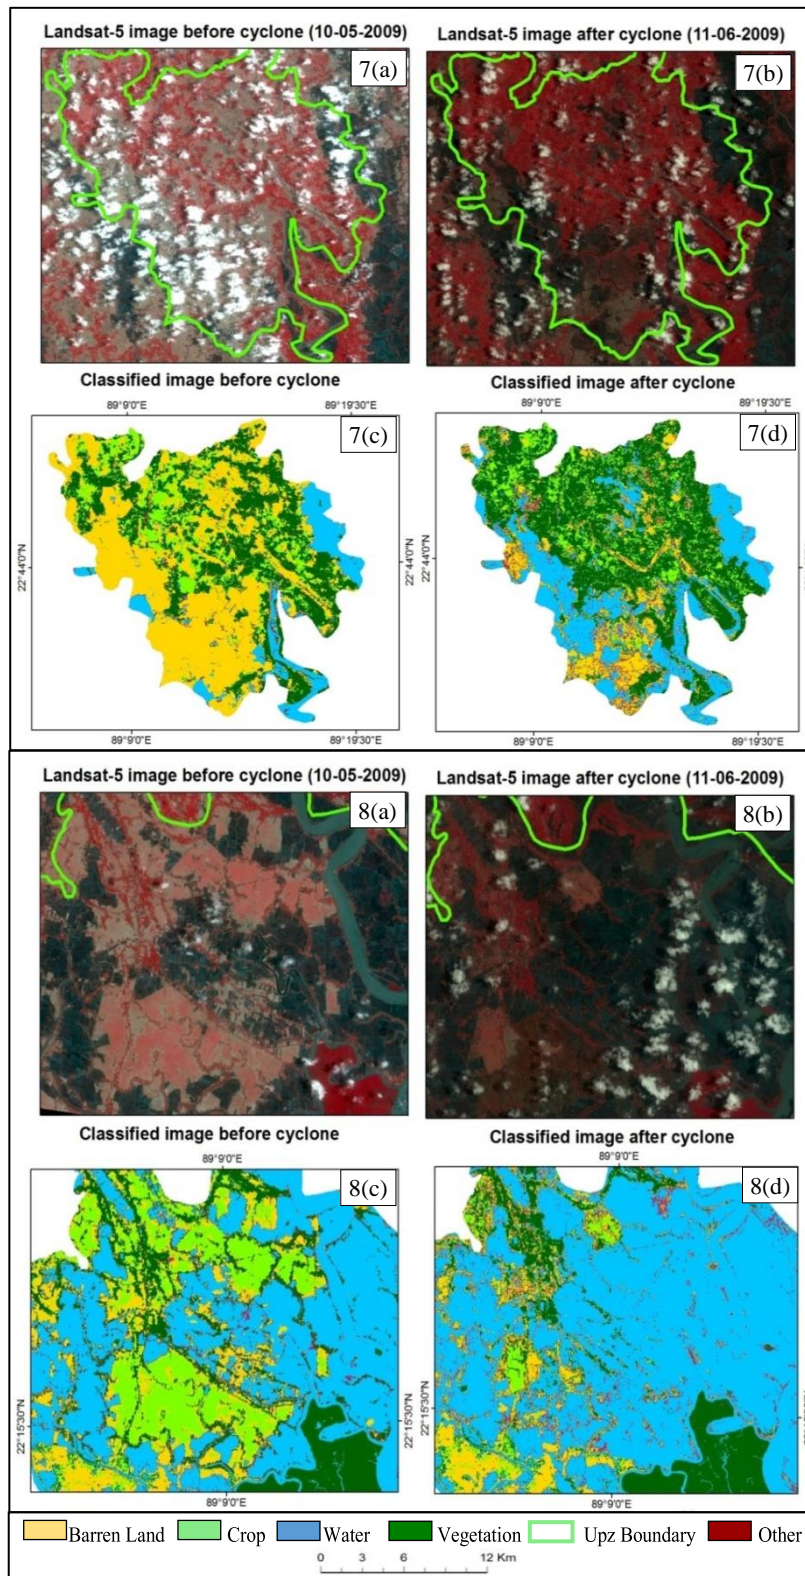
In each of the figures (from figure 3 to figure 8), (a) represents the colour composite image of Landsat TM of pre-Aila-2009, (b) denotes the same as that of (a) except for the post-Aila-2009, (c) and (d) represents Landuse/ Cover maps for pre- and post-cyclone condition as obtained through processing and analysis of Landsat TM images following methodologies as mentioned under the present work.

Fig. 7 and 8. Landuse/ Cover maps for pre- and post-cyclone condition corresponding to part of (7) Tala upazila and (8) Shamnagar upazila as obtained through processing and analysis of Landsat TM images following methodologies as mentioned under the present work.

Landuse/Cover statistics of six upazilas under the study area before and after the cyclone Aila-2009 have been given in tables 4 and 5. From figure 8, it is revealed that in the Shamnagar upazila, crop area has been decreased from 6,234 hectares to about 2,021 hectares while vegetation area has been decreased from 1,10,707 hectares to 107894 hectares after the cyclone Aila-2009 (Table 4 and 5). In contrary, water area has been

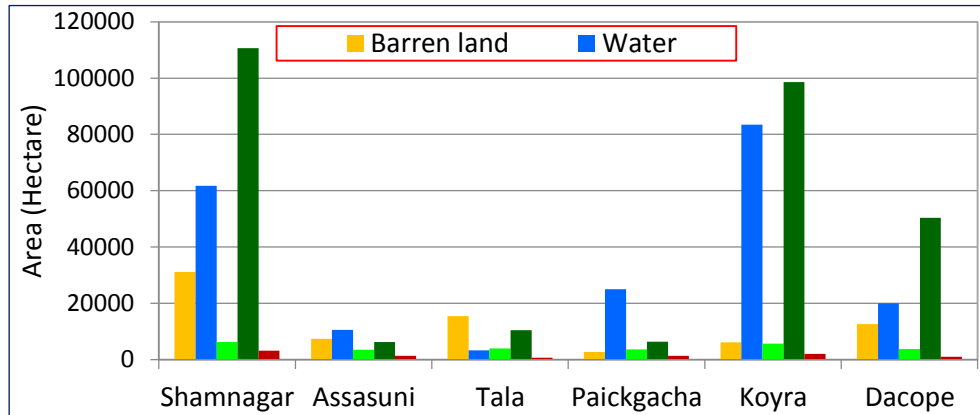
Fig. 9. Landuse/Cover statistics in six different upazilas of the study area before the cyclone Aila-2009. Results have been obtained through processing and analysis of Landsat TM images following methodologies as mentioned earlier under the present work.

From the analysis of satellite images, similar scenario was observed for rest of the upazilas. Crop and vegetation areas were decreased in each upazilas whereas water area was increased significantly. A decreasing trend in case of barren land area has been observed in each upazila except Shamnagar after cyclone-2009 hit the area. Variations of land cover pattern for the pre- and post-cyclone Aila-2009 time period in the study area have been presented in the bar diagrams in figures 9 and 10).

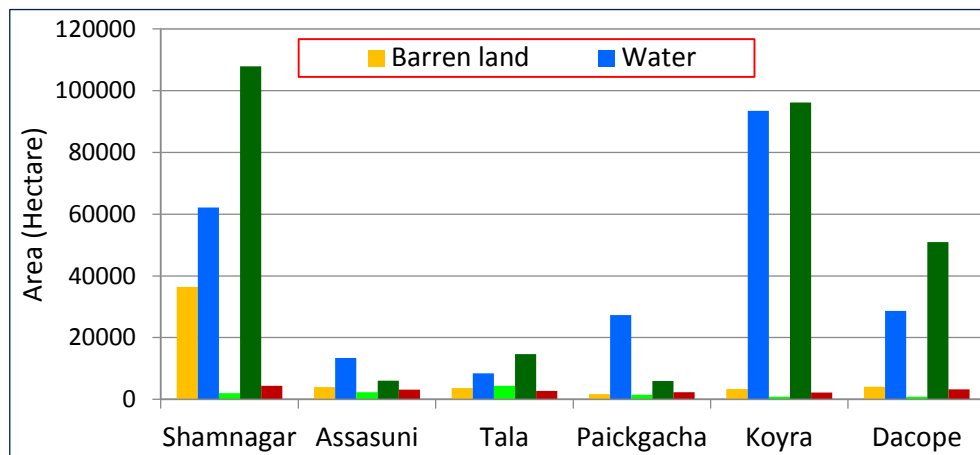
Fig. 10. Same as in figure 9, except results represent the post cyclone Aila -2009 condition.

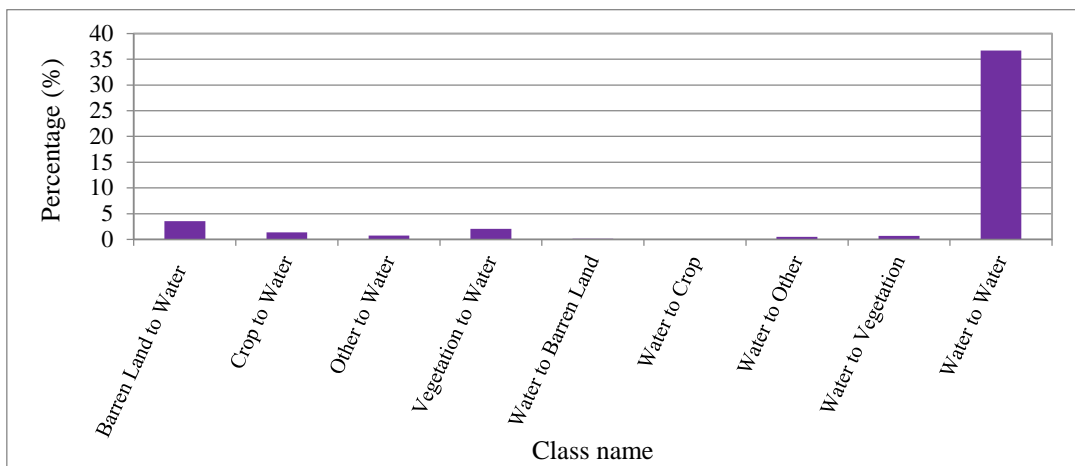
Fig. 11. The percentage of changes of land covers caused by tropical cyclone Aila in the study area.

The percentage of changes of land covers caused by tropical cyclone Aila in the study area is represented by the bar diagram (Figure 11). The spatial pattern of landuse/cover change in the study area due to cyclone surge water flooding of various land covers between pre- and post- cyclone Aila images is shown in Figure 12. Result from change analysis (Figure 12) reveals that, after cyclone Aila 3.53% of barren land area changed into water area; 1.37% cropland area flooded and 2.06% of vegetation land changed into water area (Table 6). Water bodies increased significantly in extent due to cyclone surge water flooding of various land covers. 36.69% changed occur from water body to water body.

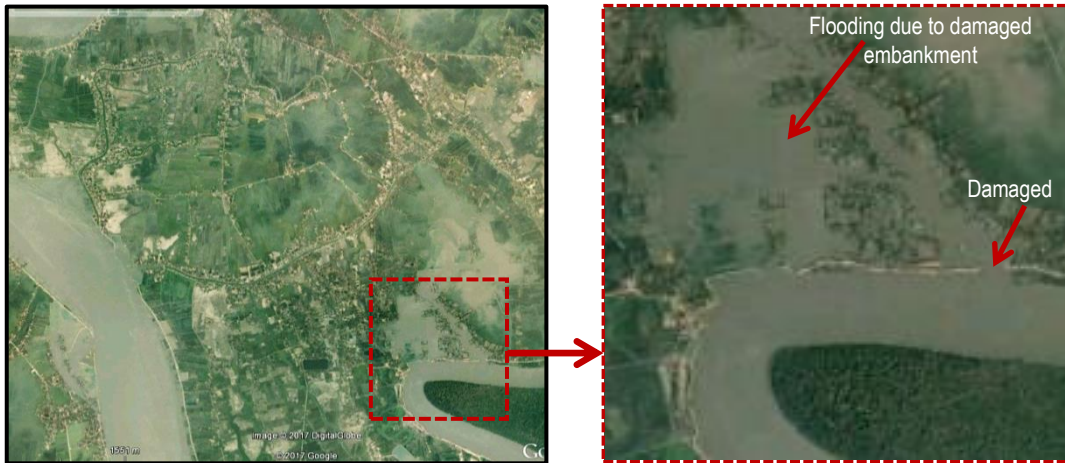
Figure 15: Worldview (Google) colour composite image of March 1, 2010 (Post Aila-2009) shows a small part of the present study: Damaged embankment allowing river water to spread up over the nearby land areas.

Figure 15 shows Worldview (Google) colour composite image of March 1, 2010 (Post Aila-2009) showing a small part of the present study: Damage embankment allowing river water to spread up over the nearby land areas. Cyclone Aila exerted pressure on the dam, causing damage and removal at certain position. Water pressure drives water to overflow over the nearby areas.

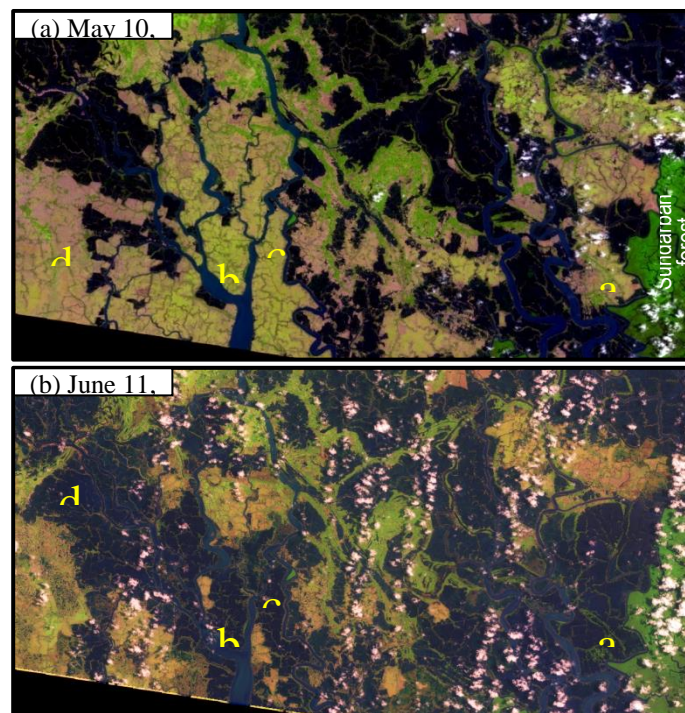
Figure 16: Landsat TM spectral colour composite images RGB (5, 4, 3) of dated (a) May 10, 2009 (Pre Aila) and (b) June 11, 2009 (Post Aila) representing the changes of surface features within the image area. Figure mainly shows the cropping activities and inundation respectively in part of Koyra and Dacope upazila under Khulna district due to cyclone Aila 2009.

Figure 16 shows Landsat TM spectral colour composite images RGB (5,4,3) of dated (a) May 10, 2009 representing Pre-Aila and (b) June 11, 2009 representing Post-Aila time sequences. These figures principally demonstrate the cropping activities and inundated areas respectively in part of Koyra and Dacope upazilas under Khulna district caused by the cyclone Aila 2009. These figures represent the changes of surface features within the image area. Comparison of the images of two dates shows significant increase in water covered areas between pre- and post-Aila time sequences. Extended flooding in terms of duration and spatial coverage have been noticed during post-Aila period as compared to other time sequence. Cyclone Aila accompanied by storm surges, flooded the villages and crop fields with saline water from the Bay of Bengal. The incoming seawater caused two-fold effects in the area e.g., (i) water logging in certain areas at different locations depending on the surface characteristics and (ii) salinity due to incoming water significantly affected the agro-environmental setup in the area. Ultimately, the prolonged water logging over the area with relatively high salinity had affected most of the vegetation were seriously affected, died and disappeared. Figures 16a and 16b represent a small part of the affected area as pre- and post-Aila condition as derived through processing and analysis of Landsat TM satellite sensor data. Salinity in the coastal area had become severe, forcing saline water to spread over the cultivated lands. As an aftermath huge area has been exposed for a long time to the regular tidal processes by sea water with high salinity. The seawater flooded villages and fields. Thousands of kilometers of road were seriously damaged or totally destroyed and hundreds of kilometers of flood protection embankments were washed away. Salinity is one of the major problems in the coastal region of Bangladesh that contributes to 20% of the total land area. About 53% of the coastal region is affected by different degrees of salinity. Salinity intrusion in this area is mainly derived through climate change as well as anthropogenic factors that make this region more vulnerable.

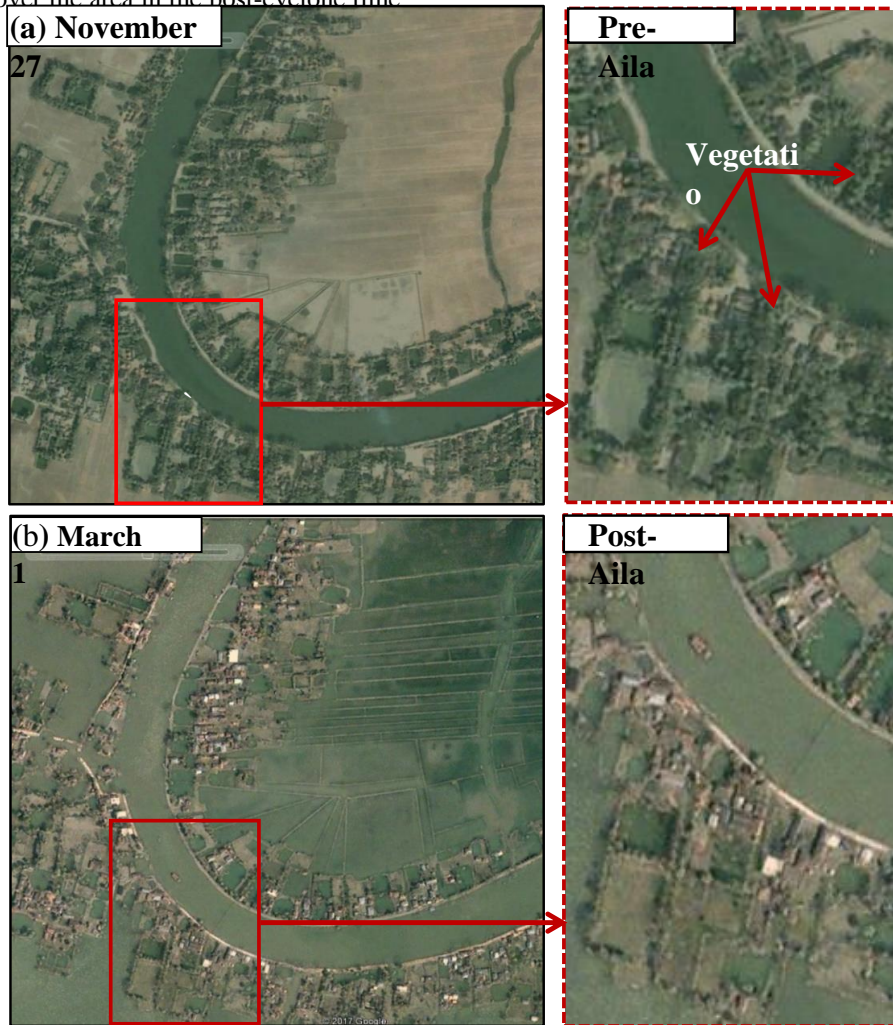
Fig. 17. Extracted Google TM spectral colour composite images of (a) November 27, 2008 and (b) March 1, 2010 representing pre-Aila and post-Aila situation respectively in part of the Koyra upazila under Khulna district.

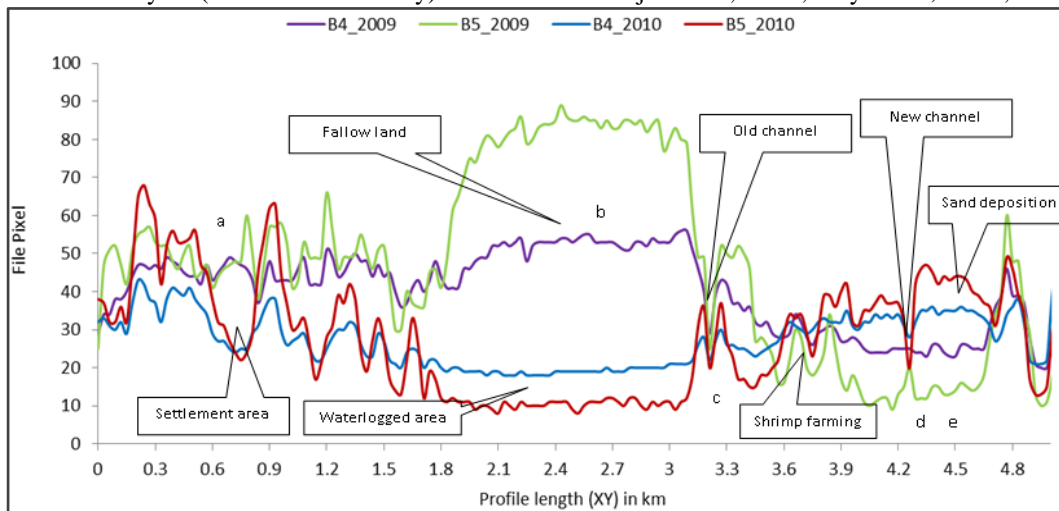
Fig. 20. Linear spatial profiles corresponding to three spectral bands (5, 4, and 3) of Landsat Tm spectral colour images on the two different dates 3 February, 2009 and 6 February, 2010 representing pre-Aila and post-Aila situation respectively in the Koyra upazila.

shown in figure. Dynamic variation of reflectance values along the profiles on two dates have been interpreted in terms of surface category, its condition and transformation into another category. Profile lines as a function of distance exhibit significant variation of surface radiative intensity over the profiling direction.

Referring to location 'a' corresponding to settlement area in 2009 was affected by Cyclone Aila and presence of flood water is readily visible in 2010 after the cyclone Aila. Thus, the spectral value corresponding to position 'a' dropped down significantly in 2010 as compared to that in 2009 prior to the cyclone Aila. Location 'b' represents fallow land in 2009 with high reflectance value, while, the value significantly dropped down in 2010 due to water logging in the area causing high absorption of radiative value. Location 'c' represents the old channel in 2009 with low reflectance value, while, the value dropped down a little in 2010 due to water logging in the area causing more absorption of radiative value. Location 'd' represents new channel in 2010 with low reflectance value, while, the value in 2009 indicate presence of mixed environment of sand and water. Again, the increasing trend of radiative value represents sand deposition in 2010, while low radiative value in 2009 represents the possible presence of water over the area under study.
