A HOUSE IN ANKARA ULUCANLAR DISTRICT IN THE CONTEXT OF TRADITIONAL OTTOMAN ARCHITECTURE

2. Examination of the historical house in Ankara Ulucanlar District: Sadık Arslan House

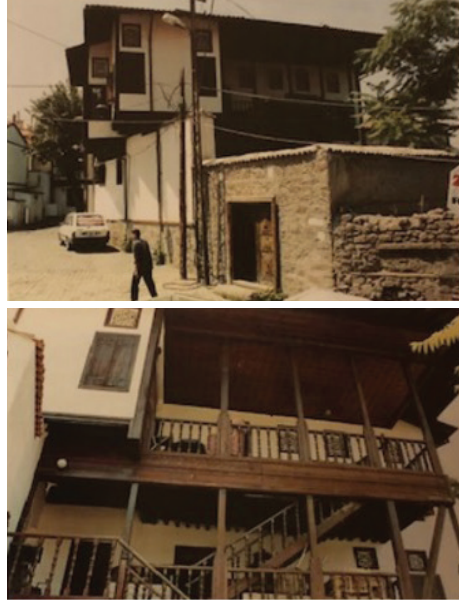
Fig. 6: A fine example of “hayat” in “Demirfirka” Neighbourhood “Doyran” Street (Tuncer, 2002, 53.)

It is seen that arrangements have been made to benefit from the view and the sun in the organization of the spaces. Houses were established in high areas to dominate the view while open and semi-open areas were created against the view. Ankara people who were bound to nature and did not want to stay away from it. Therefore, they placed the open *sofa*, which was an invention of Turkish people, in the place with the most beautiful view within the house. “*Hayat*” (*Life*) which was closely connected to this courtyard has been the most important and vital part of Ankara houses (Figure 6).³⁶

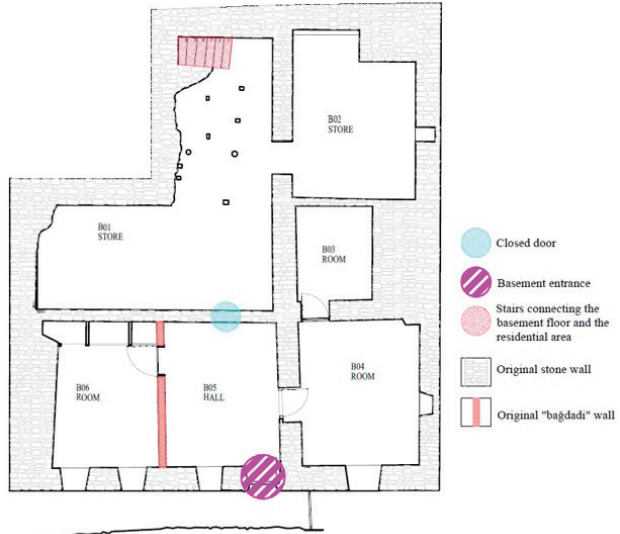
Fig. 15: Basement floor plan. (Drawn by using Nazlı Keçeci's drawings, 2020)

The basement floor (Figure 15) of the building, which is thought to have been built as a mansion, has an exit from the side facade to the street, and the staircase that connects the basement with the house has an exit to the kitchen, so this floor is thought to be reserved for the mansion workers. In addition, this floor was used as a wood / coal bunker and warehouse as a general feature of the historical Ottoman-Turkish houses. One part of this floor is accessed from the stairs in site Z08 on the ground floor, and the other part is through a wooden door on the south facade. When you descend from the ladder in site Z08, you reach the coal bunker B01. In the current state of the building,

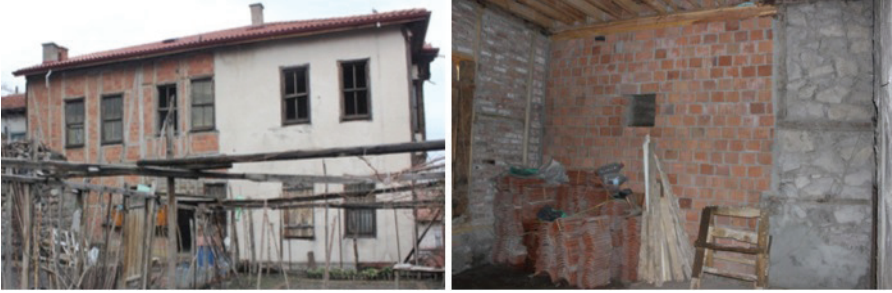
Fig. 18: Internal and external views of the renovated walls. (By Karakuş, 2020)

The outer walls of the building are 50-60 cm thick on the basement and ground floor. The basement and ground floor were built of stone material up to a certain level and there are wooden posts at regular intervals. The walls of the first floor, which is a mudbrick filling between wooden frame, are approximately 20 cm thick. It is seen that the left part of the west facade, which is in danger of collapse due to neglect, has been renovated with perforated brick material (Figure 18). The protrusions in the west and south directions on the ground floor are carried by wooden consoles. The floor and roof construction of the building is wooden. The walls are plastered both inside and outside.

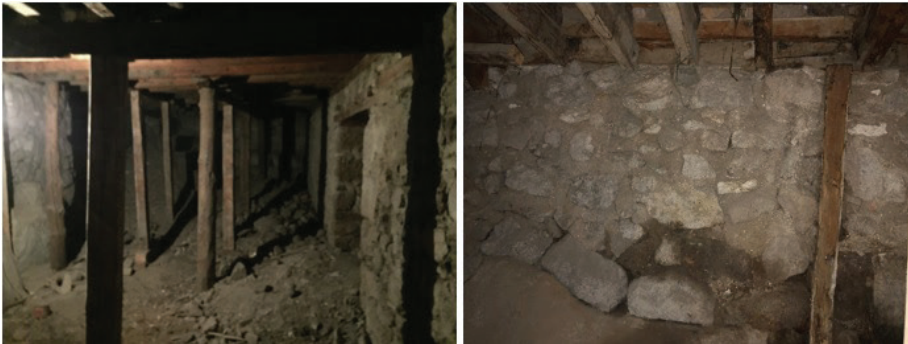
Fig. 19: Wooden pillars and stone walls in site B01. (By Karakuş, 2020)

The walls on the basement floor are completely built of stone and the thickness starts from 60 cm. A large number of wooden pillars extending from the ceiling to the ground are observed in the woodshed B01 (Figure 19). In the sites B01 and B02 (storage), the floor is earth filled and there is no ceiling cover. Therefore, wooden ceiling beams appear. Wooden beams and stone lattices are seen on the walls without plaster. The floors of the sites B05 and B06 are covered with additional concrete. It is seen that the original wooden ceiling was covered with plywood in the sites B06, B4 and B03. The walls in these areas are painted on plaster. It was determined that the wood works and windows were damaged and the window gaps were covered with wooden plates in the sites B05, B06 and B04.

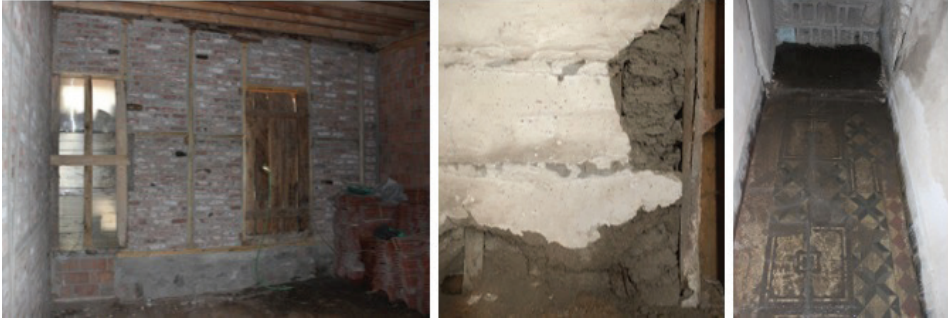
Fig. 20: Brick wall between wooden frames and original mud-brick wall in site Z03 and cement tile covering in site Z10. (By Karakuş, 2020)

On the ground floor in the sofa Z03, mud brick fillings between wooden frames are seen on the two walls whose plaster was removed (Figure 20). The floors and ceilings of the sofa Z03 and sites Z04, Z05, Z06, Z08 and Z09 are wooden. Three walls of the site Z07 have been renovated with bricks between wooden frames. On the wall, which is thought to be original, there is a wooden frame and mud brick fillings in between. The site Z07 does not have a floor cover, but the ground is earth filled. There is also no ceiling cover and wooden ceiling beams can be seen from below (Figure 21). Non-plastered outer walls of the site Z08 have wooden beams and stone and brick material. The floor in site Z10 was covered with tile material in the following periods (Figure 20). There is also no ceiling cover here and the wooden ceiling beams are also visible from below.

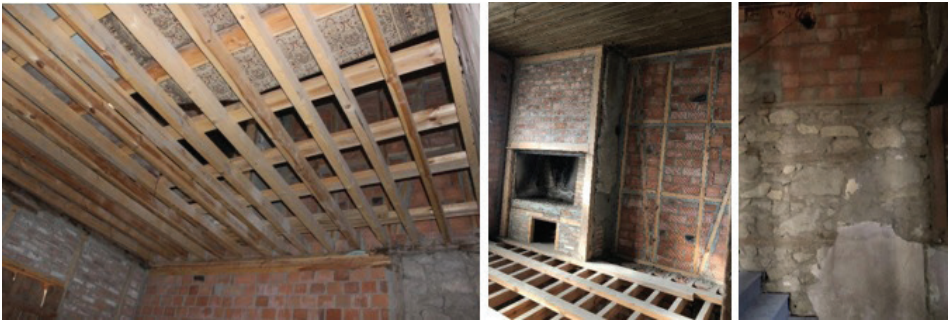
Fig. 21: Ceiling beams in site Z07 and renovated wall and floor beams and the original mud brick wall at the edge of the stairs in site 104. (By Karakuş, 2020)

Wooden beams and bricks are visible on the walls facing the north facade of the hall 101. The walls of the site 102 facing north and east are non-plastered and wooden beams and bricks are visible. The walls of site 104 are also non-plastered and wooden beams and bricks are visible (Figure 21). The floor of site 101 was covered with tiles of different colors in the following periods. There is no floor cover in the sites 102, 104 and 105 and the ceiling beams of the lower floor are visible (Figure 21). The floors of the sites 103, 106, 107, 108 and 109 are wooden. The ceilings of the sites 101, 103, 105, 106, 107,

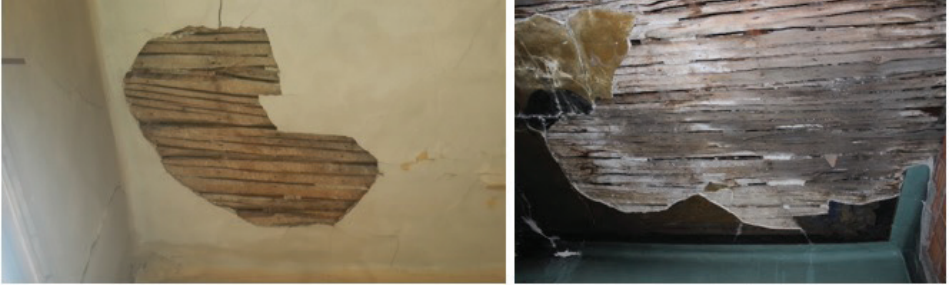
Fig. 22: Wooden piles in the ceiling of the sites 103 and 105. (By Karakuş, 2020)

108 and 109 are plastered, and wooden beams are visible at the bottom of the sections where the plaster was removed (Figure 22). It is seen that the ceilings of rooms 102 and 104 are wooden.

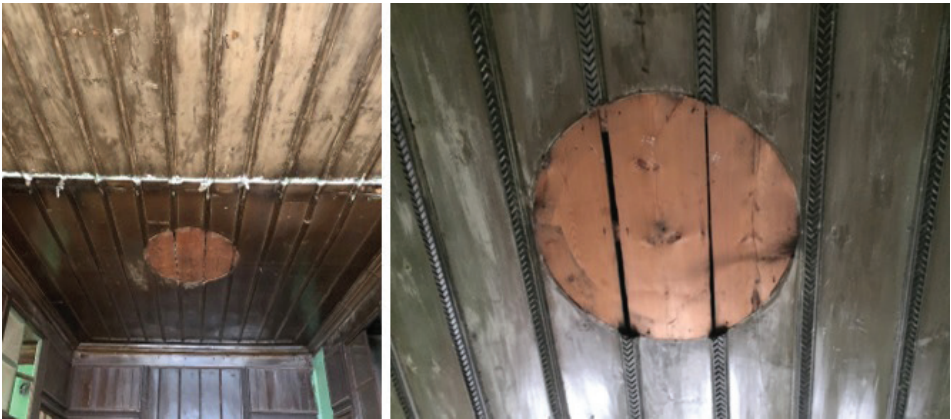
Fig. 23: Slatted wooden ceilings of the sites Z03 and Z05 and the location of the missing hubs. (By Karakuş, 2020)

As can be seen in the general characteristics of the historical Ankara houses, the decorative elements of this house were also concentrated on wooden elements and ceilings. In addition, the wall decorations of the Ottoman Empire starting from the 19th century are also seen here. It was observed that the decorated ceiling hubs of the *sofa* Z03 and the room Z05 were missing (Figure 23). In her dissertation named “Some Examples from Ceiling Decorations of Ankara Houses in XVII. XVIII. and XIX. Centuries”; Behiye Oğuz shared the photographs of the ceiling hubs which were taken in 1987. Drawings were made in line with these photographs (Figure 24-25). The ceiling of the room Z06 was decorated with wood carving, painting and *çitakari* and it has survived to the present day (Figure 26-27).

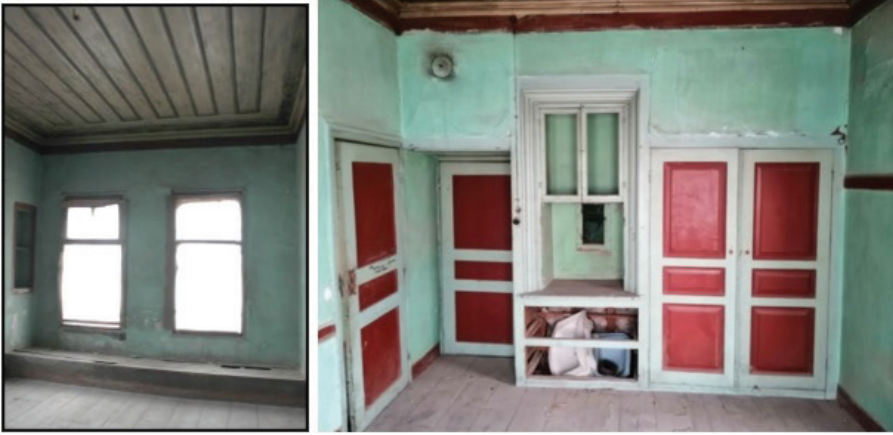
Fig. 28: Timber bench and the cupboard used as a closet in room Z04. (By Karakuş, 2020)

There is a timber bench in front of the window in site Z04. In addition, on the wall where the entrance door is located, there is a window overlooking the entrance hall and a cupboard with two doors used as a closet (Figure 28). There is a timber bench trace in front of the window and a wooden window and a closet on the wall where the entrance door is located in the site Z06. Besides, there is a wooden niche with two sections in the wall facing the west facade. There is also a timber bench trace in front of the window in the site Z09. There are two wooden cabinets on the wall where the entrance door is located. On the first floor, where the entrance door of rooms 106 and 108 is located, there are two wooden lockers, one of which was used as a closet and the other as a bathing cubicle (Figure 29).

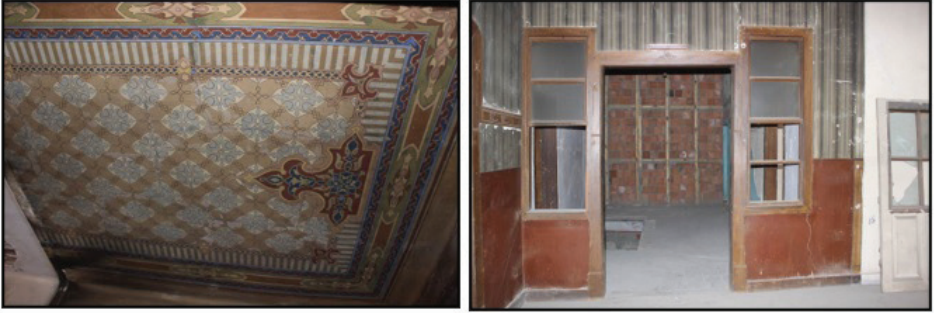
Fig. 35: Ceiling and wall decorations of site 109. (By Karakuş, 2020)

that these hand carved works have a different pattern on the top. On the ceiling of the *sofa* 109, hand carving was applied on the plaster (Figure 35-36). Rumi figures and geometric motifs, which have an important place in Turkish decoration art, have been applied to cover the ceiling of this site. Wall decorations created with straight-lined paintings in different colors on the walls of this site, which are in common with the sites 101, 105 and 107, have been preserved until today.

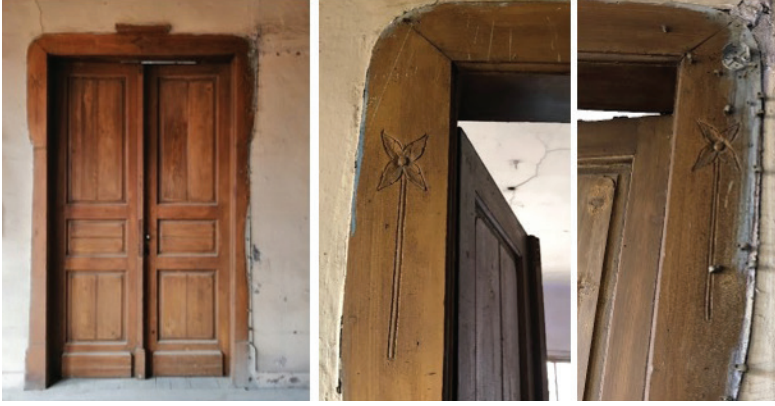
Fig. 37:
The wooden entrance door and details of the site 109. (By Karakuş, 2020)

The original decorations on the wooden door frame while passing from the site 101 to the *sofa* 109 draw a remarkable attention (Figure 37). A flower motif and a set of straight lines were carved on each side plate of the wooden door frame, and a diamond segment on the top plate. All motives on one surface of the frame were also embroidered on the back side as well. It was determined that there were double-wing wooden doors at the entrance from the site 105 to all three sites 104, 106 and 109, but these could not be preserved and only wooden frames remained. It can be seen that the double-wing

decorated entrance door of site 106 was removed and only its frame was preserved. It has been observed that the double-wing decorated entrance doors and vaults of sites 107 and 108 are still preserved. It can also be seen that the double-winged wooden entrance door of the *sofa* 109 was removed and only the door frame was preserved and there were glass panels on both sides of this frame.

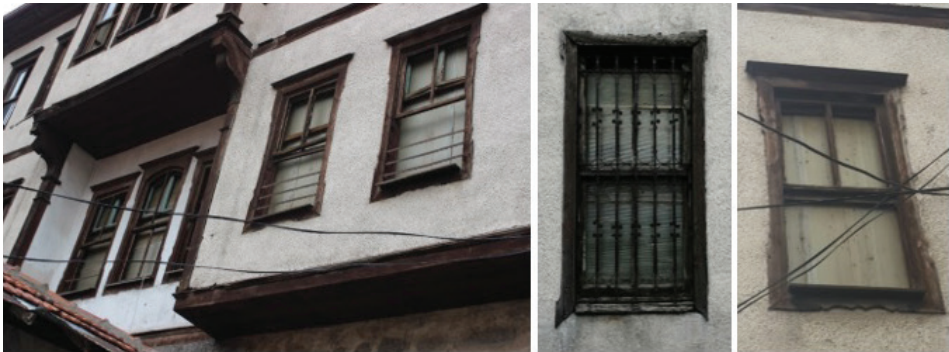
Fig. 38: Wooden guillotine windows and fence details of the building. (By Karakuş, 2020)

There are two windows on the west facade of the *sofa* Z03. There are four guillotine windows on the two exterior walls of the site Z04. There are three guillotine windows on the only outer wall of the room Z05 facing south. There are four guillotine windows on the two walls facing the exterior facade in site Z06. There are two guillotine windows on the front wall of the site Z08. There are two guillotine windows on the wall of the site 103 facing the front facade. There are two guillotine windows on the west facade of sites 104 and 105. There are four guillotine windows on the two walls of the sites 106 and 108 facing the exterior facade. In addition to the three guillotine windows, one of which is arched, on the south facade of room 107, there are two small bay windows on the sides and likewise in addition to the two guillotine windows in the east direction of the *sofa* 109, there are two bay windows on the sides.
