## Investigation of the seismic damage caused to the Gunung Sitoli (Tögi-Ndrawa) cave by the 2005 Great Nias earthquake

**Ömer AYDAN**

This paper is concerned with the damage in the Gunung Sitoli cave induced by the 2005 Great Nias earthquake and the observed damage and its characteristics are described. The investigation was carried out on July 31, 2007 about 28 months after the earthquake.

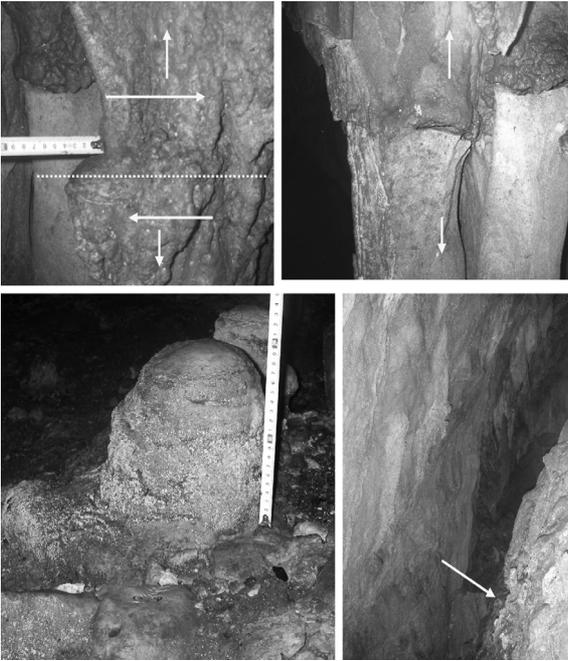
**Location 2:** At this location various forms of damage were observed (Figure 14). A column was ruptured with a separation of about 20-25 mm and 40 mm horizontal offset and the fractured part was healed. The same column was newly ruptured at 38 cm above the previous crack location. Two stalagmites with a height of 16-17 cm were found on the floor of the cave. Furthermore, a slab was separated by 40cm from the NE wall and there was a stalagmite growth with a height of 50 mm at the back of the separated block.

Figure 14. Various forms of damage at Location 2.  
Şekil 14. Lokasyon 2'de değişik hasar şekilleri.

The healing of fractures with a separation of 20-25 mm at locations 2 and 4, implies a large previous seismic event. If the growth rate of 0.143mm/year is adopted, such an event could have been taken place 140 to 175 years before the present. This roughly corresponds to the 1861 event (M8.6) just beneath Nias Island or to the 1833 event (M8.8) to the south of Nias Island. The new fractures shown in Figures 14 and 17 are definitely associated with the 2005 Great Nias earthquake. Stalagmite growths on fallen stalactites at locations 2 and 4 indicate that there were very large seismic events 350-500 years and 1100-1600 years ago.

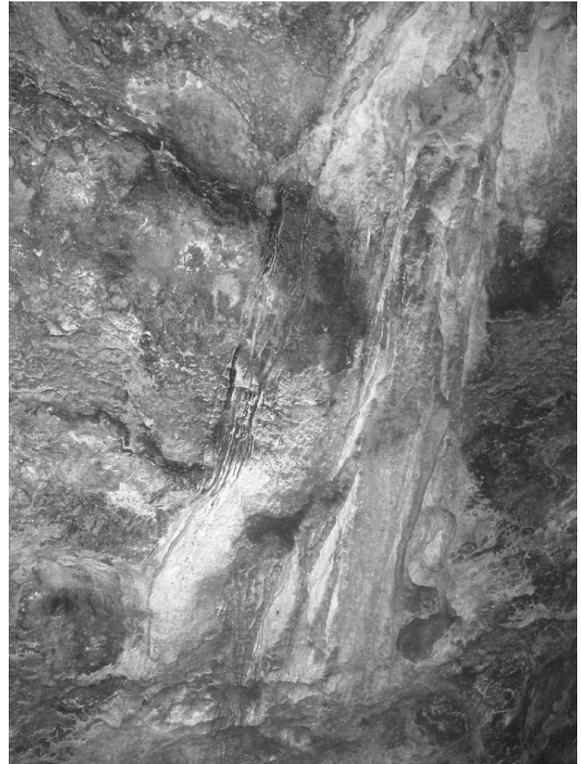
**Location 3:** A large roof collapse had occurred and the diameter of the cave is about 20 m at this location. On the NE wall of the cave, the surface of the NE dipping fault can be observed (Figure 15a) Although the solution of the surface of the fault made it difficult to observe the striations, it is possible to recognise a sense of the movement of the fault (Figure 15b).

Figure 15. Views of the cave and fault at location 3 (CS3).
