Remains from a Demolished Cultural Heritage: A Historical House in Karaagac

Gamze Fahriye Pehlivan*

To cite this article: Pehlivan, Gamze Fahriye. "Remains from a Demolished Cultural Heritage: A Historical House in Karaagac." *Art-Sanat*, 15(2021): 249–285. <https://doi.org/10.26650/artsanat.2021.15.0011>

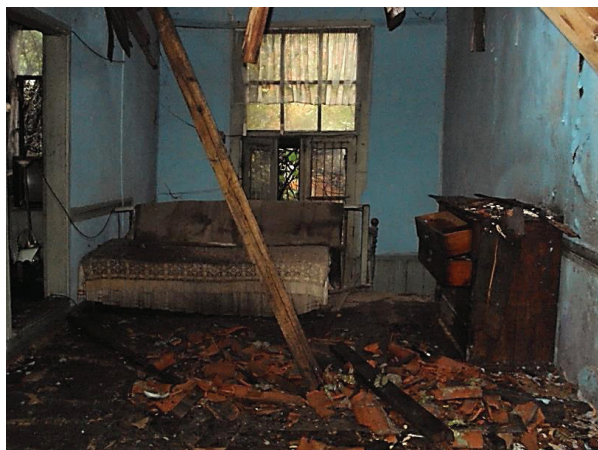
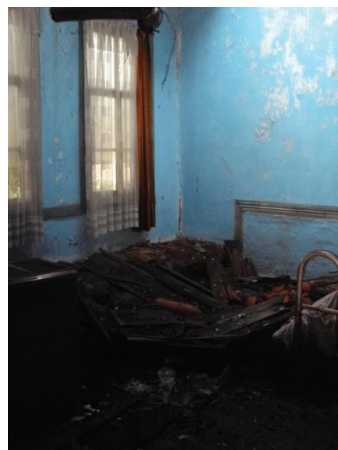
F. 5: Photo from Sofa and Z1 Room

Sofa (PA/23.10.2009)

Z1 Room (PA/23.10.2009)

Z1 room: The room is high as 13 cm from the sofa. There is a built-in wardrobe and a sedir (a kind of fixed couch) in front of the window on the left. Sedir while served as the seating function for this room has enabled the window to be opened thanks to the elevation it created for the basement floor (F. 5, F. 8). The windows of this room are not original. The surface of all windows and doors in rooms on the room side is dark brown oil paint. Unlike other rooms, the ceiling covering has rounded corners and a simple pattern. Dark brown oil paint was used on the ceiling. Part of the roof and ceiling collapsed. There is blue paint on the walls. The mouldings on the wall, baseboards, built-in wardrobe and door are painted green.

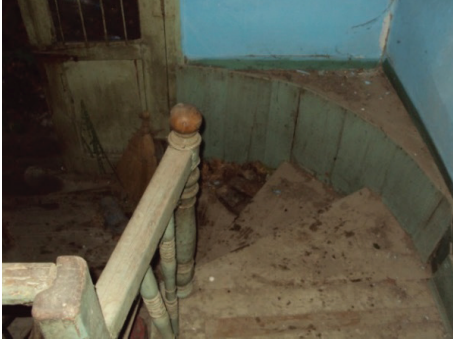
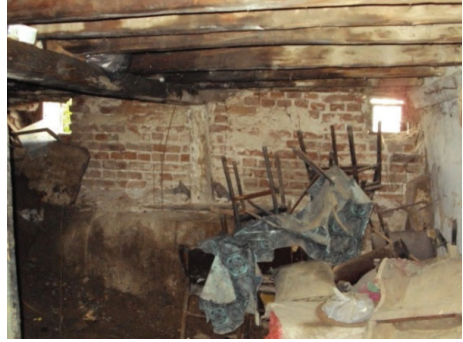
F. 9: Stairs Leading Down to the Basement and Under-Sofa Space (Taşlık) Photo

B3 Under-sofa (stony) space: The wall belonging to the entrance facade is thicker than the wall on the upper floor and it was constructed in the form of a stone wall. The construction of a non-plastered timber frame with brick wall on the stone wall caused this wall to become thinner (F. 9).

The floor surface is stony and there is no coating on the ceiling, and the floor beams are observed. In the middle of this room there are two carrier timber posts which were thought to have been added later. The third one was placed on the wall (F. 9, F. 10).

Staircase (PA/23.10.2009)

Under-Sofa Space (Taşlık) (PA/23.10.2009)

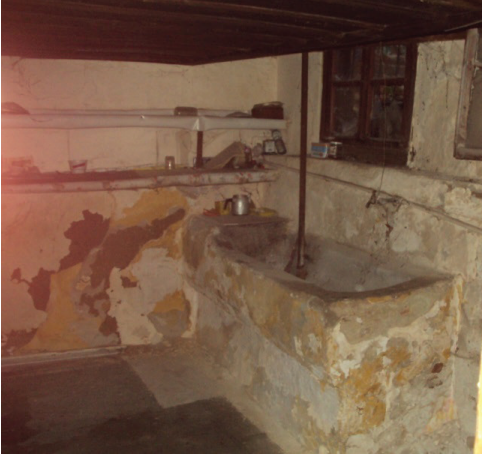
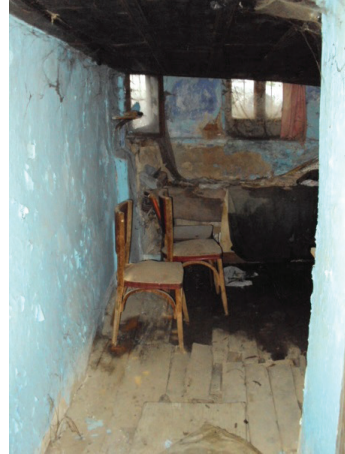
F. 11: Photo from Kitchen and B2 Room

B1 kitchen: There is a timber doorstep at the entrance. The first window on the right is opened using the height of the sedir. The other window does not open because the sedir is removed (F. 10, F. 11). When the windows are examined, it is seen that unlike other basement windows, a small latch is used instead of casement bolt. As the wall from the upper floor turned into a stone wall, the wall width increased. The kitchen has a cast concrete sink and a built-in fireplace with fire door; however, its surface has some deterioration. The flooring of the kitchen is cement screed and the ceiling is covered with timber.

B1 Kitchen (PA/23.10.2009)

B2 Room (PA/23.10.2009)

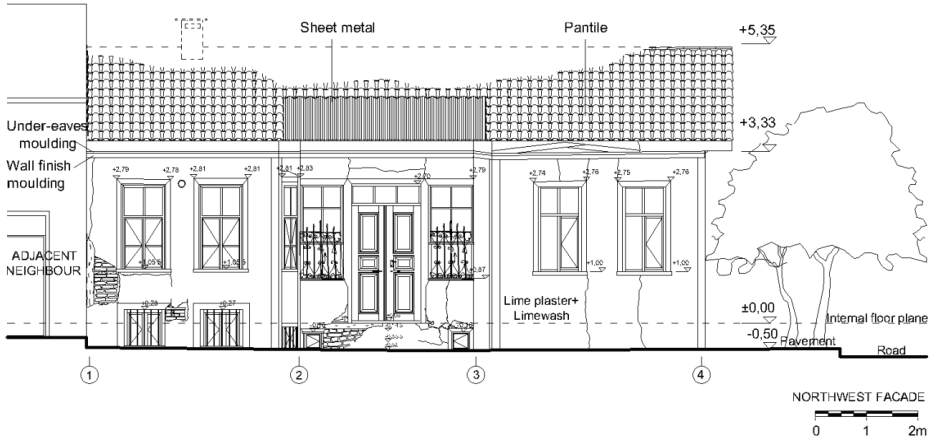
F. 12: Northwest Facade of the House (PA/22.12.2009)

At first glance, symmetry appears to prevail in the facade layout of the building, but when examined carefully, it is seen that it is not fully symmetrical. Facade height is 5.35 m.

The walls of this facade have been renovated with a timber frame with brick infill. The lime plaster and whitewash are used on the facade. The posts in the corners of the building are not plastered but they are covered with vertically timber claddings. Where the wall ends and the roof begins, there is a wall finish moulding and under-eaves

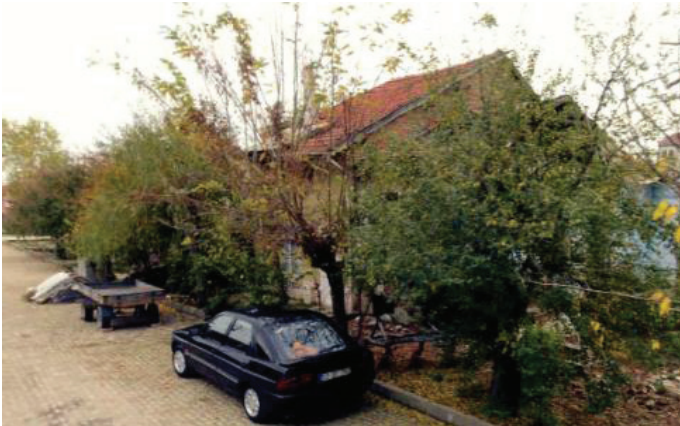
F. 20: Parcel of Housing in 2015 (Arabulan, "Kentsel Dönüşüm Kapsamında Kimliğin Yeniden Kazanımı: Edirne - Karaağaç Örneği," 215).

According to an examination conducted by Arabulan in 2015, only a part of its northern wall and roof residual remained (F. 20)³². According to the examination I conducted in 2019, it was found that the trees on the pavement on the northwest (entrance) facade of the building were cut down however they were present in 2009 and 2015. Except for a few trees in the backyard, other trees have not survived to the present day. Reforestation was done in the parcel. The original well in the backyard has been preserved but only a few rows of stones in the upper row have fallen (F. 21, F. 22).

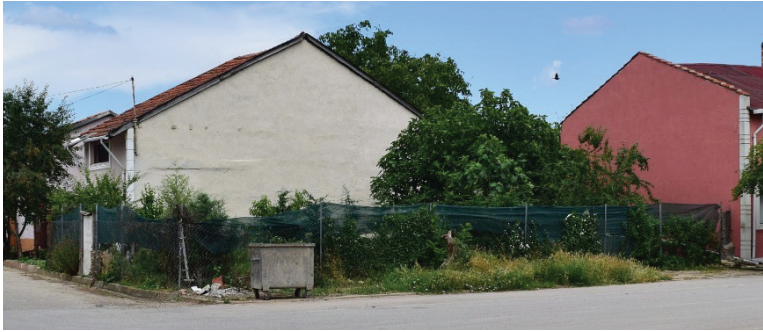
F. 21: Parcel of Housing in 2019 (PA/28.10.2019)

There are no elements of the building left except the basic remains of the building, a few timber posts and filling materials. On the wall of the building the adjacent neighbour in Dilaverbey Street, there are traces of the wall and roof of the traditional house that was demolished. Apart from these, it can be said that there are no remains of the building as if the house never existed (F. 21, F. 22).

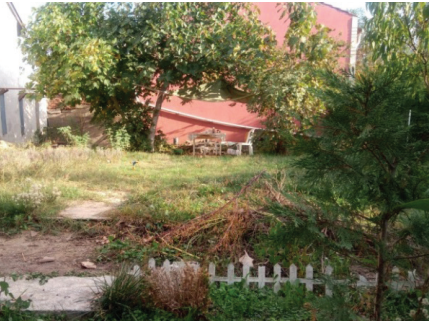
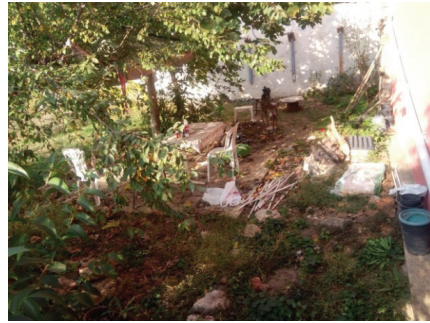
F. 22: Photos of the Parcel from Dilaverbey and Istiklal Street

A Photo from Dilaverbey Street (PA/28.10.2019)

A Photo from Istiklal Street (PA/28.10.2019)
