# Van Tuşpa Excavations 2013\*

Erkan KONYAR – Can AVCI

**Keywords:** Tuşpa, 2013 Excavation, Van, Urartu, Mound

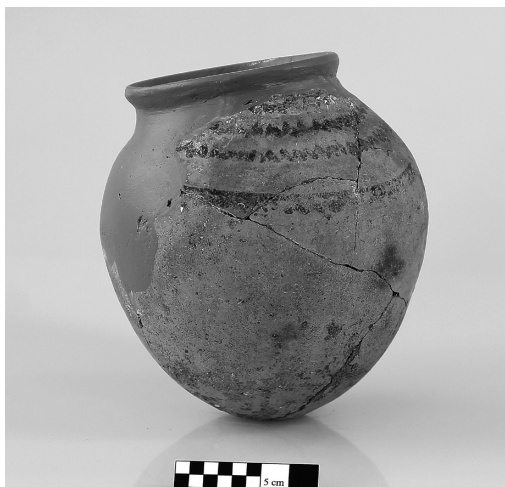
*Fig. 5*  
Festoon ware pottery  
from trench N21,  
Van Fortress Mound

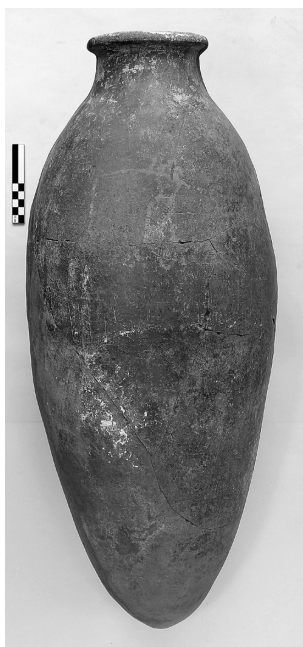
*Fig.10  
Urartian period  
egg-bodied storage pot,  
Van Fortress Mound,  
trench M26*

Describing the Urartian buildings in trench M26 in general it is seen that the southern one of the two square rooms adjacent to each other opens to the paved area and the northern one opens to the area identified as pantry (Fig. 6-8). There is no clear architectural separation between the paved area and the pantry; however, it is clear that there are two different structural characters and plans. The paved courtyard has a length of 5.90 m in the north-south direction and has currently a width of 3 m; it actually extends further south and east. The paved area formed with small river stones seems to be arranged in three rows in some parts, which must be due to the repairs and levelling of the ground. In the north of this paved area is the room identified as pantry or storage room with its *in situ* finds. This unit, which extends outside the trench, measures 2.90 m north-south and 2.50 m east-west. Along the south and east sides of the room are platforms of 45-60 cm width built with a single row of stones (Fig. 9). About the middle of the southern platform are two slab stones placed perpendicularly forming a niche-like area of 85 x 60 cm with compressed earth ground. Similar architectural elements are also known from Ayanis and Yoncatepe. Such small rooms connected to kitchens and work-areas via doors were arranged with platforms. Based on similar evidence, it can be suggested that storage jars were stacked on these platforms (Fig. 10).
