## Determination of Stress and Deformation Zones of Historical Mus Murat Bridge

### Tarihi Muş Murat Köprüsü Gerilme ve Deformasyon Bölgelerinin Belirlenmesi

Aylin Özodabaş<sup>1\*</sup>, Cüneyt Artan<sup>2</sup>

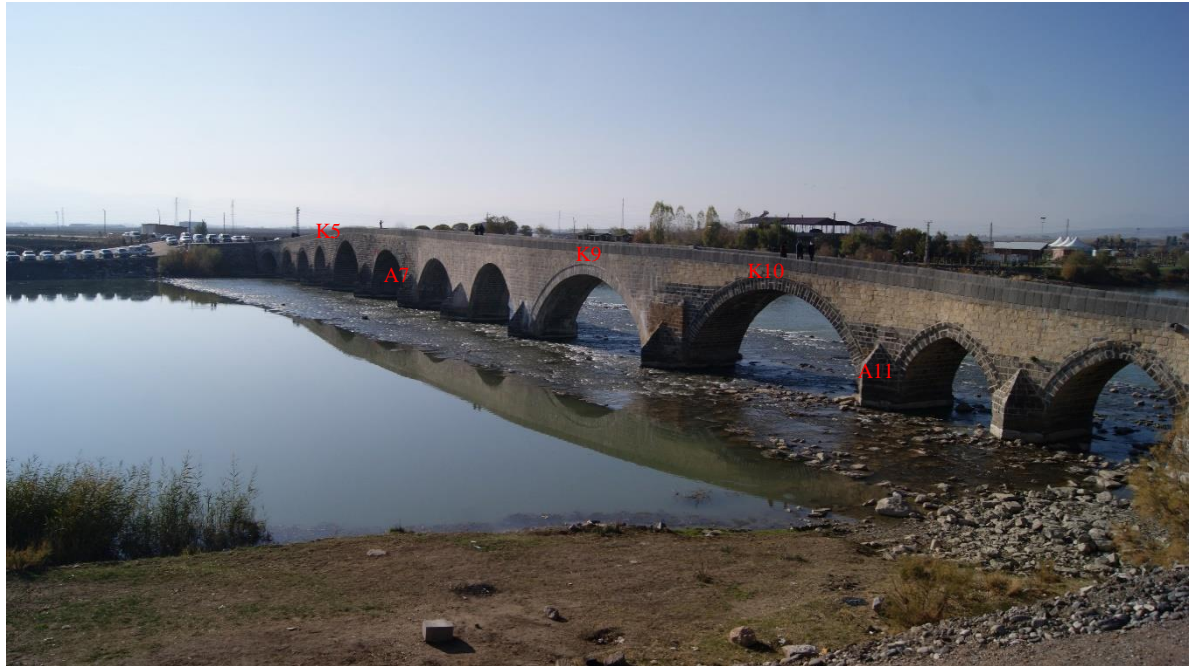
Figure 3. Historical Murat Bridge Upstream View (Present Condition November 2020)

The bridge, which was rationalized with 12 arches, is pedestrianized today. The bridge was registered by the Diyarbakır Regional Board for the Conservation of Cultural and Natural Properties in 1990 [22]. The drawings of the historical building are shown in Figures 1 and Figure 2, and its present condition is shown in Figure 3.

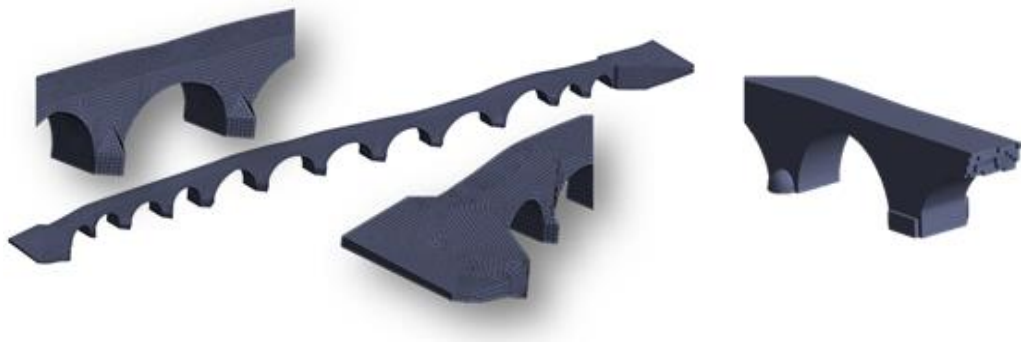
The bridge geometry is meshed according to the Hex dominant method. The general view of the mesh and the bridge model are shown below in Figure 5.

Figure 5. Model and mesh display of Historical Murat Bridge

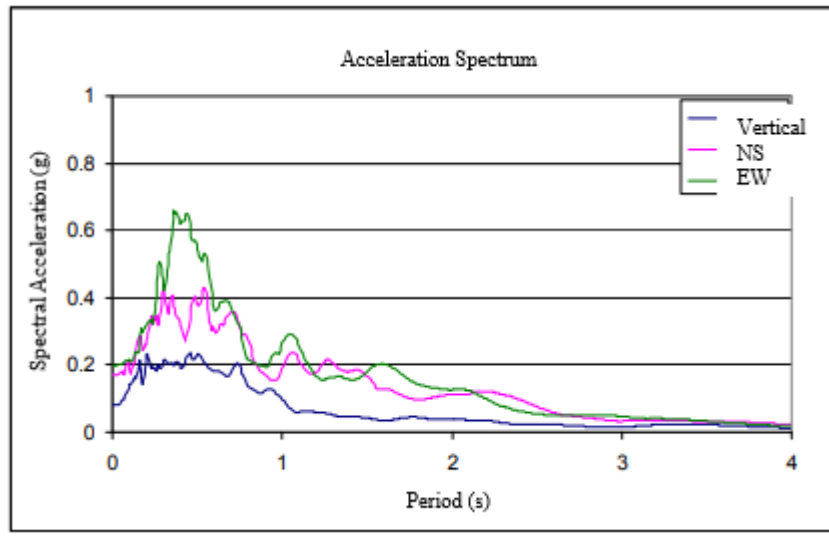
The data of the Van earthquake that occurred in 2011 were taken from a technical report prepared for the earthquake [28]. In Table 3, accelerometer stations measuring earthquake data are presented. One of the measurement stations, Mus Malazgirt station, is approximately 90 km away from the historical bridge. The acceleration spectrum graphic of the earthquake is presented in Figure 8.

Figure 8. Van acceleration spectrum (period-acceleration) [28]

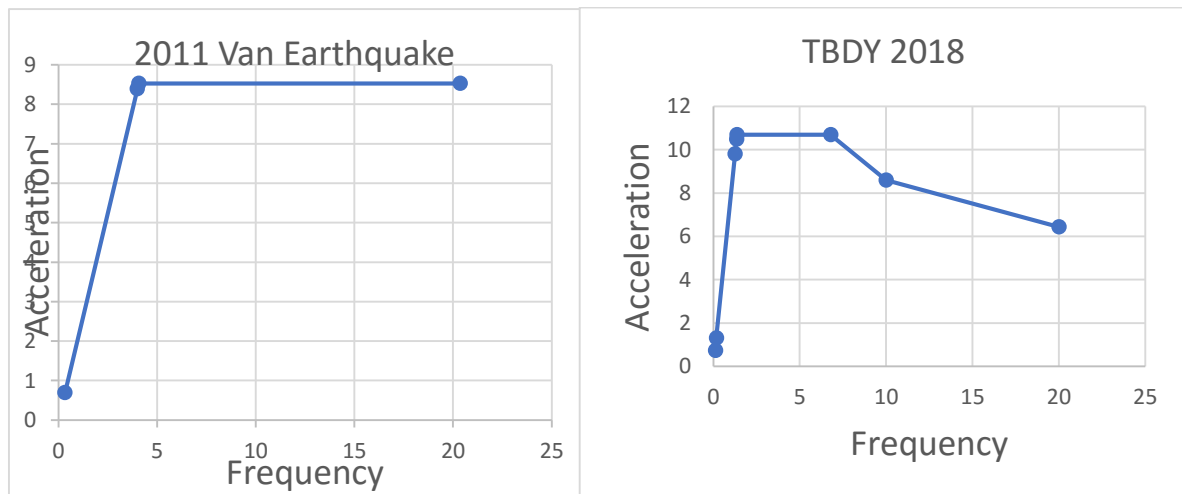
In Figure 9, the frequency acceleration graphics that are created according to the acceleration response spectra found in the earthquake data and used in the analysis are presented.

Figure 9. Earthquake data used in the analysis (frequency-acceleration)

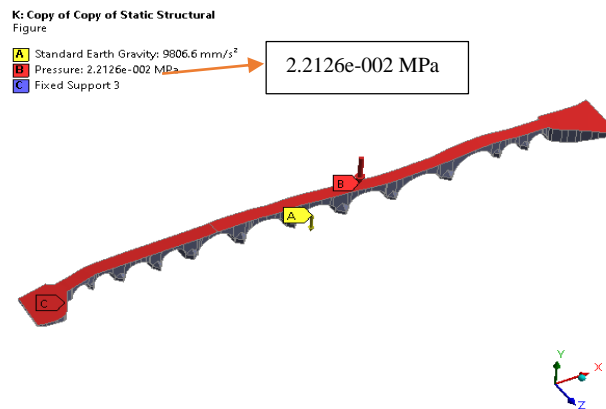
3. *Vehicle and Hydrostatic Analysis:* Vehicle analysis was conducted to examine the behavior of the building under vehicle load. H30-S24 vehicles were loaded to the building with certain assumptions. H30-S24 vehicle type and axle spacing are shown in Figure 10. By choosing the minimum axle spacing, 42 vehicles were fitted to the structure and analyses were conducted under the applied pressure. Vehicle load analysis model of the building is presented in Figure 11.

Figure 11. Model of vehicle loading analysis

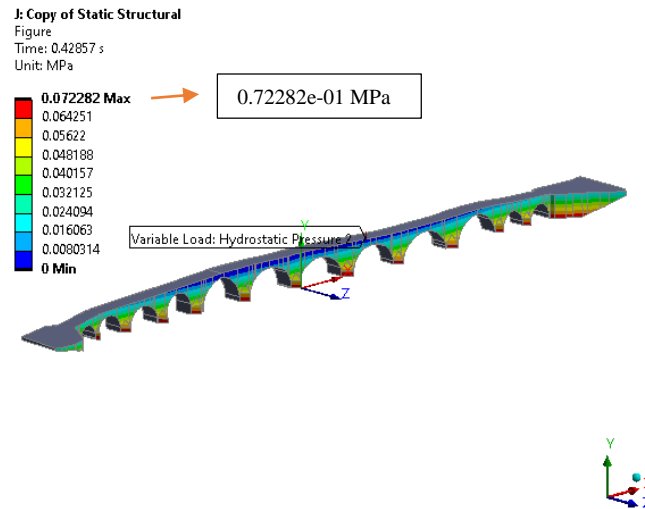
The historical bridge is located on the riverbed, and there is no information available about the discharge of the river, so the hydrostatic analysis has been conducted with certain assumptions. The analysis was conducted as if there was water at the level of the bridge deck, upstream of the bridge, along the riverbed. The exerted pressure has been increased by 10% taking into account the dynamic effect of water flow. Hydrostatic pressure diagram effected on submerged areas is given in Figure 12 and hydrostatic analysis model is given in Figure 13.

Figure 13. Hydrostatic analysis model
