# Proposals to Develop Sustainable City Center Axes Upon Case Studies: Istanbul, Erzincan, Balıkesir, Bursa, Adıyaman

Dr. Tayibe Seyman Güray, Msc. Burcu Kısmet Beykoz University, Department of Architecture. tayibeseymanguray@beykoz.edu.tr, burcukismet@beykoz.edu.tr https://orcid.org/0000-0001-5692-9669 https://orcid.org/0000-0002-7690-9953 Received: 27.06.2021 Accepted: 29.09.2021 DOI:10.17932/IAU.ARCH.2015.017/arch v07i2004

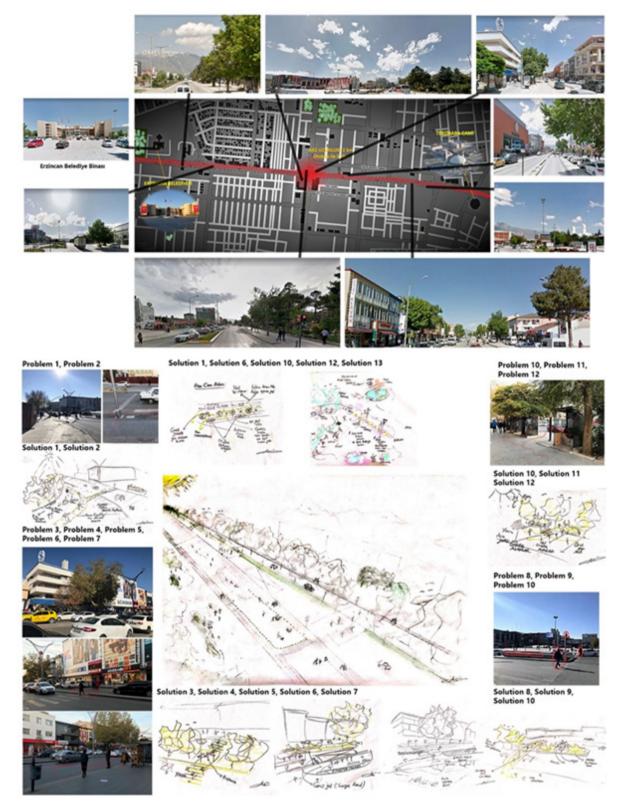
Figure 3. Description and sustainability proposals for the axis in Erzincan by A. Adan

The specific sustainable solutions for the selected axis are classified in different areas: solutions about mobility issues are increasement of pedestrianly movement based transportation, implementing crossovers and traffic lights, continuous pedestrian paths providing same width along the axis, implementing a bicycle path to the existing road, placement of bus stop, increasement of traffic signs to prevent accidents, underground parking lots that ground levels are designed as open green public areas and encouraging electrical cars from macro scale by adding battery units on the axis. Integration of ramps and visually impaired paths are designed for the entrances of buildings, pedestrian paths and crossovers. In order to improve green areas, afforestation on the axis and transformation of idle open areas and car parking areas to green public spaces are designed. Also, these green areas are considered as earthquake assembly area. Transforming unemployed overpass into a small-scale green street bazaar to improve local economy are planned. Reusing the existing pavement by applying top coat solutions against slipperiness or roughening the pavement material are designed and transforming the unused ornamental pool into seating area with green is planned. Placement of recycle boxes for each 400 m is planned.

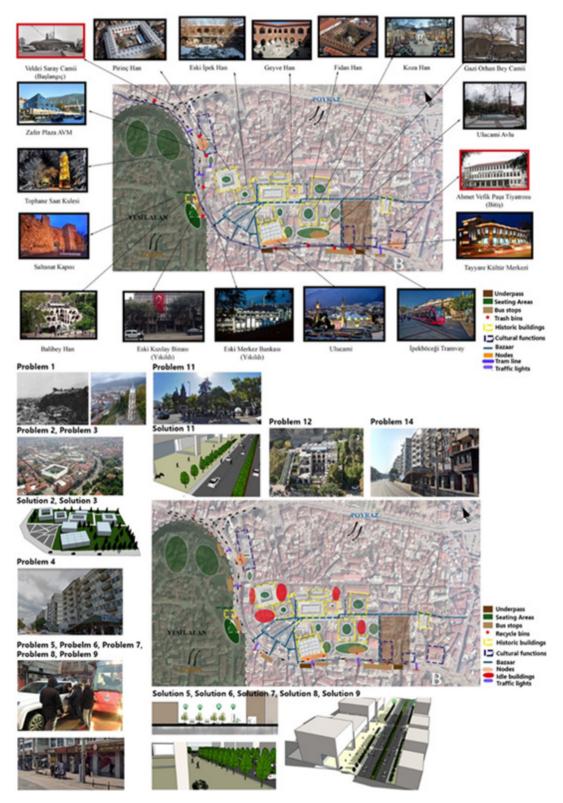
Figure 5. Description and sustainability proposals for the axis in Bursa by M. Bakan.

The specific sustainable solutions for the selected axis are classified in different areas: solutions about mobility issues are increasement of pedestrianly movement based transportation, implementing crossovers and traffic lights on the axis, moving the existing tram network to a parallel street, implementing a bicycle path to the existing road, relocation of bus stops, increasement of traffic signs to prevent accidents and excessive usage of car horn, underground parking lots that ground levels are designed as open green public areas and encouraging electrical cars from macro scale by adding battery units in gas station on the axis.

In addition, reconsideration of a new milder steep escalator system by arranging at different levels which includes landings is important for urban safety and connectivity. Integration of visually impaired paths is designed for the entrances of buildings, pedestrian paths and crossovers. In order to obtain green areas; afforestation on the axis, transformation of idle open areas and car parking areas to green public spaces and protection of existing green areas are planned. Also, this large green area is considered as earthquake and disaster assembly area. Transforming unemployed underground pass into a small-scale bazaar to improve local economy and solar panel-based lighting system to the underground pass are designed to have safer urban environment. Standardization about advertisement signboards and mesh panel systems for HVAC external units are proposed to solve visual pollution. For the continuity of cultural heritage; restoration, renovation and refunctioning the abandonment historical Hans area are planned which aims to transform Hans area into a cultural Han district with small exhibition areas, bookshops, cafes and performing areas. Placement of recycle boxes for each 400 m is planned.

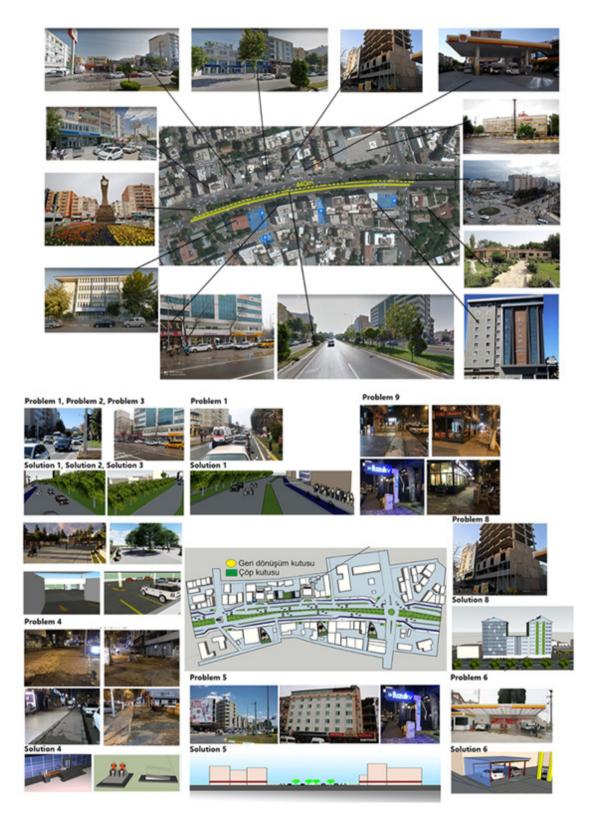
Figure 6. Description and sustainability proposals for the axis in Adayaman by §. Bozkurt.

The specific sustainable solutions for the selected axis are classified in different areas: solutions about mobility issues are increment of pedestrian movement-based transportation, implementing a bicycle path to the existing road, increment of traffic signs to prevent accidents, underground parking lots that ground levels are designed as open green public areas and encouraging electrical cars from macro-scale by adding battery units on the axis. Integration of ramps and visually impaired paths are designed for the entrances of buildings, pedestrian paths and crossovers. In order to improve green areas, afforestation on the axis and transformation of idle open areas and car parking areas to green public spaces are designed. Also, these green areas are considered as an earthquake assembly areas. Completion of the unfinished construction work with sustainable approach and materials and defining a proper function for the economy and social life of Adiyaman are planned. Also, a night lightening system based on solar energy is assigned to the whole axis which will improve urban environmental comfort and urban safety. Limitations and standardization about exterior extensions of cafes and restaurants are planned. Standardization about signboards and mesh panel systems for HVAC external units are proposed for the facades of buildings on the axis. Placement of recycling boxes for every 400 m is planned.
