Architectural Evaluation Analysis by Using GIS, Case Study: Kaleiçi, Antalya

Ayşe Hazal Aygün^a, Ali Cemil Düzgün^b

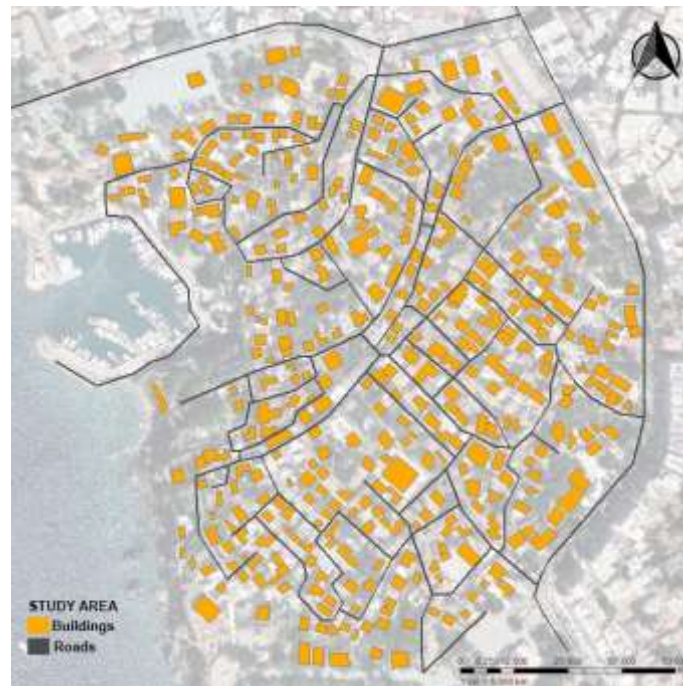
In this section, the transportation, height, functional and development period analyzes of the study area are realized by using GIS. Within the scope of the study, 418 buildings in Antalya, Kaleiçi region were examined. The Antalya Kaleiçi maps used in this section are taken from Google Earth. The drawings on the maps were drawn as a result of the authors' research, on-site observations, and analysis.

Figure 3: Study Area, Kaleiçi, Antalya.

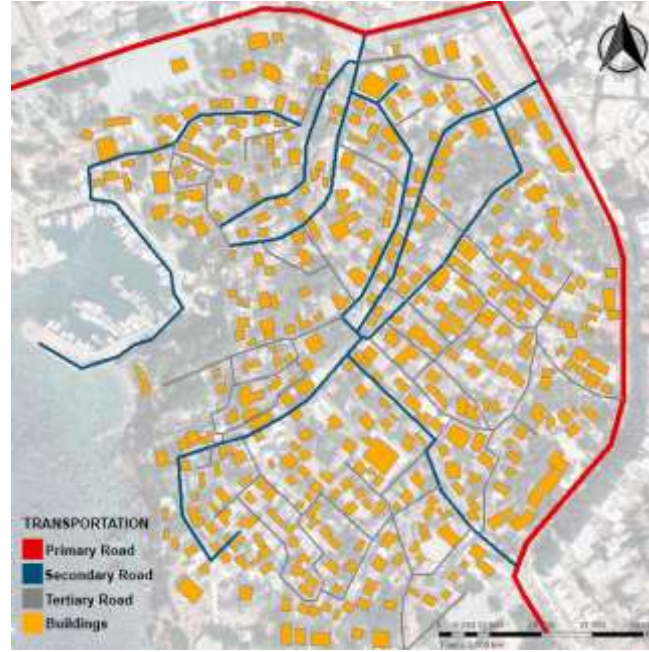
Figure 4: Transportation Analysis

Primary roads surround the borders of Kaleiçi. Secondary roads in the region where vehicle entrances are controlled by time limitation are predominant. Some dead-end streets and roads without vehicle access are considered tertiary roads.

Transportation to study area is provided by the main roads coming from the Kaleiçi and the Republic Square. People also go to the region by sea transportation. The dominant transportation circulation within the boundaries of the study area is provided by pedestrian route. (Soydan, 2020).

The regulation for the vehicles serving to businesses is that the vehicles servicing to the businesses as distributor, marketing, fuel, services as food, drink, cleaning materials could enter the area between 06:00 and 12:00 and they will be out of until 12:30. (Uluç, 2014).

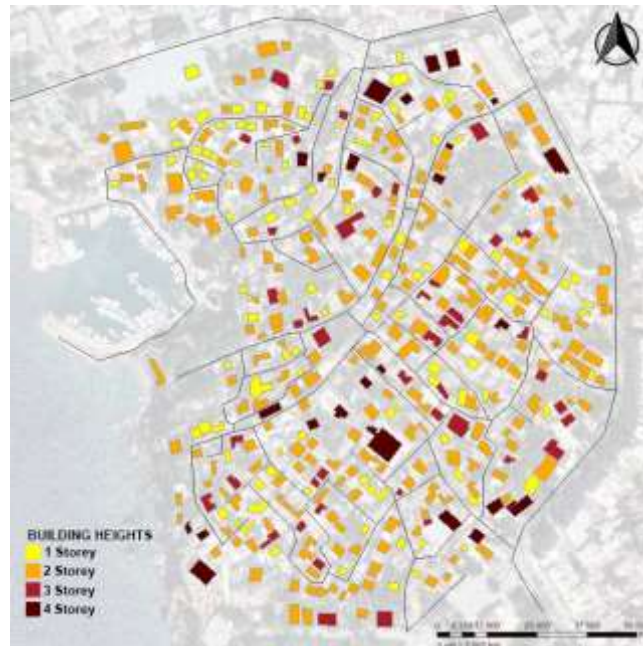
Figure 5: Building Heights

Traditional Kaleiçi houses are usually 2-storey buildings, as seen in Fig.5. When the floor height analysis is made in the region, it is seen that most of them are 2-storey buildings. 235 of the 418 structures analyzed are 2-storey buildings. While 111 buildings are single-storey, 46 buildings are 3-storey and 26 buildings are 4-storey. These analyzes are shown with a pie chart with percentages in Fig. 9.

As a result of observations, researches and GIS analyzes, some findings about Antalya Kaleiçi region were obtained. There are different properties within the study area. Traditional Kaleiçi houses are usually 2-storey. When the floor height analysis was made, it was seen that 235 of the 418 buildings examined consist of 2-storey buildings. Based on building height analysis, as shown in Fig.9, 26.6% of the total buildings is 1, 56.2%, 2, 11%, 3% and 6.2% on 4 floor.

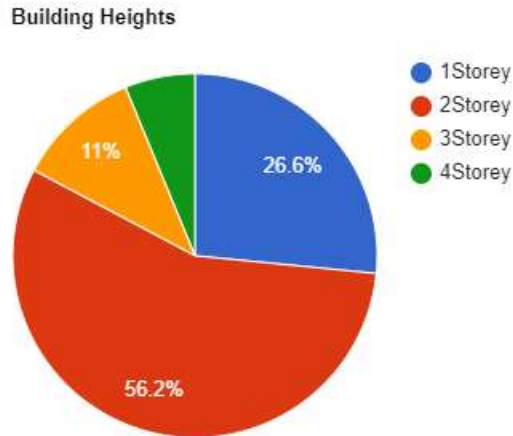
Figure 9: Pie-Chart of Building Heights

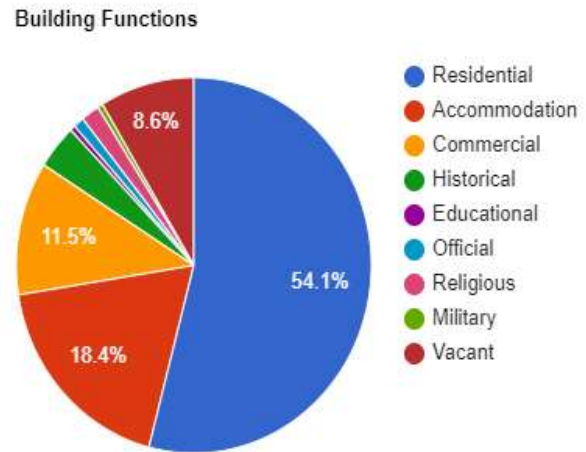
Figure 10: Pie-Chart of Building Functions

As explained, there are many different historical textures in the Kaleiçi region of Antalya, one of the oldest settlements in Anatolia. There are buildings from Byzantine, Seljuk, Roman, and Ottoman periods that still exist in the Kaleiçi region. The monuments include the Clock Tower, the Hidirlik Tower, the Hadrianus Gate, a broken mosque of minarets, churches and hammam. They are all very important. In addition to these structures, the majority of residential buildings in the region are. Fig.6 shows structures with different regional functions. As shown in Fig.10, 54,1 percent of the total buildings are residential according to the share of these functions.
