A Study on Conservation of Church Buildings in Turkey: The Example of Yalova/Esenköy Azize Paraskevi Church

(1st International Conference on Applied Engineering and Natural Sciences ICAENS 2021, November 1-3, 2021)

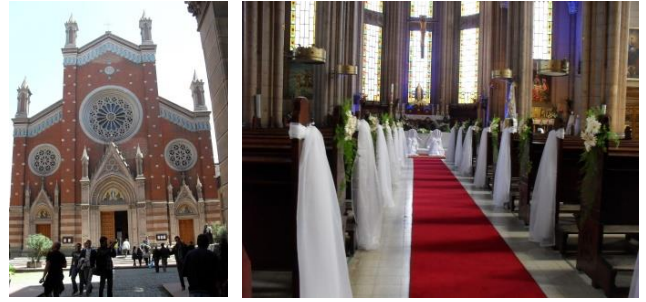
One of the prominent church structures in the context of conservation in Turkey is the Sent Antuan Church in Istanbul/Beyoğlu. The building, which was built in 1724 with the Gothic architectural style, was demolished due to the tramway line and it was started to be rebuilt in the same area in 1906. The structure, which continues to exist today with its Neo

Gothic style is used for tourism purposes as well as its original function (Atıcı and İnceoğlu, 2020) (Figure 1).

Figure 1. Saint Antuan Church under conservation, Istanbul (Personal archive, 2011)

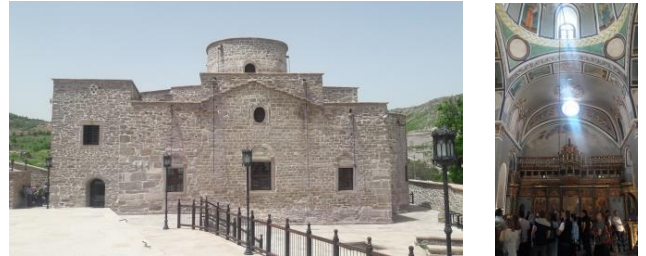
One of the church structures that have survived and conserved in Turkey is located in Konya/Sille. The church structure, which is known to have been built in B.C. 327, has continued its existence with various repairs (Tapur, 2009). The building, which was one of the important worship centers of the period, serves as a museum today (Figure 2).

Figure 2. Aya Elenia Church under conservation, Konya (Personal archive, 2017)

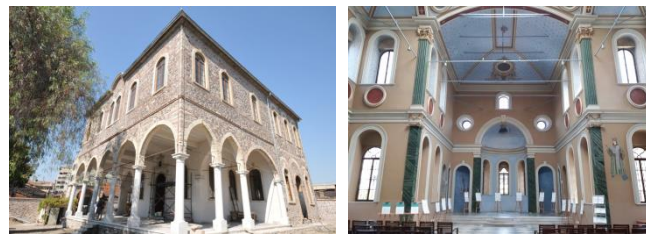
Ayavukla Church, located in Izmir, is one of the places of worship that is of great importance in the context of conservation. The building, which was opened for worship in 1887, started to serve as the Izmir Archeology Museum in 1924, after its congregation left Turkey with the population exchange. The building, which has been evaluated with different functions in the processes that have reached the present day, started to host various cultural events with the completion of the restoration works in 2010 (URL 1) (Figure 3).

Figure 3. Ayavukla Church under conservation, Izmir (URL 2; Personal archive, 2018)

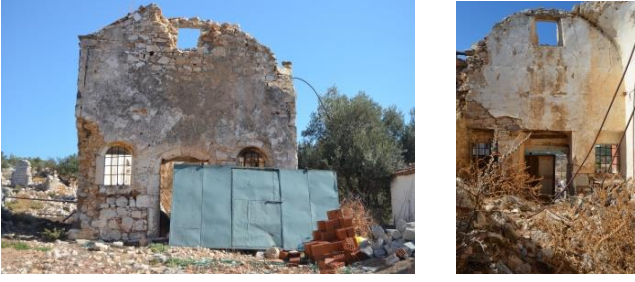
It is possible to talk about the existence of churches in a dilapidated condition in addition to the church structures that are under conservation in Turkey and continue their existence both with their original functions and with re-functioning. These structures can be found in various urban centers as well as in rural areas. In this sense, one of the examples identified is located in the İzmir/Urla countryside, in the Nohutalan District. The stone-material building was unused and neglected after the Christian population left the settlement due to the population exchange (Olğun and Yörür, 2020) (Figure 4).

Figure 4. A ruined church building, Izmir (Olğun and Yörür, 2020)

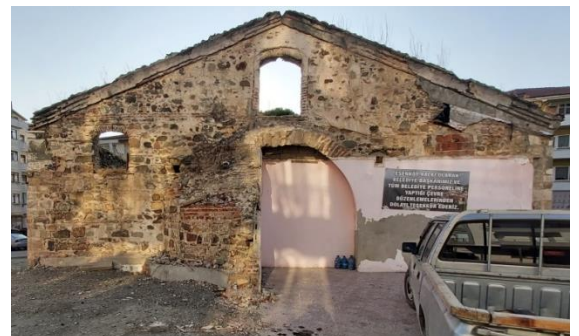
In Esenköy, both before the exchange; it is known that there are monumental structures and houses built with traditional methods after the settlement of Muslim users. However, most of them have been lost before reaching the present day. Azize Paraskevi Church, which has not been lost yet but is in a very neglected condition, has qualities worth examining as one of the oldest monumental works in the settlement. Only the exterior walls and some interior elements have survived from the church building, which is located on Yalova Street, at a central point of the settlement (Figure 7, Figure 8).

Figure 8. The view of Azize Paraskevi Church from the east wall on Yalova Street (Personal archive, 2021)

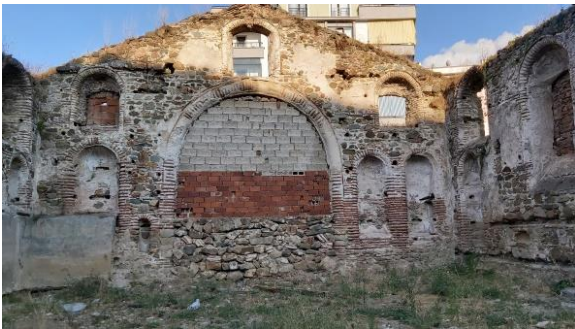
The church structure is in a very dilapidated condition today. There are few elements of the building in its interior. These can be listed as niches, apses, windows and doors (Figure 10, Figure 11). No items that could be associated with this building were found in its surroundings. New residences continue to be built in the immediate vicinity of the building. However, many unqualified buildings adjacent to the site were removed.

Figure 10. The apse and niches of Azize Paraskevi Church (Personal archive, 2021)

- Clearing the building from unqualified structuring around the church,
- Documentation work,
- Preparation of its restitution with detailed research on its past,
- Considering the absence of the congregation, its re-using with an appropriate function and the preparation of the restoration project accordingly,
- Giving information to the users of the settlement about the importance of the building and raising awareness of conservation.

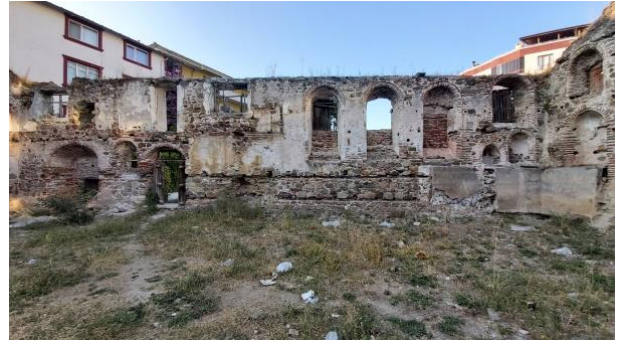
Figure 11. Apertures in the north wall of Azize Paraskevi Church (Personal archive, 2021)
