## Material Deficiencies of Reinforced Concrete Structure of Botas Petrol Platform

Petroleum produced in Turkey, which is exported from Iraq by Kerkük–Ceyhan Pipeline and Azerbaijan by Bakü-Ceyhan Pipeline is exported to world at BOTAŞ Plant. Reinforced Concrete (RC) platform of the plant has significant structural and material problems. It has been found out that some RC pile columns have been losing their bearing capacity. Since concrete used in the structure was not designed to resist sulfate and salt effects, observations have revealed that columns and beams were damaged due to these effects. If the necessary precautions are not taken as soon as possible the structure is likely to complete its economical service life in the near future. The structure needs to be repaired and strengthened. This paper presents some technical suggestions to overcome the problem.

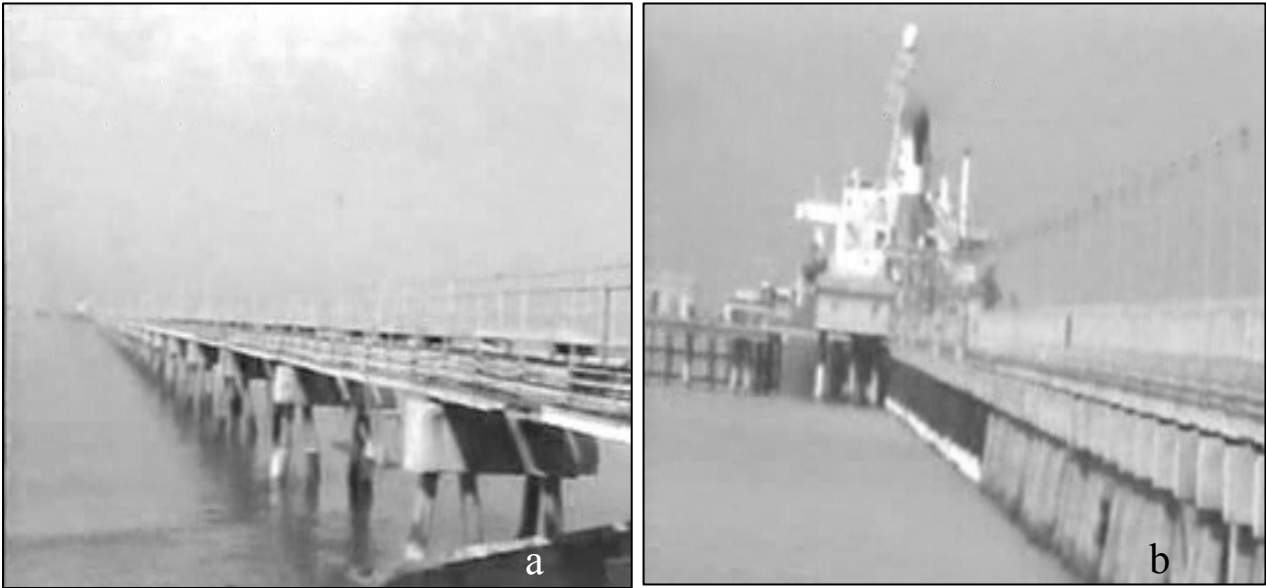
Fig. 2. a& b) General layout of the piers

In this study, structural damages and corrosion of the reinforcement in the BOTAŞ platform are investigated. The plant is located at Iskenderun Gulf in north-east part of the Mediterranean Sea in southern Turkey. Geographical Map of the studied region is given in Fig. 1 and general view of the pier is given in Fig. 2. BOTAŞ-Dörtyol platform structure is 1320 m in length. Pier has two parts: the first one is loading and rail transport platform, the other is the part used to load tankers up to 65000 tons of gross weight.

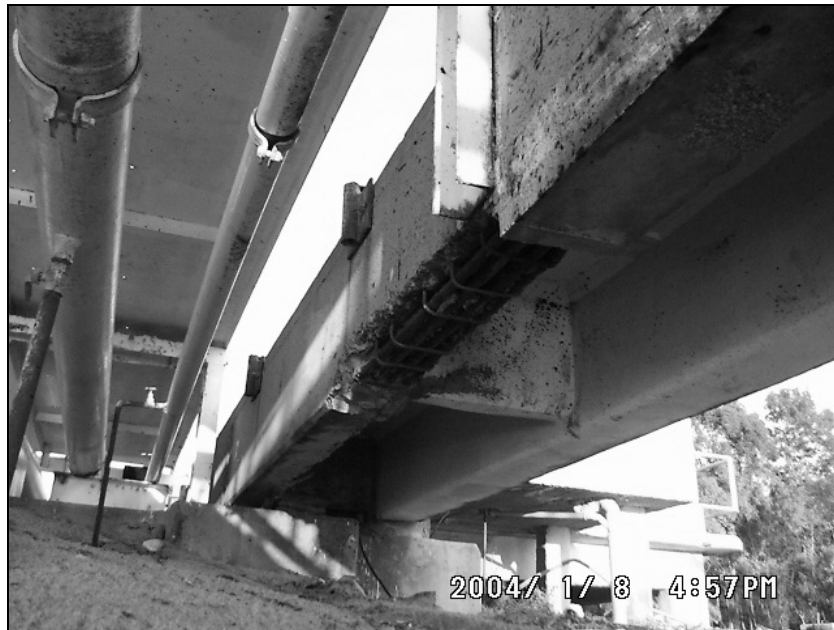
Fig. 3. Some damages in a beam

RC members of Dört Yol petroleum loading pier have suffered from serious structural damages (See Fig. 3. to Fig. 9.). In design practice of RC structures tensional strength of the concrete is usually ignored and longitudinal reinforcement bars on tension side carry tensional stresses. Therefore, reinforcement bars carrying tension loads should be prevented from external effects like corrosion through whole service life of the structure. However, in the investigated structure, these bars corroded heavily as seen in Figs. 3 and 4. Due to loss in reinforcement area, flexural capacity of the sections significantly reduced. As a result, beams may fail even under normal dead and live loads, without being subjected to a dynamic loading such as earthquake.

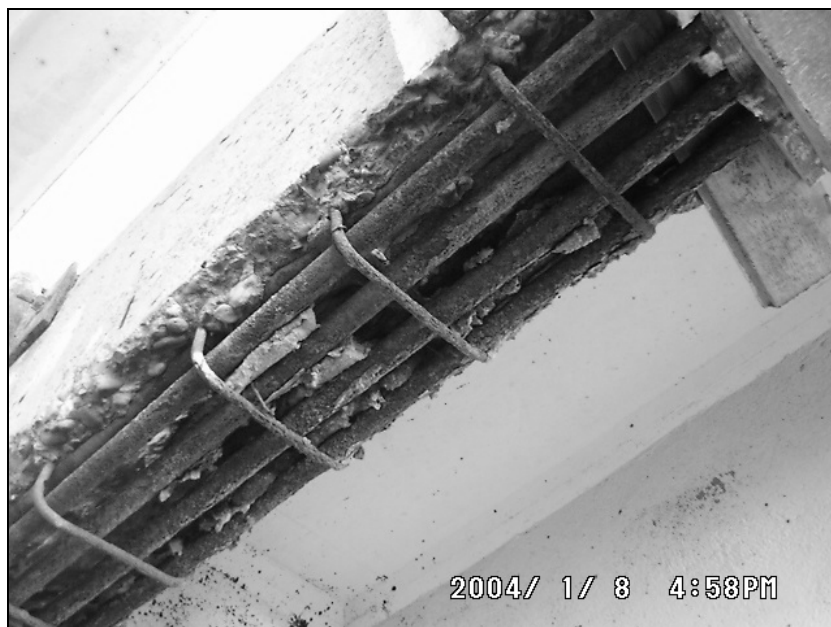
Fig. 4. Concrete damage and corrosion of uncovered reinforcement bars at a beam element

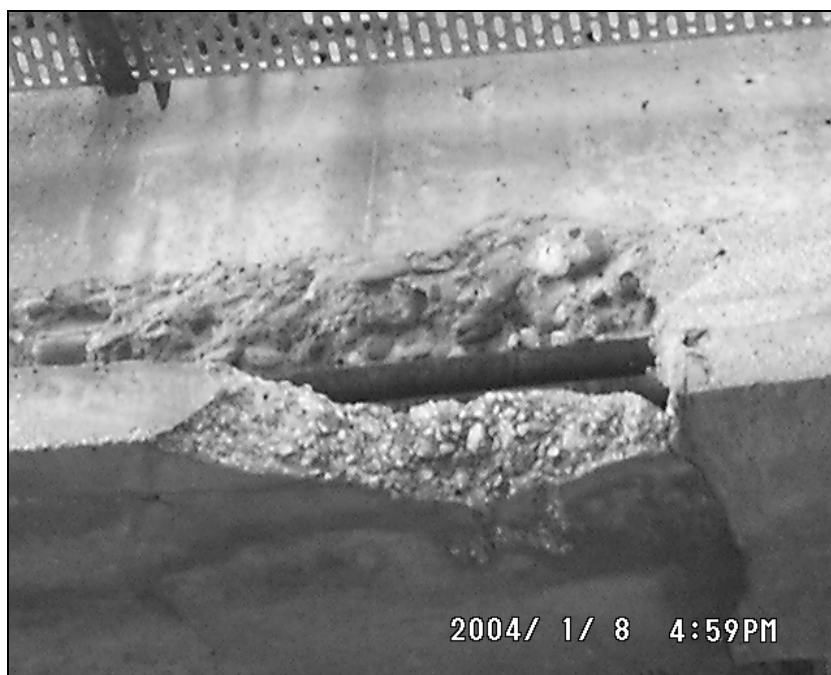
Fig. 5. Concrete damage at beam faces.

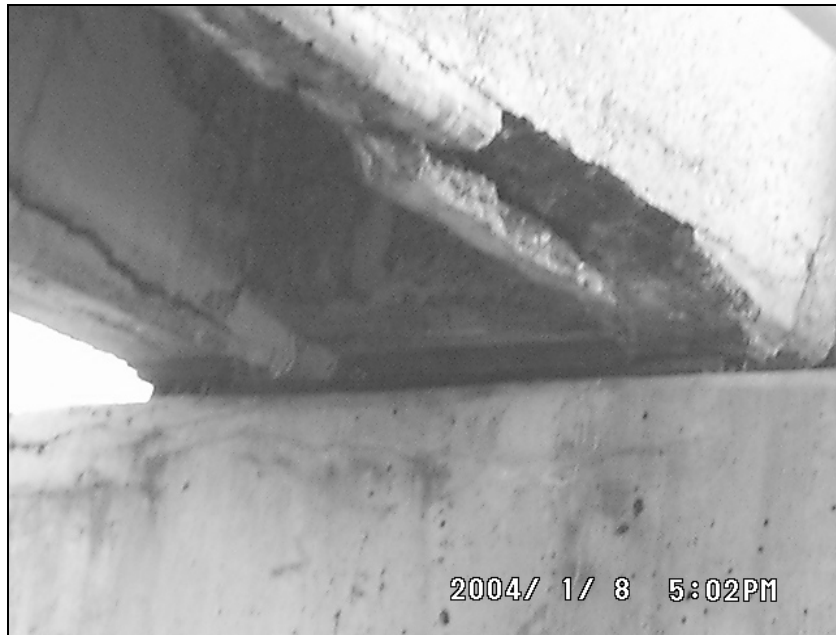
Fig. 6. Separation of concrete at beam faces

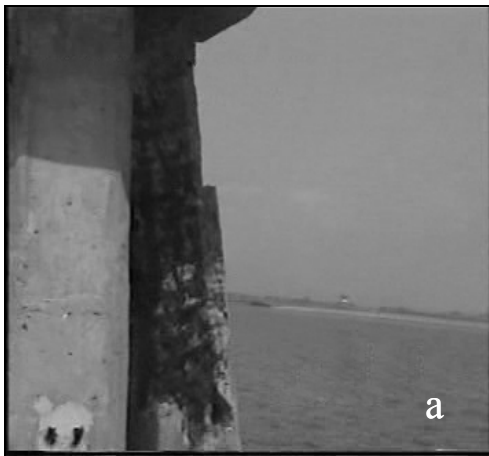
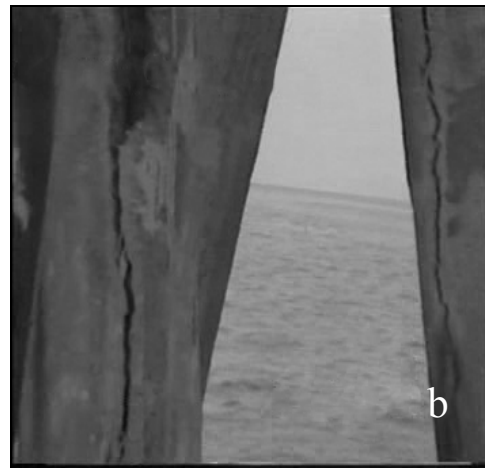
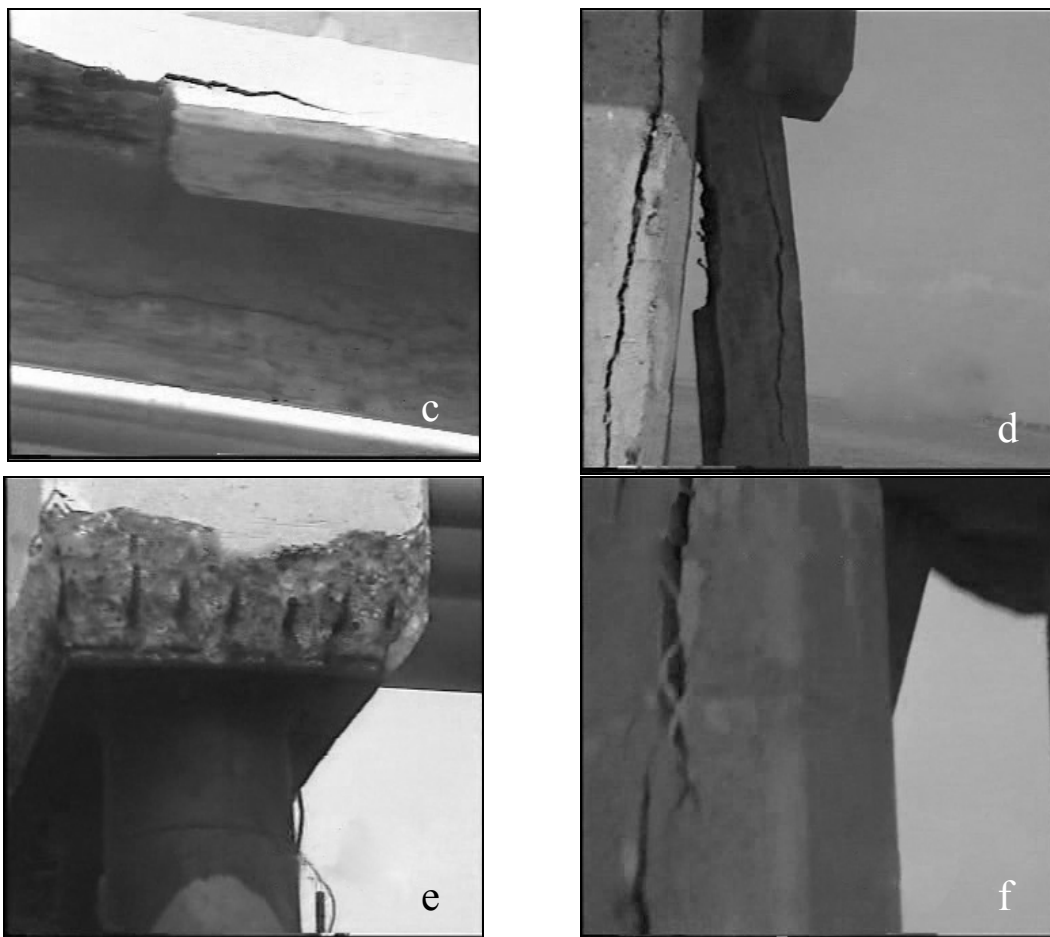
Fig. 7. Corrosion and structural damage in RC piles near to sea surface,  
a, d & e) Longitudinal cracks.  
b) Damage in the pile.  
c) Transverse cracks.  
f) Reinforcement separated from concrete

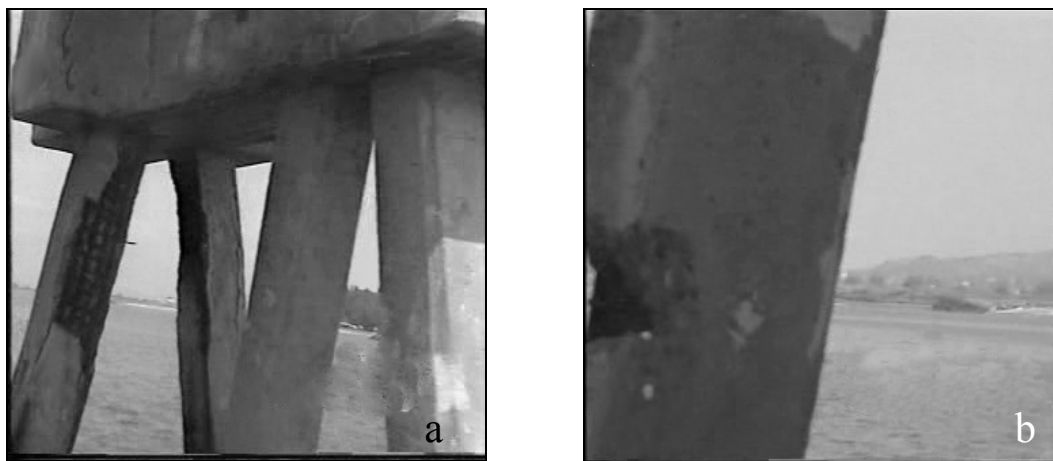
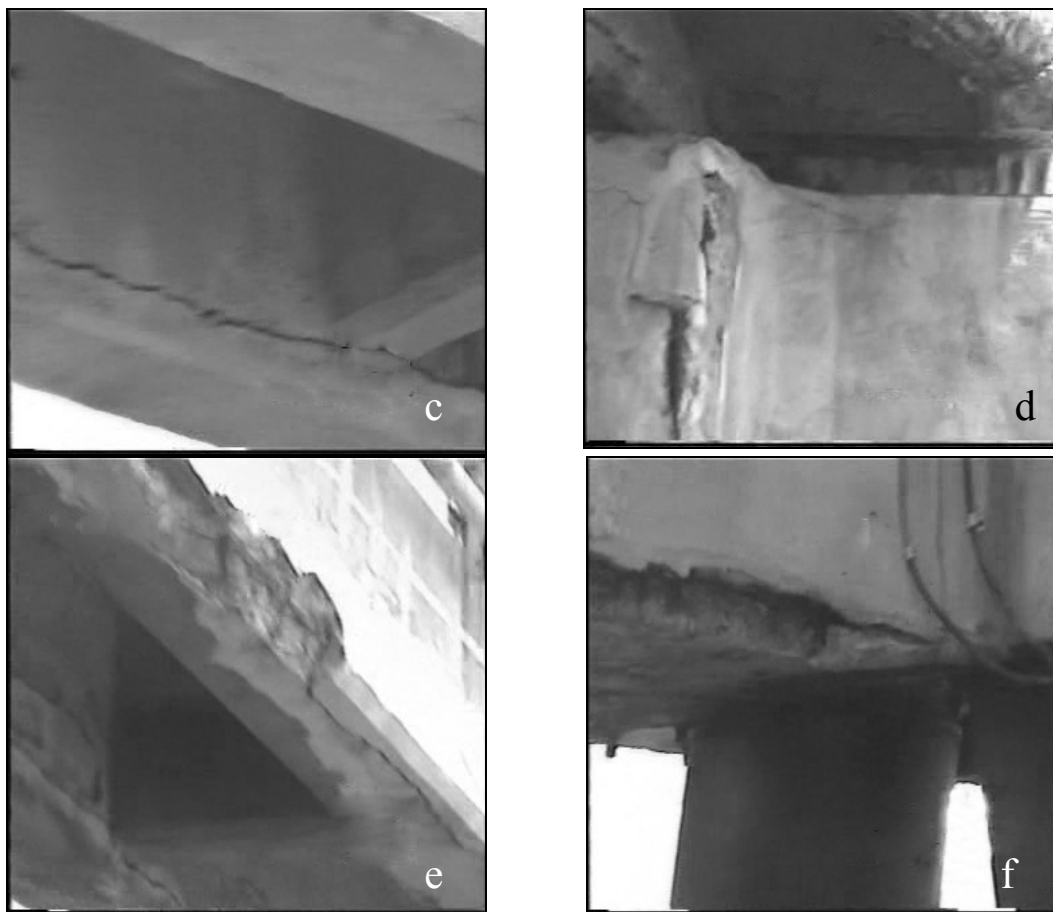
Fig. 8. Corrosion and structural damage in RC piles near to sea surface  
a) Damage in two piles.  
b) Concrete fall down and reinforcement corroded.  
c) Longitudinal cracks in a beam.  
d, e & f) Serious damages in beams

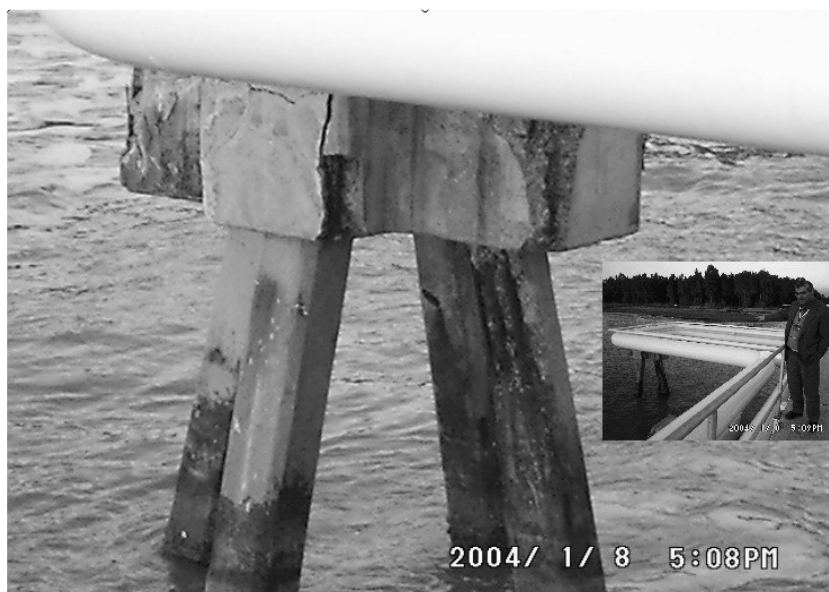
Fig. 9. Corrosion and structural damage in RC piles

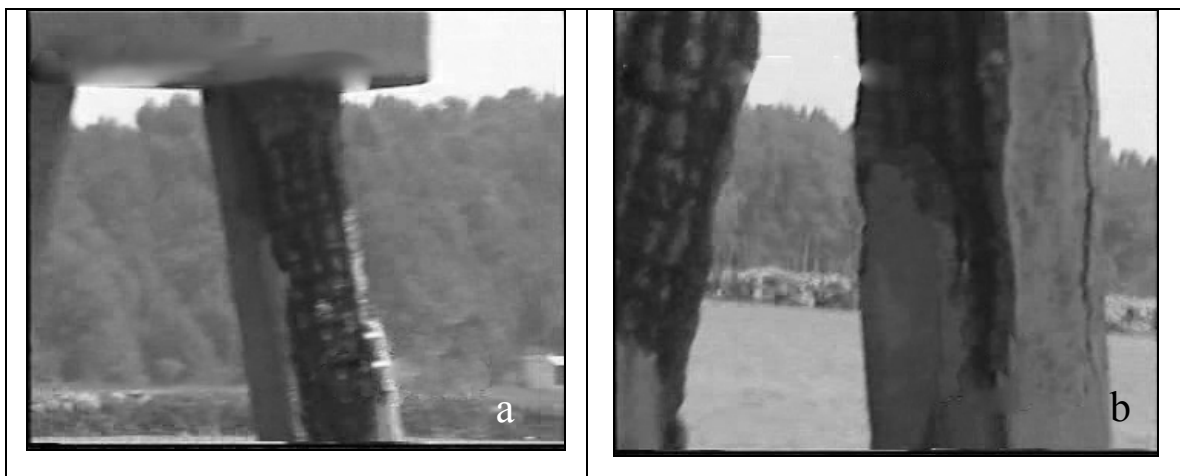
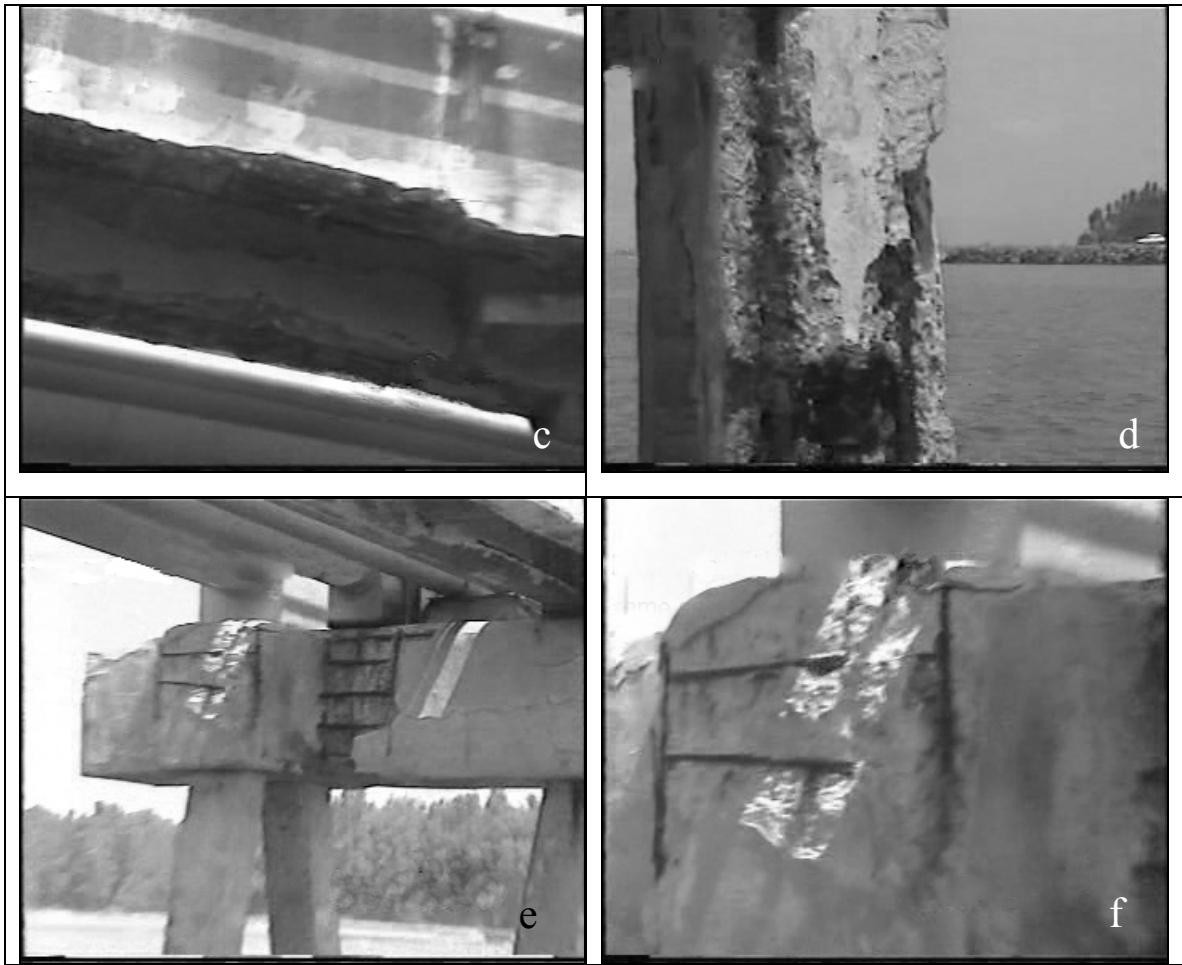
Fig. 10. Covers of concrete beams have fallen completely.  
a, b, c & d) Corrosion and structural damage in piles.  
e & f) Damage in concrete and corrosion of the reinforcement bars.

Corrosion is a process of chemical and electro-chemical reactions eventually causing metals to lose their mechanical properties. Especially steel bars are not resistant against effects coming from water and atmosphere [6]. Some RC elements in BOTAS-Dörtyol petroleum platform pier suffering from corrosion are given in Figs.10-13.

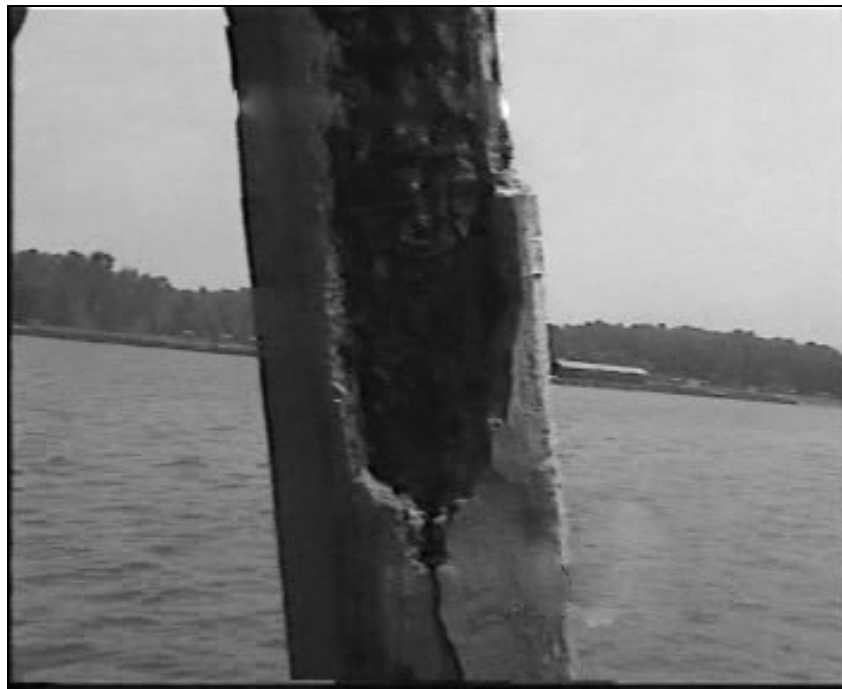
Fig. 11. Cover of concrete has fallen and the reinforcement is corroded heavily.

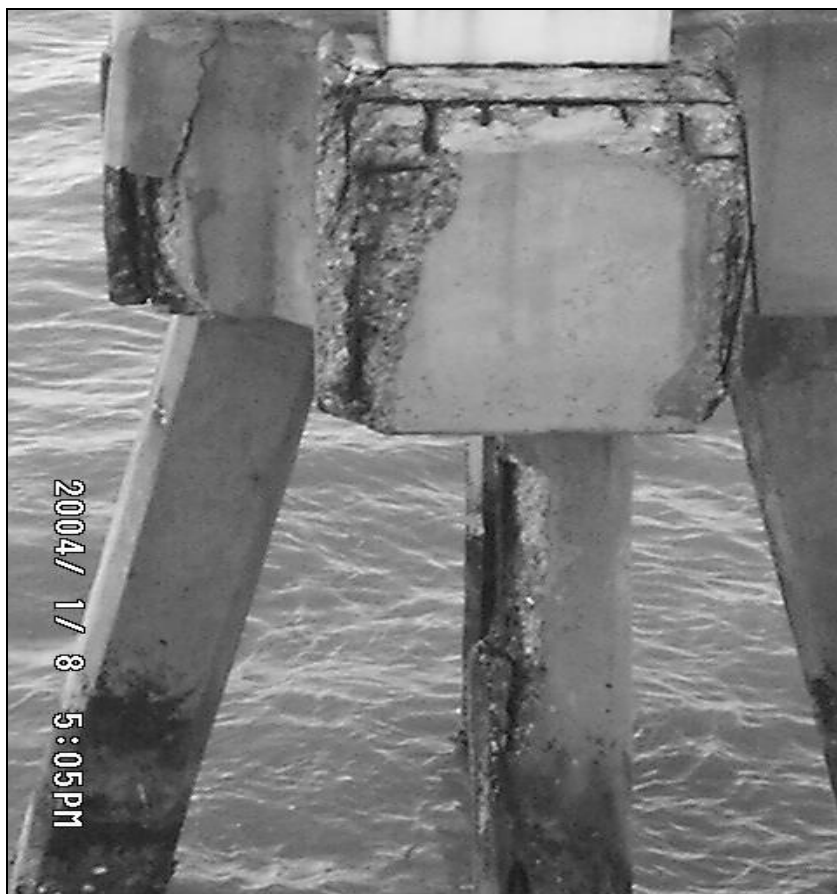
Fig. 12. Corrosion in RC piles

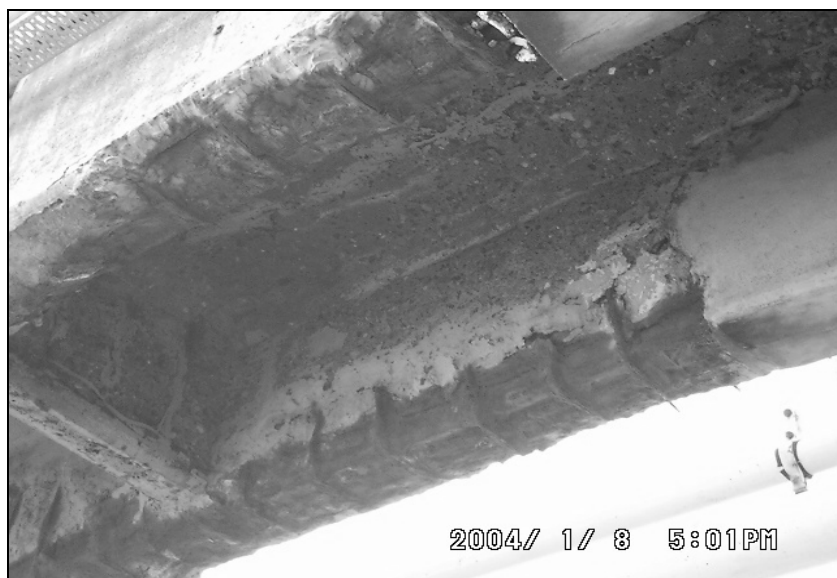
Fig. 13. Corrosion in RC beams
