Study on the Influence of Knots on the Seismic Performance of Chinese Traditional Wooden Building Beams

Log is widely used in Chinese traditional wooden buildings, which has good compression, bending, tensile and seismic performance, but the existence of knots in log will have a greater adverse impact on the structure. Taking the residence of Zhou Fujiu, a salt merchant in Yangzhou as an example, the building was built in the late Qing Dynasty, covering an area of 3700 square meters. Through the field investigation of Zhou Fujiu building in Yangzhou, it is found that in addition to the common natural cracks, the wooden beams with knots in the tension zone are obviously damaged. In order to further study the influence of knots on the seismic performance of wooden beams and provide relevant theoretical basis for the protection of traditional Chinese wooden buildings, six different wooden beams were designed according to the scale of 1:5.28, and the low cycle reciprocating loading test under three-point loading was carried out. The effects of knots at different positions and depths on the seismic performance of timber beams are simulated respectively. The hysteretic curve and skeleto

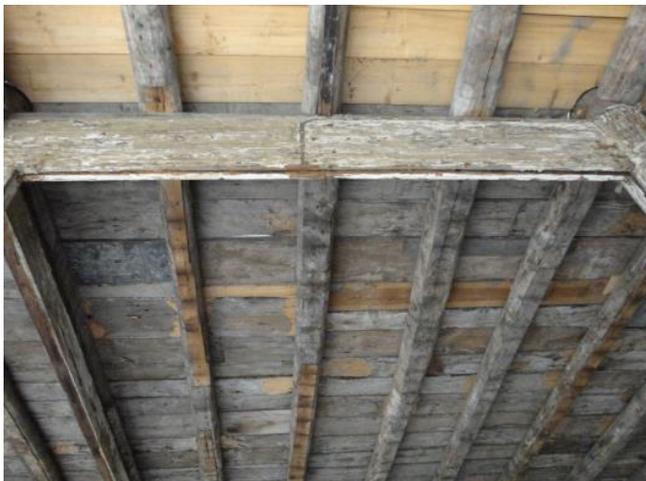
Figure 1. Cracks in square beam

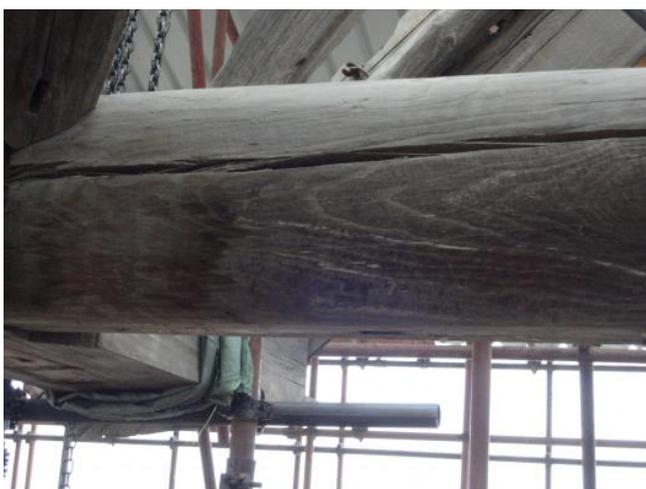
Figure 2. Cracks in square beam

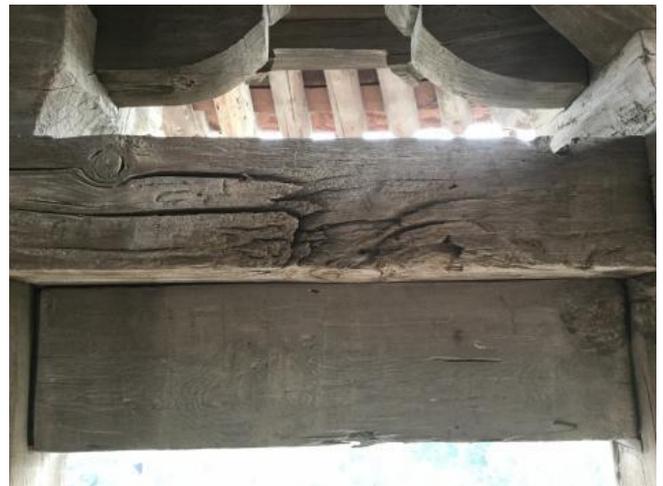
Figure 3. Damaged beam with knots

In the process of field investigation of Zhou Fujiu building timber beam in Yangzhou, it is found that when there are knots in the mid span bending area of the beam, the damage effect is the most significant. Based on this, the method of slotting in the middle of the wooden beam span is used for artificial simulation, and the simulated knots have the following characteristics: the beam section decreases when in tension; When pressed, it shows mutual extrusion and sliding. The height to width ratio of wood beam section is 3:2. Combined with the actual size of the wood beam of Zhou Fujiu building in Yangzhou, the scale of the model is 1:5.28. A total of 6 wood beams with a width of 80mm, a height of 120mm, a span of 2300mm and a clear span of 2160mm are manufactured. The wood variety is American Douglas fir.

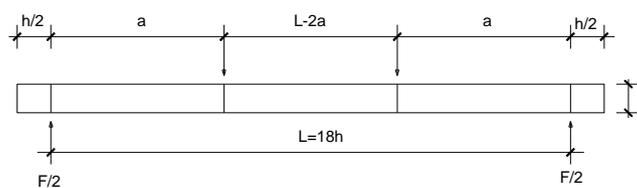
The specimen is loaded at three points, and the distance between the two loading points is 6 times of the section height, i.e. 720mm (Fig. 6).

Figure 6. Schematic diagram of three point loading test of wooden beam

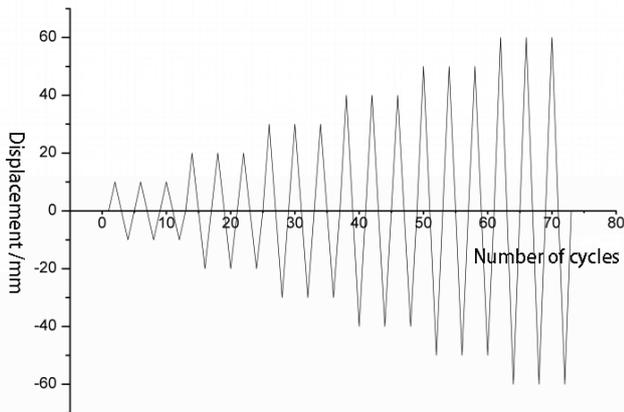
The low cycle reciprocating force is applied by the servo loading hydraulic press and the mode of displacement control loading is selected. The amplitude of displacement change is 10 mm during loading, and three cycles are carried out for each stage (Fig. 7).

Figure 7. Loading mode of wooden beam

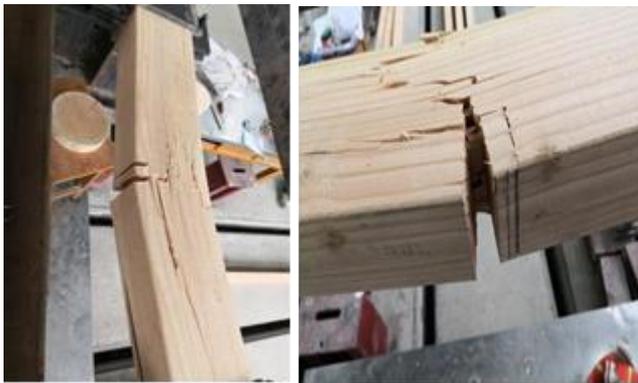
The damage of the six components finally occurred at the knots, which is consistent with the actual damage of the wooden beams of Zhou Fujiu building in Yangzhou. The experimental phenomena of the three members in group S1 are basically the same, and the cracks appear first on the side where the knots exist, and the deeper the knots are, the earlier the cracks appear. With the progress of loading, the cracks on one side of the knot gradually expand and eventually develop to the whole mid span section, resulting in the failure of the member (Fig. 8). There are knots on both sides of the middle span of the three members in group S2, and obvious cracks appear at the initial stage of loading. With the increase of displacement value, inclined cracks gradually appear along the middle of the span to both sides, and the width and length of cracks increase continuously until the members are completely destroyed (Fig. 9).

Figure 8. Midspan failure of S1 group

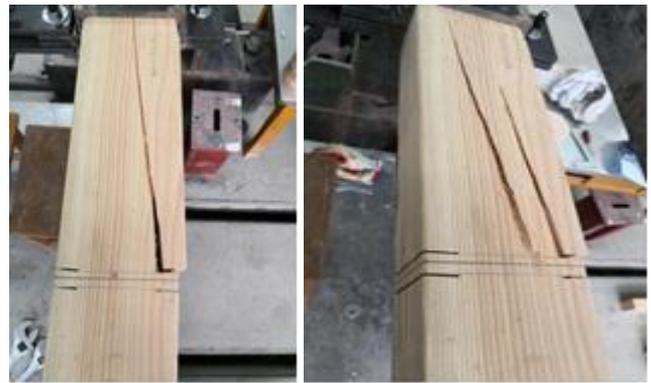
Figure 9. Midspan failure of S2 group

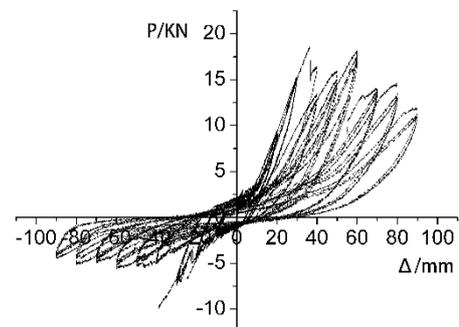
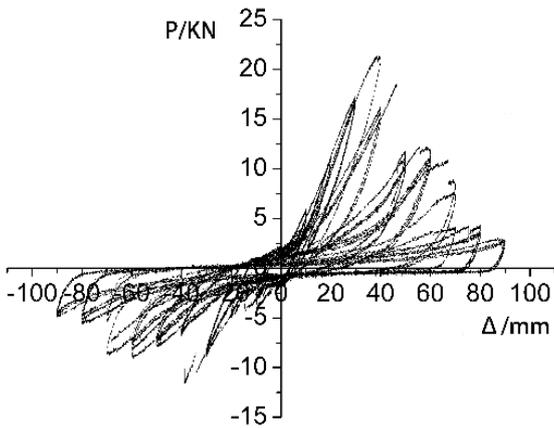
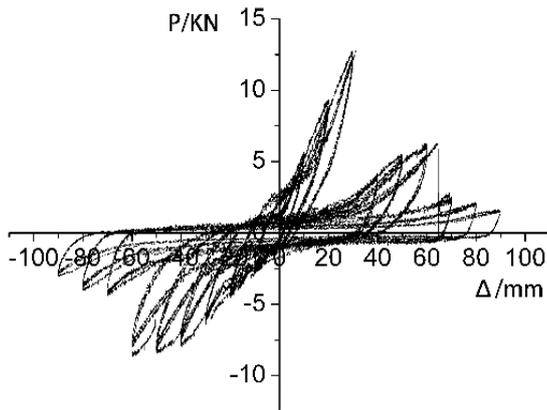
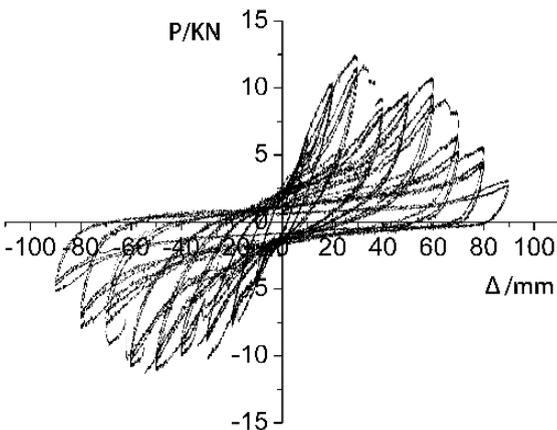
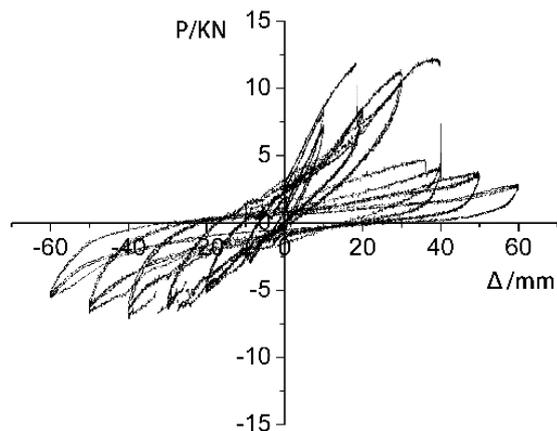
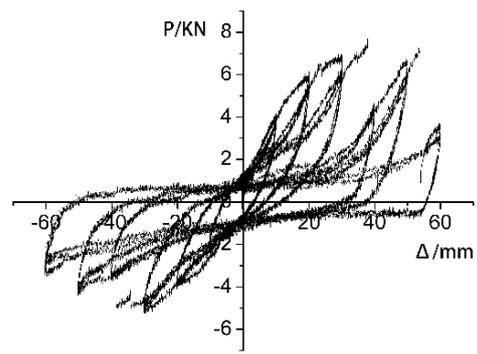
By comparing and analyzing the hysteretic curves of six wooden beams (Fig. 10, 11, 12, 13, 14, 15), we can draw the following conclusions: 1) S1 group wooden beams only have knots on one side of the middle span, the hysteretic curves show obvious asymmetry, and the bearing capacity of the side with knots is lower than that of the intact side in each stage of loading. There are simulated knots on both sides of the middle span of S2 group timber beam, so the hysteretic curve is basically symmetrical. 2) At the later stage of loading, the stress concentration will appear at the knots, the bearing capacity of the beam will decrease rapidly, and the hysteretic curve will become an inverse S-shape. 3) When other conditions are the same, with the increase of node depth, the bearing capacity decreases more. S1-3 and S2-3 of S1 group and S2 group are the members whose bearing capacity decreases most. 4) When the depth of the knots is the same, the existence of knots on both sides is the most unfavorable to the bearing capacity of the beam.

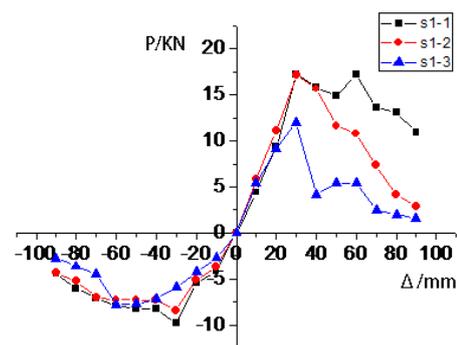
By analyzing the skeleton curves of S1 and S2 groups (Fig. 16, 17), it can be found that the deeper the knot depth is, the earlier the failure time is. Taking group S1 as an example, when the displacement is 30mm, the S1-3 member will enter the failure stage, which is obviously earlier than the other two members in the same group.

In the process of forward loading, the ultimate load of S1-1 member with 12 mm knot depth is 17.2 KN, while that of S1-3 member with 40 mm knot depth is 12.6 KN, which is 26.7% lower than that of S1-1. The decrease of ultimate load is obviously related to the increase in knot depth. Comparing the skeleton curves of the two groups of members, it can be found that when there are knots on both sides of the bending zone and tensile zone, the bearing capacity of the wooden beam decreases more significantly. Under positive loading, the depth of the knots of S2-1 is the same as that of S1-1, both are 12mm, but the ultimate load is only 12.7 KN, with a decrease of 26.1%.

Figure 16. Skeleton curve of S1

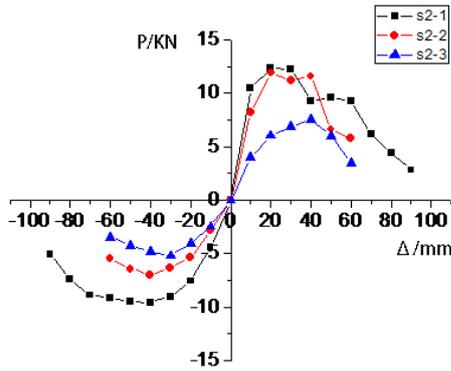
Among the six members, S2-3 is the most disadvantageous in the depth and distribution of knots. There are knots with a depth of 40mm on both sides of the bending zone and tensile zone of the member, and the bearing capacity decreases most. In the forward loading process, the ultimate load of S2-3 is only 7.6 KN, which is 55.8% lower than that of S1-1 member with the least damage.

Figure 17. Skeleton curve of S2

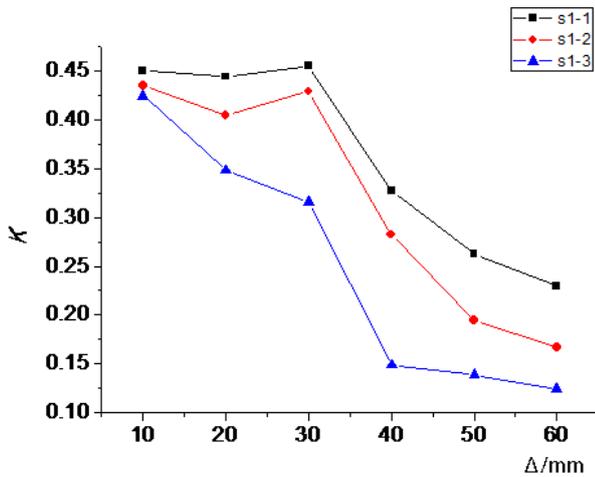
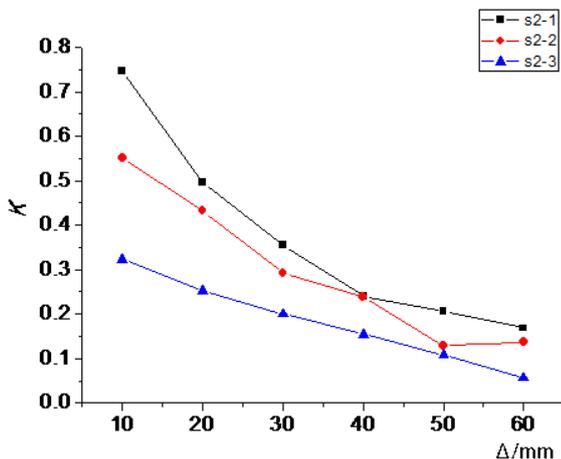
It can be seen from the degradation curves that the stiffness of the six members is degraded in the process of low cycle reciprocating loading (Fig. 18, 19). The initial stiffness of the members is larger, but with the increase of loading displacement, the cracks of the members develop along the knots, leading to the gradual decline of stiffness. The degradation range of member stiffness increases with the increase of knot depth. In group S1, the stiffness degradation of S1-3 is the fastest; In S2 group, S2-3 members enter the plastic stage quickly, and the stiffness decreases significantly at the initial stage of loading.

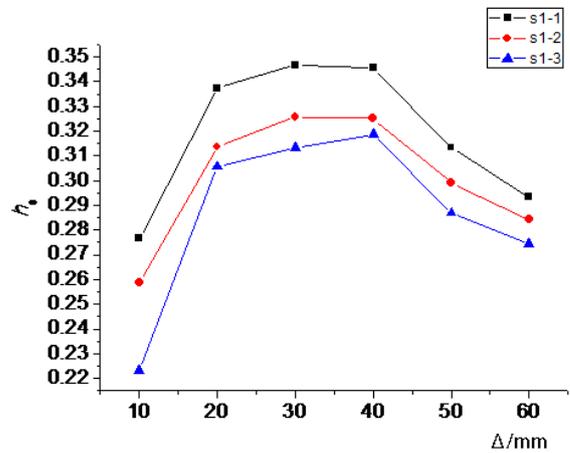
With the increase of displacement, the energy dissipation coefficient increases slightly in the initial stage and decreases rapidly in the later stage. The energy dissipation capacity of members with different depth and position of knots is different. The energy consumption coefficient of S1 group reaches temporary stability when the displacement value is 20 mm, and increases slightly (Fig. 20); When the displacement value is 40 mm, the energy dissipation coefficient decreases rapidly, and the member is damaged. It can be seen from the figure that S1-1 with the shallowest knot depth has the best energy dissipation capacity. It can be found that when there are wooden joints in the bending area and tensile area of the wooden beam, the energy consumption coefficient of the member is lower, and the decline section of the energy consumption coefficient appears earlier. When the displacement value is 30mm, the energy consumption force begins to decrease significantly (Fig. 21).

Figure 20. Energy consumption curve of S1

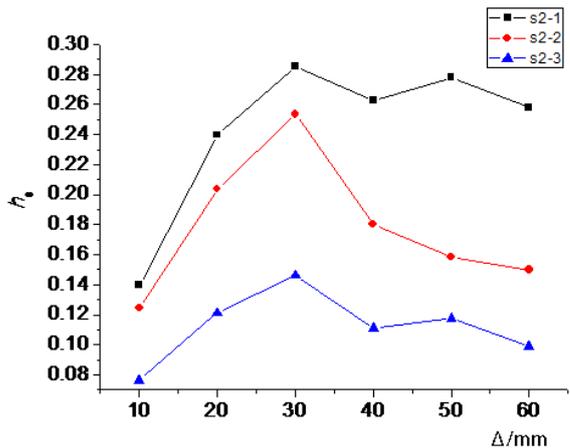
Figure 21. Energy consumption curve of S2
