Characteristic Architectural Elements of Traditional Barbaros Houses with a Single-Living Space and Their Relationship with Daily Life*

Barbaros is a rural settlement in Urla, İzmir, Turkey. This study aims to understand the architectural elements of Barbaros houses with a single-living space, their spatial organization, relation with daily life, and the local terminology for them. Moreover, it is aimed to reveal possible similarities and dissimilarities between architectural elements of other single-living space rural houses in different settlements in close geography. The site survey data was collected in 2016, 2017, and 2020. Fourteen houses were examined, all of which still preserve their original spatial characteristics and architectural elements. The plans and architectural elements of each of the 14 buildings were documented in sketches and photographs. The architectural elements of each house and their characteristics, including form, material, and location in space, were analyzed. The Barbaros case was compared with other rural settlements in Çeşme, Karaburun and Urla. Oral interviews were conducted with 13 people to reveal the relationship between architectural elements

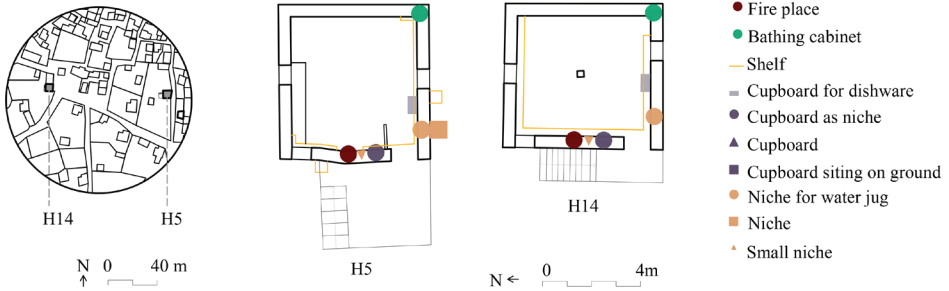
F. 3: Scaled plan sketches of H5 and H14 with architectural elements (Prepared by Saribekiroğlu, 2022)

After realizing the extreme similarity of two single-room houses in the Barbaros rural settlement in Urla, İzmir, Turkey, the question of whether single-living space buildings in Barbaros have a pattern in the organization of their architectural features was researched. These two houses are almost identical in terms of architectural elements and their positioning within the rooms³ (F. 3, F. 4). Both houses are two-story buildings with a barn at ground level and a single-living space at the first level. They both have their entrances in the west wall. On this entrance wall, a door, a cupboard, a small niche, a fireplace, and a window are placed from south to north, respectively (F. 3, F. 4). In addition, there is a wooden shelf at the upper level on the west wall of both houses (F. 3, F. 4). On the north wall, both rooms have a window and wooden shelf at the upper level. The east walls of both rooms are blind, without

openings or architectural elements. At the southeast corner, a bathing cabinet is placed in both rooms. Additionally, on the south walls of both rooms, there is a window, a wooden cupboard with shelves for dishware, a niche for water jugs, and a niche, running from east to west, respectively.

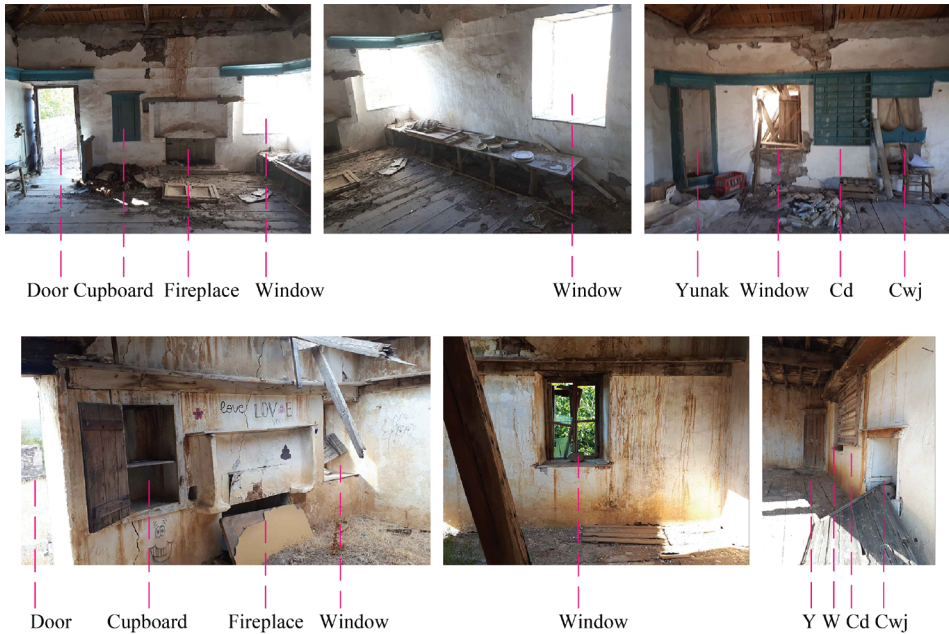
F. 4: Living spaces of H5 and H14 at first level. Above photos belong to H5 and below ones to H14. Left: West walls. Middle: North walls. Right: South walls. Y: yunak. W: window. Cd: cupboard for dishware. Cwj: cupboard for water jugs (Photos by Saribekiroğlu, 2017; prepared by Saribekiroğlu, 2022)

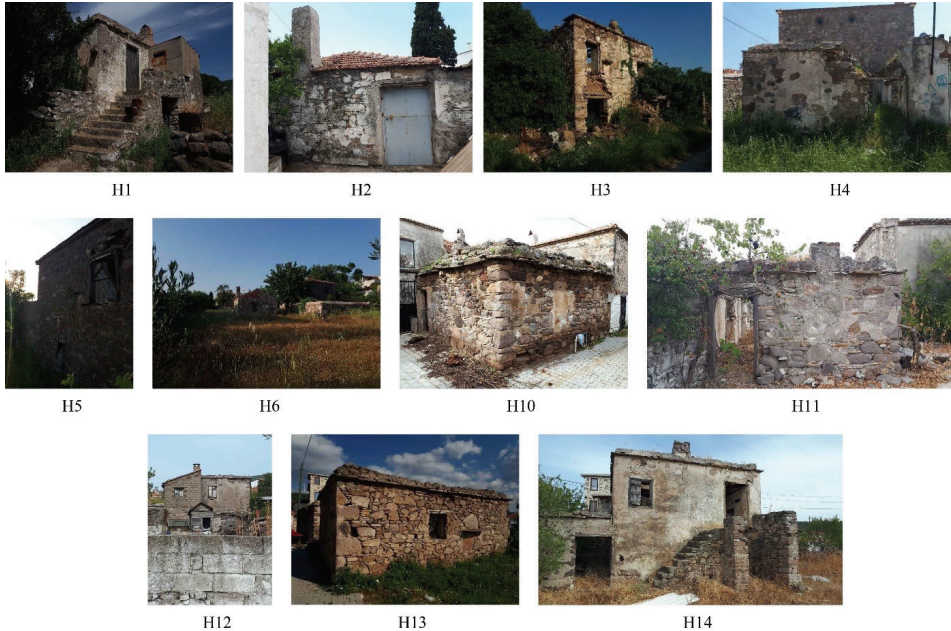
F. 5: Exterior views of surveyed houses (Photos by Sarıbekiroğlu, 2017-2020)

All of the 14 single-living space houses studied are stone masonry (F. 5). 11 of them are accessed from a courtyard (H1, H2, H4, H5, H6, H8, H9, H11, H12, H13, and H14) and three of them are accessed from the street (H3, H7, H10) (F. 6). Houses may be located in the middle of their plots (H6) or may be adjacent to one or more of the plot borders (F. 6). Other than the houses, traditional Barbaros residential plots may include a barn, *mağaza*³⁵, toilets, well, *mengere*³⁶, and oven. Traditional Barbaros houses are one or two storey structures. In this study, of the 14 surveyed living spaces, nine are one storey and so the living spaces are at ground level (H2, H4, H6, H7, H8, H9, H10, H11, and H13). Five of them are two storey and so the living spaces are on the first level (H1, H3, H5, H12, and H14). The ones on the first level are accessed with a stone masonry exterior stair. The stairs lead to a landing, where access to living spaces is provided. Beneath these living spaces, there exist barns on the ground level.

Of the 14 houses, six have doors (H1, H2, H5, H6, H12, H14) (F. 5). Five houses are severely damaged and their doors do not exist (H3, H4, H8, H10, and H11) (F. 5). The existing four are single-wing wooden doors (H1, H6, H12, and H14). One has a single-wing metal door that is not original (H2). One has a double-wing wooden door (H5). All wooden doors are composed of vertical timber planks adjacent to each other and horizontal timber elements on the interior face fixing timber planks together.

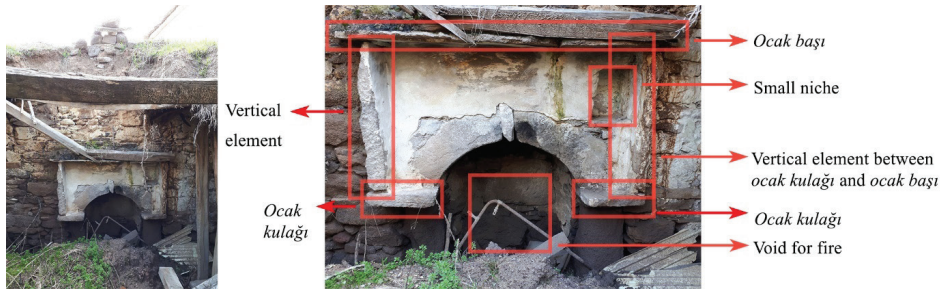
F. 8: Fireplace in H10 and its elements (Photos by Sarıbekiroğlu, 2017; prepared by Sarıbekiroğlu, 2022)

Fireplaces are formed of a void for fire, chimney for smoke, two small shelves called *ocak kulağı* at two sides, a shelf called *ocak başı*, and vertical elements between the *ocak başı* and *ocak kulağı*. All 14 houses have all these elements except H4 and H11. In those, *ocak başı* are lost. H10 has a small niche in the area bordered by the *ocak kulağı*, *ocak başı*, and in between the vertical elements (F. 8). The *Ocak başı* can be made from wood or slate stone. As the narratives of the interviewees indicate, fireplaces were used as heating and cooking element; and their shelves were used to store cooking-related objects and lamps.

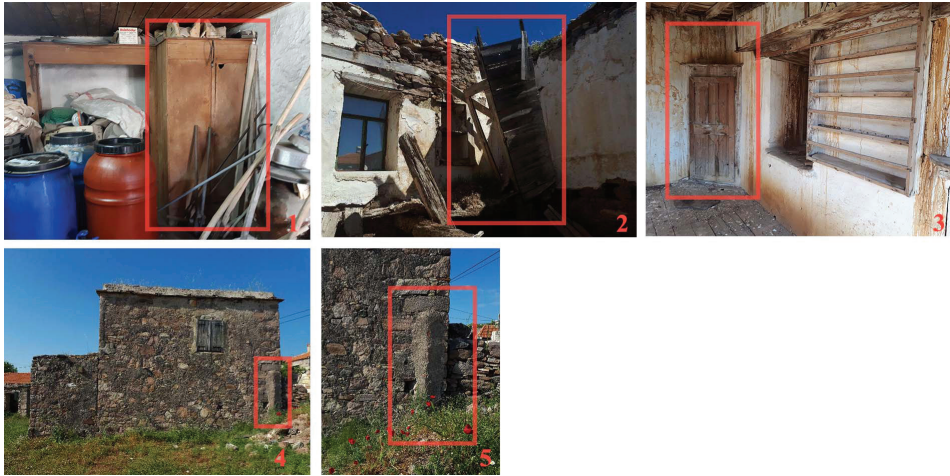
F. 9: 1: *Yunak* with cupboard in H2. 2: *Yunak* as wooden cabinet in H12. 3: *Yunak* as a niche in H14. 4: Water outlet of *yunak* in H14. 5: Close view to water outlet of the *yunak* in H14.

The bathing cabinet is called *yunak* in Barbaros houses. Among the surveyed houses, there are three types of *yunak*: a wooden cabinet, a wooden cabinet combined with a cupboard, and a niche at the corner with a door (F. 9). Wall surface finishing does not differ inside these types of *yunak*, it is the same as the interior wall finishing of the space, which is limewash. For the bathing cabinets on the first level, a void at the ground passing through the wall section is made for the water outlet. This void leads to an exterior channel made with *çöplem*³⁸ tiles (F. 9). The *yunak* ground level is elevated to around 10 cm higher than the ground level of the living space. Of the third type *yunak*, only H5 and H13 have wooden doors. H5 is ornamented with diamond shaped wooden pieces.

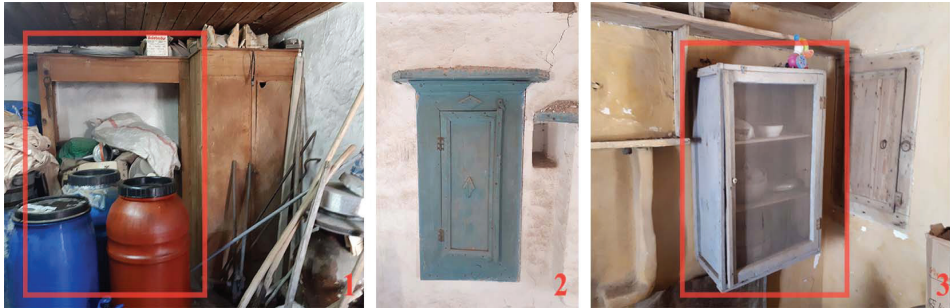
F. 10: 1: Cupboard sitting on the ground in H2. 2: Cupboard as niche in H5. 3: Cupboard fixed on the wall in H9. (Photos by Saribekiroğlu, 2017)

In the surveyed houses, four types of cupboards are seen: a cupboard as a niche (H1, H2, H5, H6, H9, H11, H12, and H14), a cupboard on the ground (H2), a cupboard as an element fixed on the wall (H9), and a cupboard with shelves for dishware (H2, H5, H6, and H14) (F. 7, F. 10). All types of cupboards are built with wood.

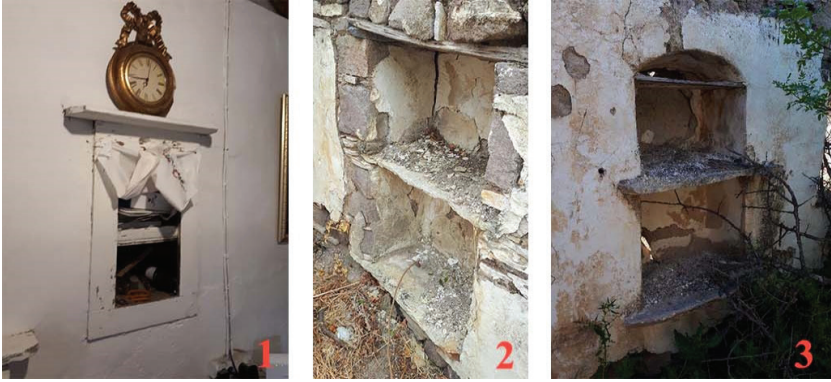
F. 11: 1: Niche with shelf on top in H7. 2: Niche in H11. 3: Niche with arched top in H13.
(Photos by Sarıbekiroğlu, 2017, 2020)

In the surveyed houses, there are three types of niches: niches with shelves (H2, H3, H4, H5, H6, H9, H12, and H14) (F. 11), niches for water jugs (H1, H3, H4, H5, H6, H7, H8, H11, H12, and H13) (F. 12), and single void small niches (H1, H3, H5, H12, and H14) (F. 13). Water jug niches can be for a single jug; double jugs and double jugs with another niche under or top (F. 12). Double water jugs niches at H2 and H13 have narrow wooden shelves on top of them. The niches for water jugs mostly have semi-circular shaped wooden elements possibly to make the movement of the jug easy to pour the water (F. 12).

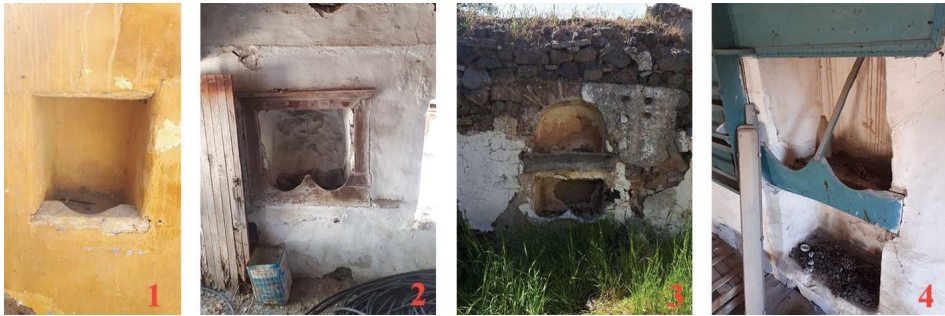
F. 12: 1: Single jug niche in H9. 2: Double jug niche in H6. 3: Double jug niche with another niche on top in H4. 4: Double jug niche with another niche under it in H5.
(Photos by Sarıbekiroğlu, 2017)

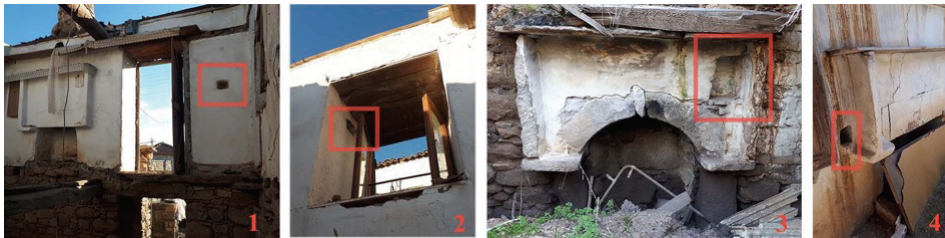
F. 13: 1: Small niche in fireplace wall but not next to fireplace in H1. 2: Small niche in window opening in H1. 3: Small niche under *ocak başı* in H10. 4: Small niche next to fireplace in H14.
(Photos by Sarıbekiroğlu, 2017)

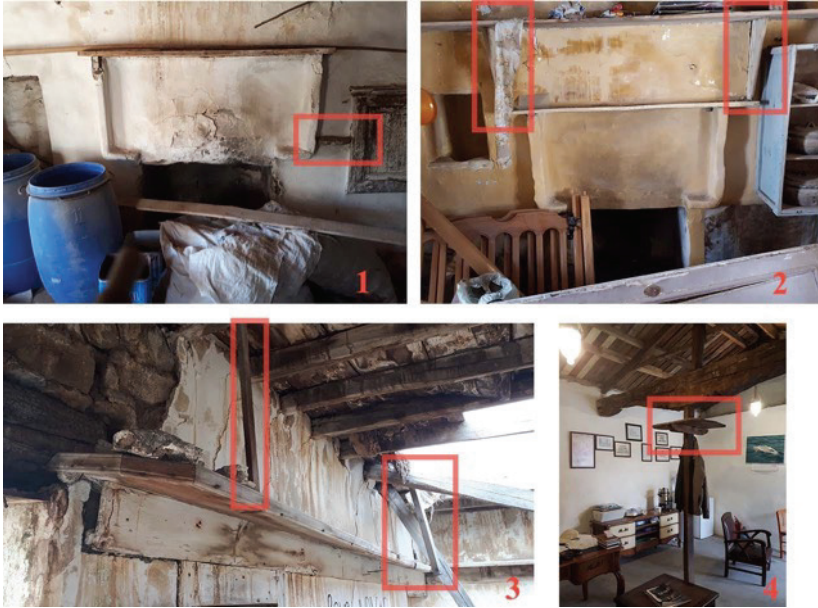
F. 14: 1: Small wooden shelf at *ocak kulağı* level in H6. 2: High level shelf supported below in H9. 3: High level shelf suspended to beams in H14. 4: *Direk başı* in H7.
(Photos by Sarıbekiroğlu, 2017)

başı is seen in H7 (F. 14). It is made of wood. Interior shelves on walls can be made of wood or slate stone. Interior shelves can be partial or extend along with the whole wall. There are mainly three different levels for shelves: the lowest for *ocak kulağı*, the middle for *ocak başı* and the highest for top levels of openings: windows and doors (F. 14). Exterior shelves are made from slate stones (H3, H5, and H13) (F. 15). All exterior shelves are next to a window (F. 15). While H5 and H13 have one exterior shelf, H14 has two at two different facades. In H13, the same slate stone functions as an exterior shelf and shelf of niche in the wall at interior.

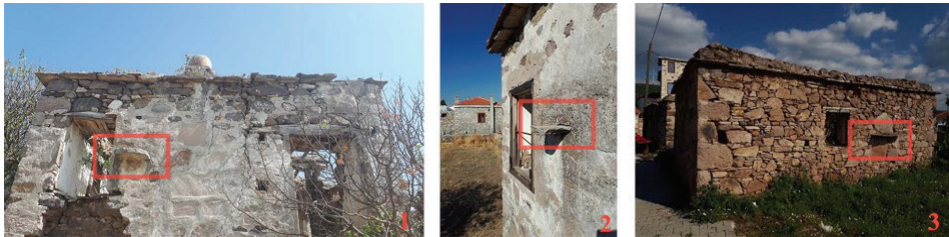
F. 15: 1: Exterior shelf in H3. 2: Exterior shelf in H5. 3: Exterior shelf in H13.
(Photos by Sarıbekiroğlu, 2017)

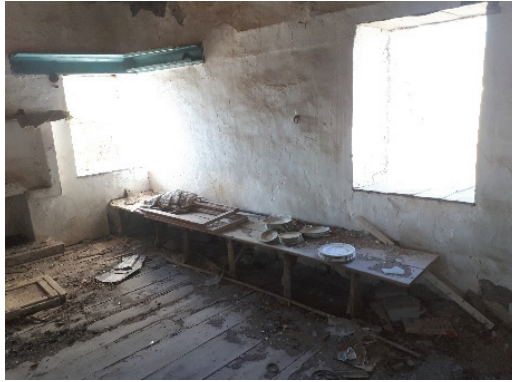
F. 16: Sitting platform in H5 (Photo by Sarıbekiroğlu, 2017)

A sitting platform is only seen in H5. It is made of wood (F. 16).

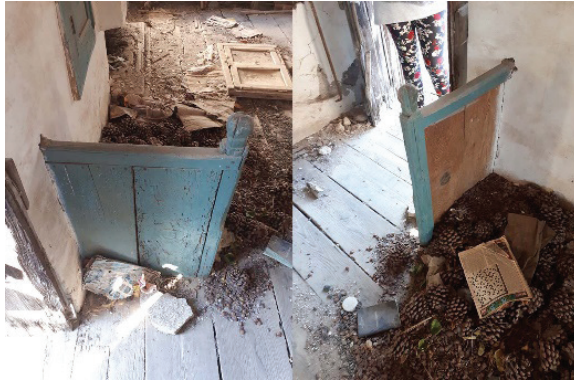
F. 17: Balustrade in H5 (Photos by Sarıbekiroğlu, 2017)

A balustrade is only seen in H5. It is made of wood and one face is colored in blue (F. 17). Ü.D. shares with us that old houses had wooden elements called *trabazan* in the very entrance of the house to hold while taking off shoes.

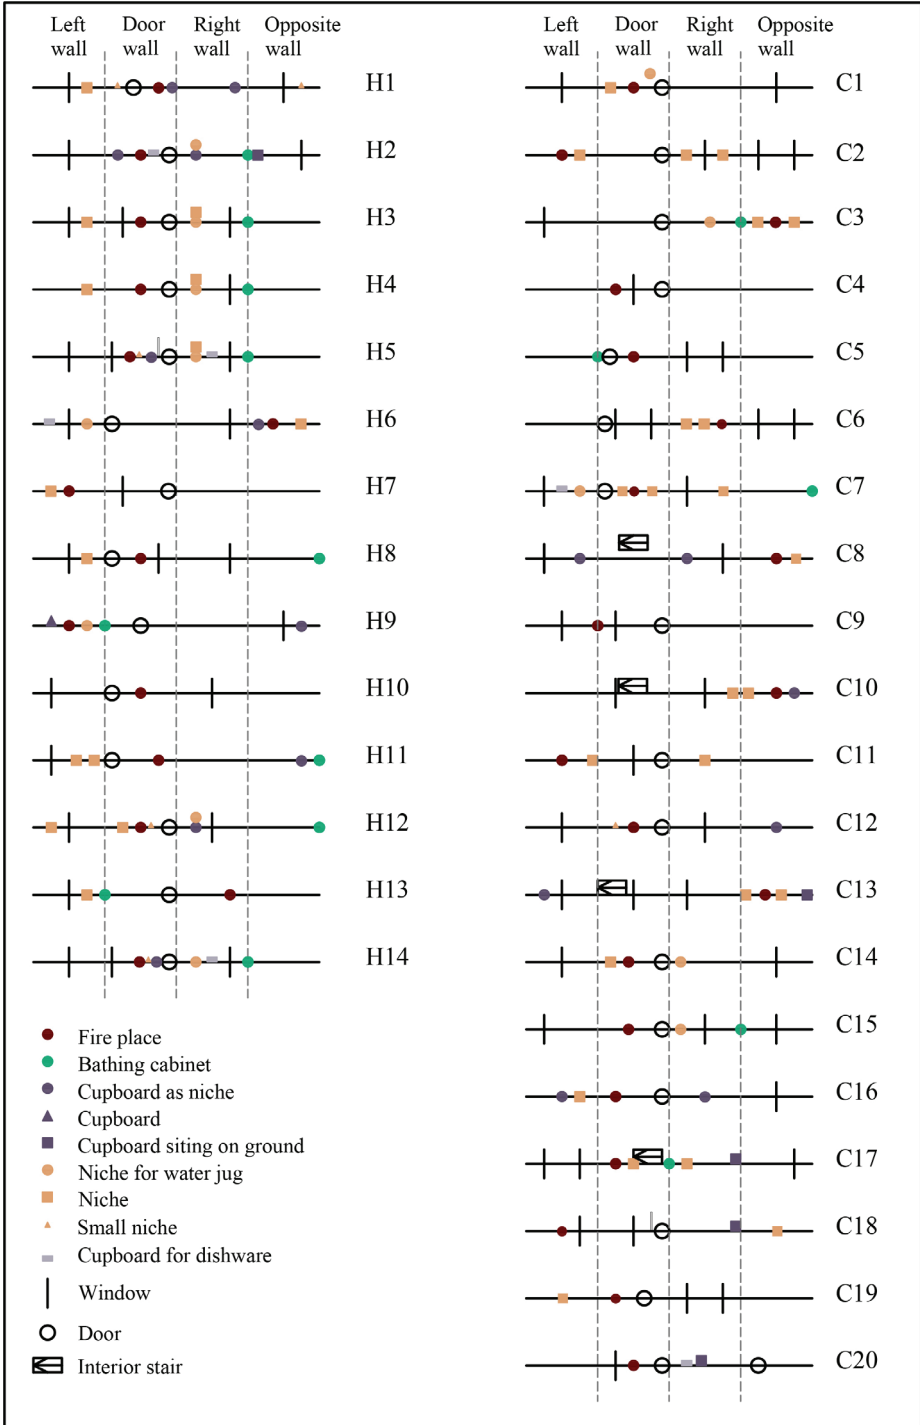
F. 20: Linear ordering of architectural elements in Barbaros houses and compared Urla, Karaburun and Çeşme rural houses. (Prepared by Sarıbekiroğlu, 2022)

A repeated pattern for architectural element layout is seen at H3, H5, H8, and H14 (F. 20). Aside from these four houses, specific positioning according to orientation for architectural elements could not be observed. In these four houses not only openings which are the elements directly influenced by the orientation in terms of sun and wind; but also fixed furniture has the same positioning. A possible reason for the similarity can be that all four houses were built by the same builder.
