CONSERVATION OF TRADITIONAL HOUSES AND A CASE STUDY ON SAFETY EVALUATION BY USING LIMIT ANALYSIS

Z. Sena GÜNEŞ KAYA¹, Selahattin ERSOY^{2*}, Kemal Kutgün EYÜPGİLLER³

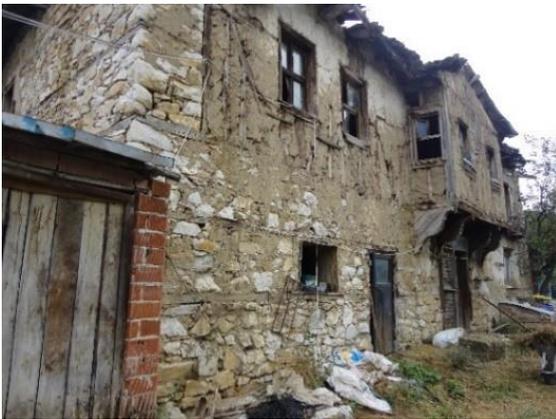
Figure 2. Raimler House in Serçeler village, 2018.

Dual-function (residence and barn) structures have ground floors with two entrance doors for each function and small ventilation windows. In residential buildings, there exist large windows as well as doors. The floors are built with floorboards with an average thickness of 2-3 cm installed over wooden beams. Ground floor ceilings are covered with wood if the venue is room. The ceilings of other areas are uncoated and making the floor beams visible. The same applies to the upper floors. While the ceilings of the rooms are covered by wooden planks – some even with embellishments on them, “sofa” usually does not have a ceiling cladding. Within the scope of this study, Orhaneli district center and the nearby villages of Deliballılar, Kusumlar, Sadağı, and Serçeler were examined. Some sample images of Orhaneli houses are given in Figure 2 and Figure 3.

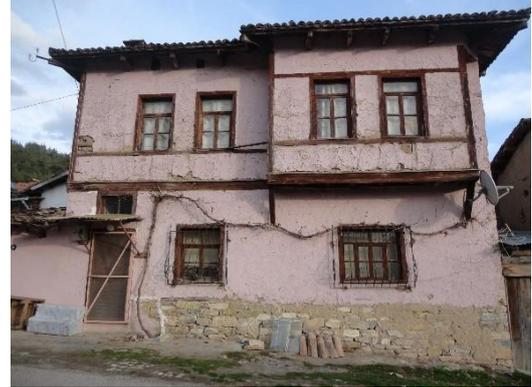
Figure 3. Deliballılar village door no: 100, 2014.

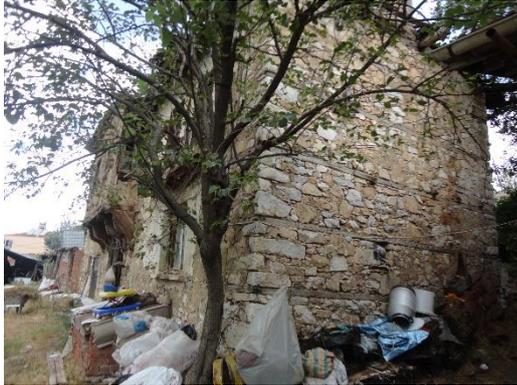
Figure 5. A typical example of a continuous stone masonry wall on the ground floor and upper floor with embedded wooden beams.

The ground floors of the residential houses are predominantly built with stone masonry with wooden beams placed horizontally at an average of 1.25m intervals as shown in Figure 5. For some of the houses, there are both stone masonry walls and wooden skeleton walls with adobe infill, on the ground floor (Ali Osman Gezgin House, Anbarcılar House, Efeler House, no: 32, no: 100, no: 111). It is observed that some of the houses were completely built by a wooden frame system with adobe infill (Remzi Bey Mansion).
