THE CHURCH AT DEREĞİZİ SECOND PRELIMINARY REPORT

James Morganstern and Richard E. Stone

The second campaign at the site of the Byzantine church at Dereğizi in southern Anatolia took place in June 1968. Work continued at the Antalya Museum during late August and early September.¹

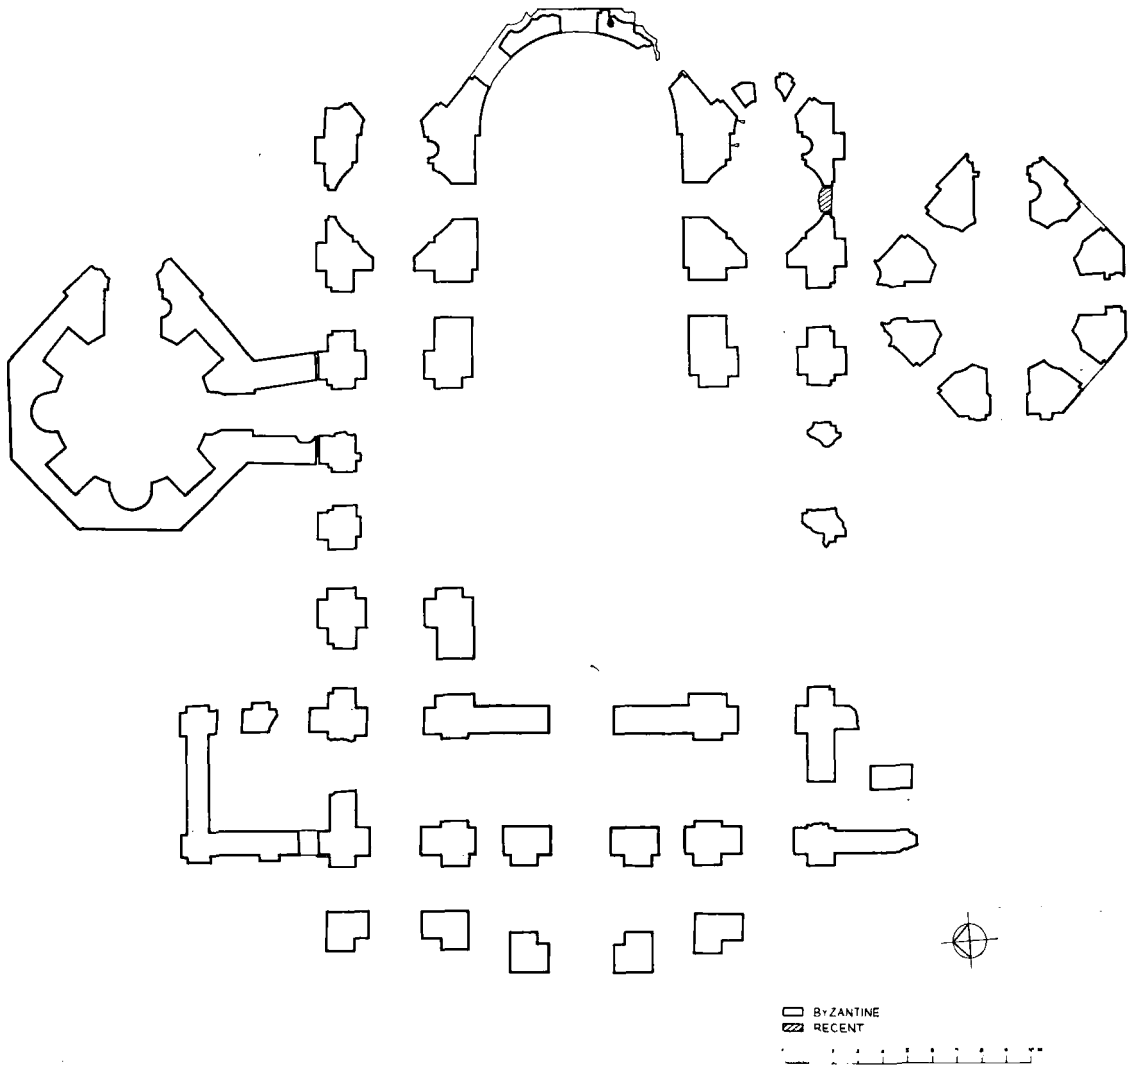
Fig. 1

The mosaics under consideration include three sets: those of the diaconicon, the nave, and those of the north octagon (fig. 1). All except the patch in the nave were consolidated and cleaned, and the fragments in the diaconicon were removed to the safety of the Antalya Museum².

In the church the two central piers of the main apse were located and measured, and the recently constructed stone wall in the south window of the diaconicon was re-plotted (fig. 1). In addition, the vaults above the chancel and the east bay of the nave were re-studied. The upper portions of both vaults are definitely built of stone; both, however, date from the original building period.²⁷

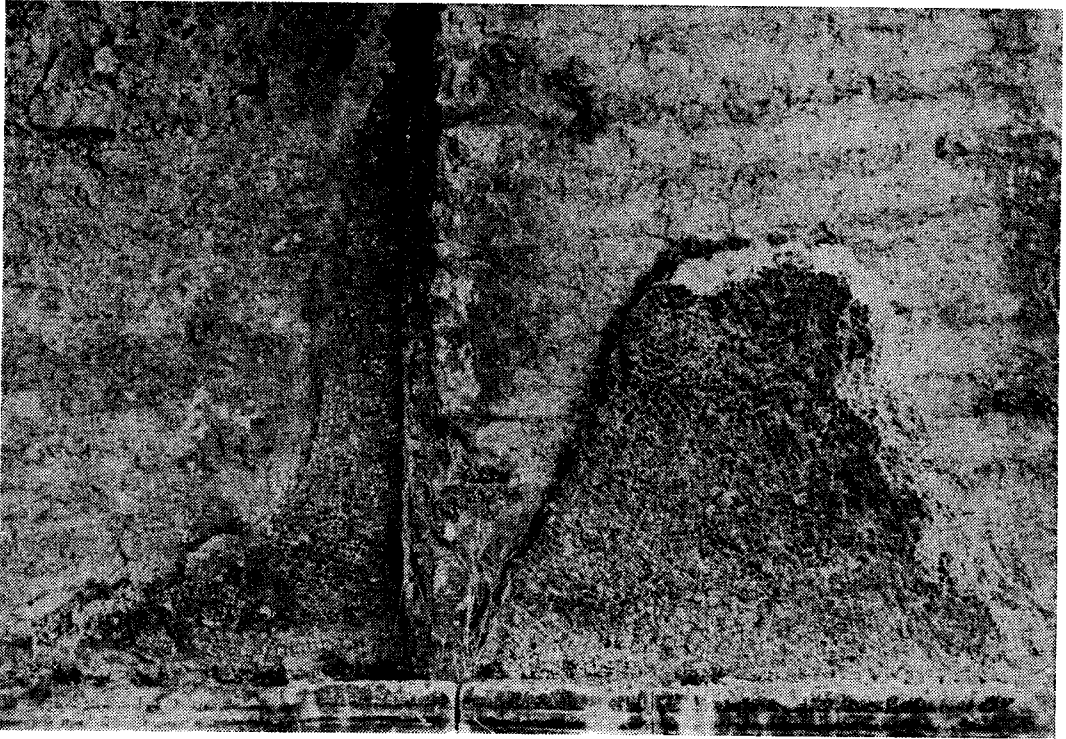
Fig. 2

The mosaics of the diaconicon are particularly instructive³. They consist of three fragments, which, before their removal, decorated the half-dome of the apsidiole and the barrel vault of the adjacent chancel-like element. They rested against the cornice and extended from the northern section of the half-dome to the neighboring barrel vault (fig. 2).

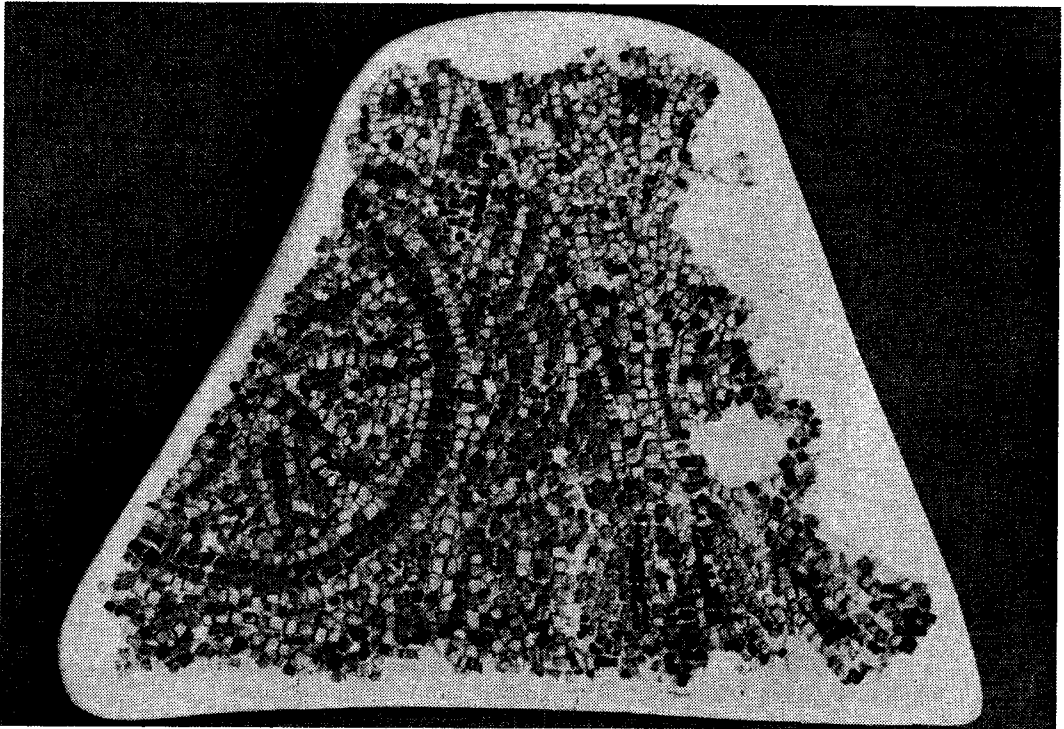
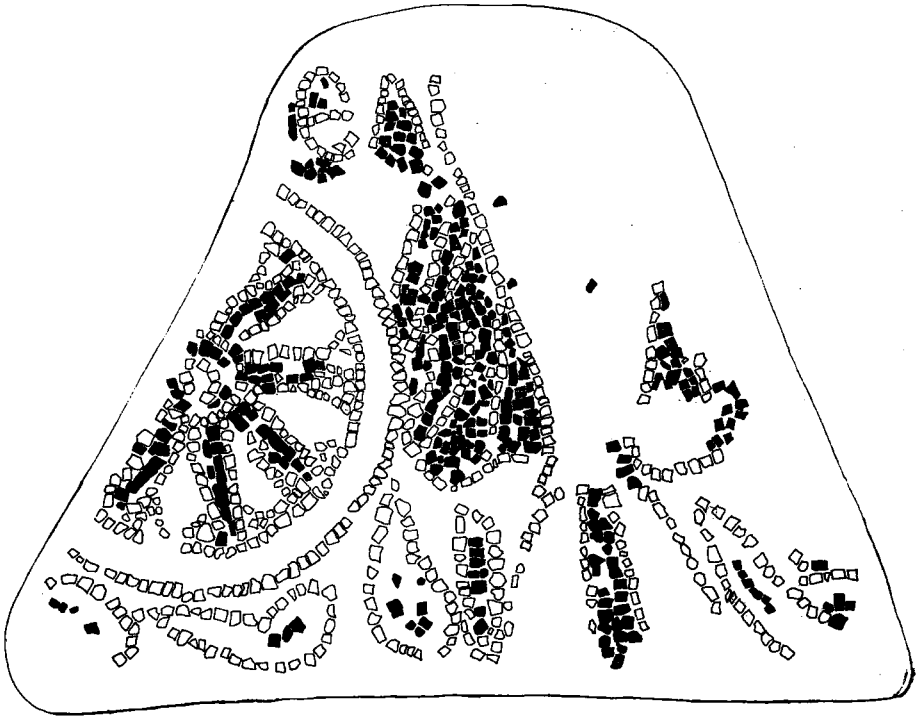
Fig. 3

Fragment I (figs. 3 and 4) depicts part of the vision of Christ in Majesty⁵. The left half of the fragment is filled by a large wheel, surrounded by fire and accompanied by an inscription⁶. To the right appears part of a cherubim or seraphim: his feet are visible at the base of the fragment; the two wings, which cover his legs, are indicated by the pale V-shaped area above. The area to the right of the cherubim-seraphim is filled with fire. The background appears only occasionally.

The wheel is rendered primarily by tesserae dipped in red lead paint⁷, the

rim by tannish-brown stones, and the inscription above the wheel by white marble. The cherubim-seraphim is modeled by predominantly light cubes. His feet are cream and pink marble, with some red-brown glass, and his wings are varied light marbles and glasses. The fire is rendered primarily by reddipped cubes, and the background is indicated by green, turquoise, and blue glasses.

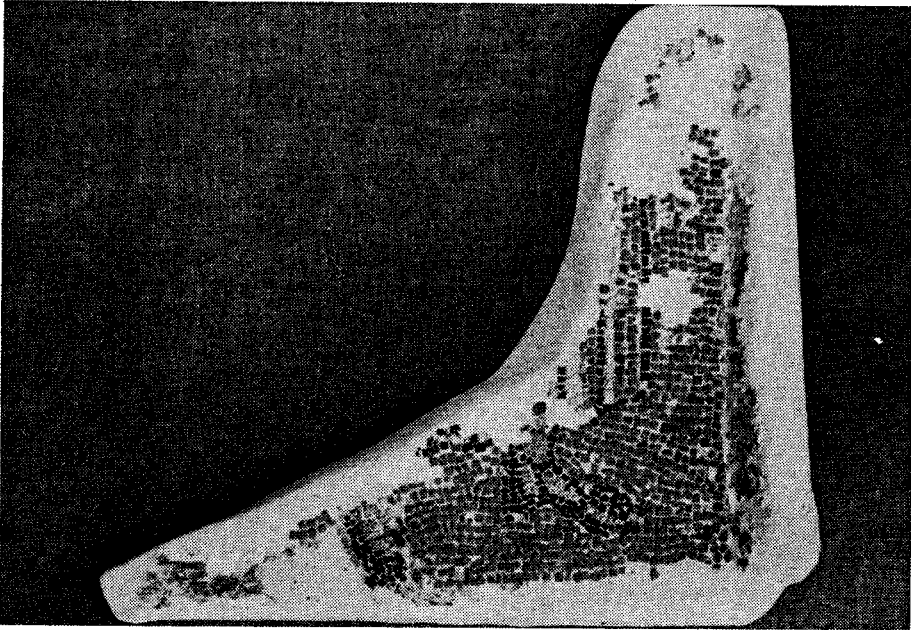
Fig. 6

Fragment III (fig. 6) reveals the lower portion of a male figure, clad in tunic and sandals and set against a plain background⁸. The figure starts forward to

The tunic worn by the figure is rendered by white marble and transparent amber glass; the shadows, by various green glasses. His feet are modeled with pink and tannish-cream marble and red-brown glass; the sandals are indicated by red-brown and opaque bright red glass. The background consists primarily of apple green glass.

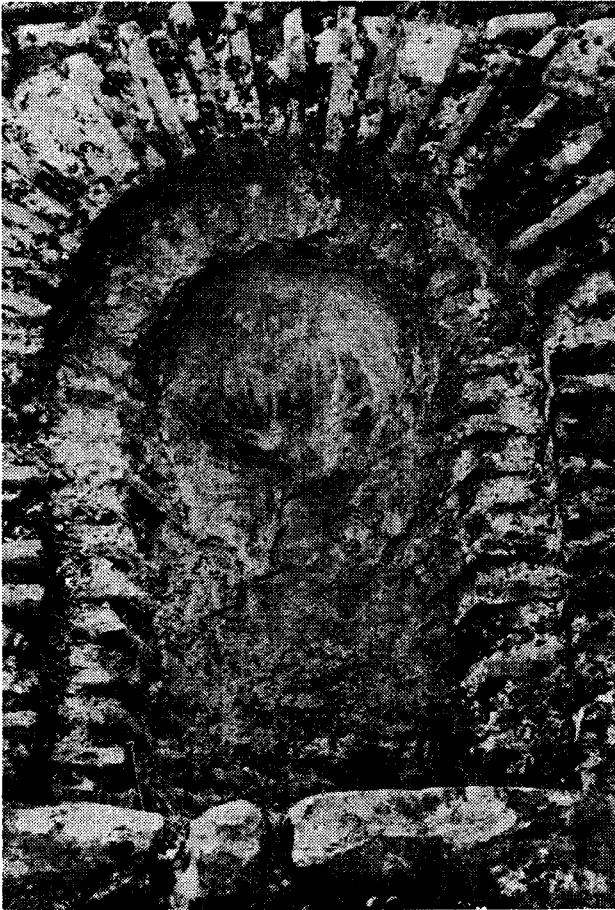
Fig. 7

The cross which decorated the western niche is the better preserved (fig. 7). Originally it must have filled the semi-circular niche (0.66 × 0.30 × 1.135 m.); today, little more than its upper half remains. The vertical and the horizontal members are broadly drawn, outlined by a thin band, and joined perhaps by a boss at their intersection. Both flare slightly as they approach the edge of the niche; their terminations are no longer clear. The four quadrants formed by the cross are each filled by a single lily, delineated with a few thin bands. Beyond the

lilies are other traces of paint. Just what they represent is still uncertain²³.

The cross, the lilies, and the other traces are all rendered in red-purple paint, applied directly to the plaster²⁴. The painting seems to be contemporary with the construction of the octagon.

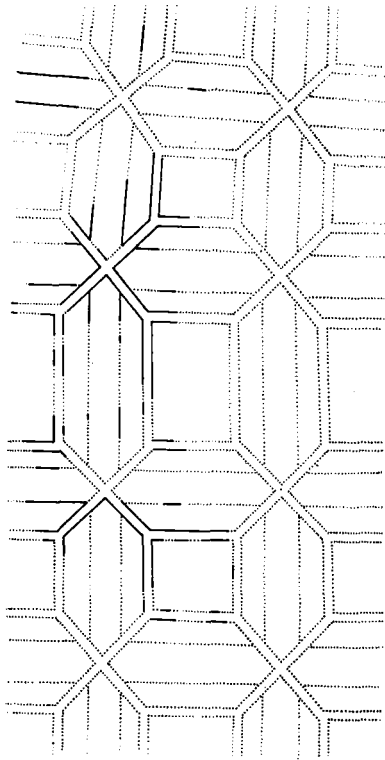
Fig. 8

The design is wholly geometric (fig. 8). Although only a few traces remain, it is still possible part of the original design: a series of large intersecting octagons, set against a broad rectangular grid²⁵.

The octagons are delineated in black paint; the grid is rendered by wide bands

of red-purple²⁶. The painting appears to be contemporary with the construction of the church.

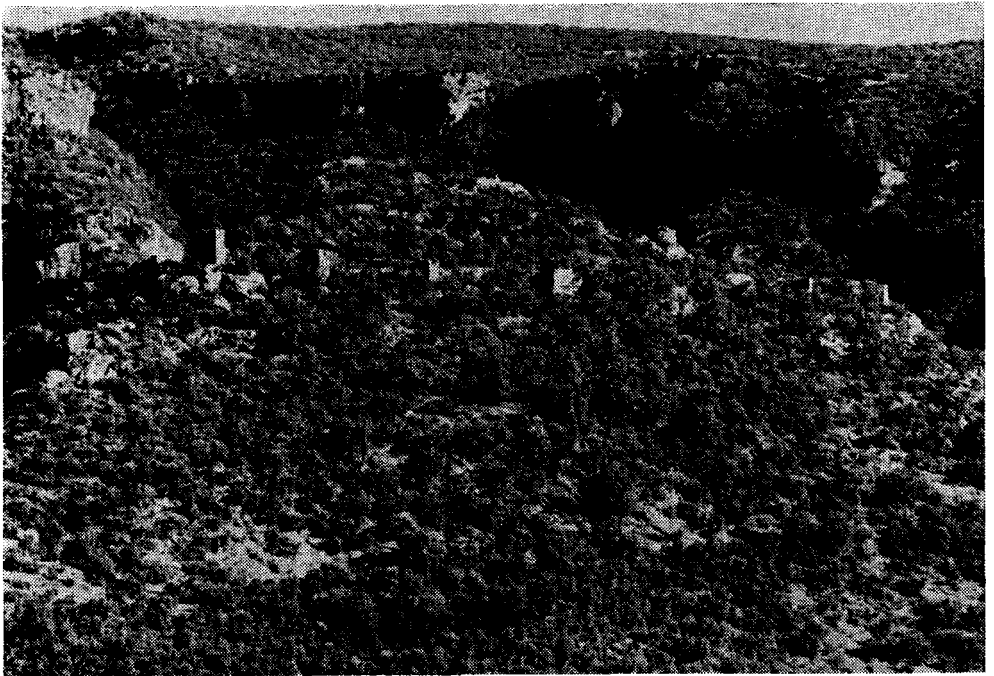
Fig. 9

The neighboring fort (fig. 9) was also studied further.³⁰ Its plan was clarified, and several new discoveries were made.

The perimeter wall, which crowns the top of the hill, is roughly triangular in plan. Its three flanks face to the north, the southwest, and the east. The northeast angle is anchored by the pentagonal tower noted in the first preliminary report, and the northwest angle, by an irregular polygonal salient. The spur wall, or *avancée*, cited in the first report, begins at the southeast angle and continues down the spine of the hill to the southeast, where it terminates in a small circular structure.³¹ The northern flank is protected by four salients: two are pentagonal, one rectangular, and one triangular. The southwest flank is reinforced by at least one triangular salient.

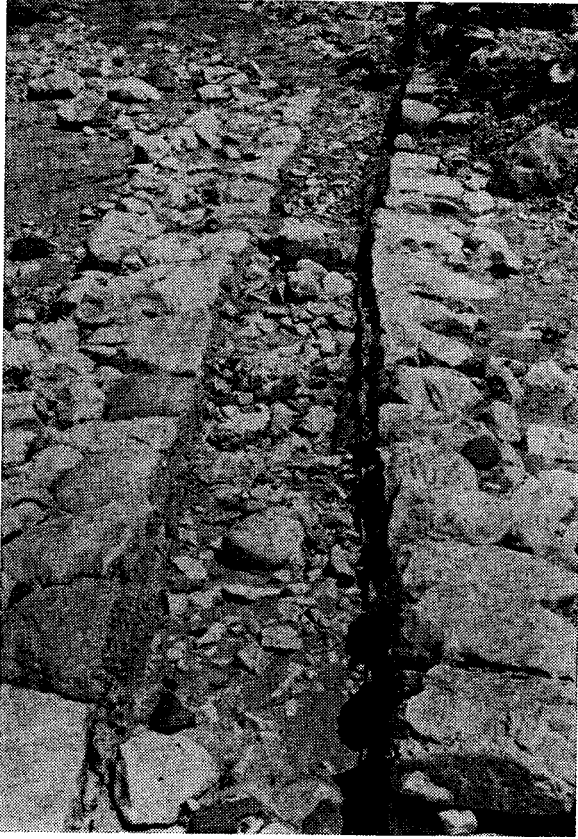
Fig. 10

West of the fort, above the west bank of the Kasaba River, an old water channel was found. It continues downstream on the west bank of the Demre River south of the fort (fig. 10), past the fort at Demre (Myra), and along the north slope of the valley at Andriake³⁴. Its source could not be located. Its width measures generally between 0.25 - 0.40 m.; its depth varies depending on the location. Near the fort at Dereğzi the channel is rock-cut; further downstream, it is built of stone and mortar. Its date is uncertain. It does, however, seem to post-date the large Roma structure at the north edge of the Andriake valley³⁵.
