TOPRAKLI - 1972 FIELD EXPEDITION DIG-PRELIMINARY REPORT

LUIGI POLACCO

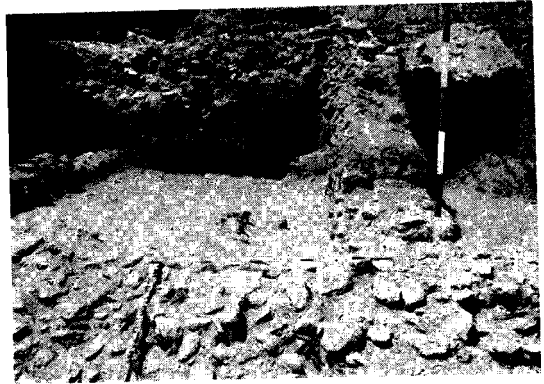
Res. 10

The facing on the side towards the valley too is open to some observations (Fig. 10). It shows large tracts dotted with gaps. The portion that is best preserved corresponds to another wall which descends the slope of the hill at right angles to the wall for about 15 metres 60, equal in projection to the base at 13 metres 85 (Pls. III-IV; Fig. 11). This second wall does not tie up with the facing on the valley side, therefore it evidently was built at a later date (Fig. 12). Furthermore this wall which we shall call “buttress”, diminishes in height as it descends in altitude and is embedded, as it were, in an embankment. The outcome of this fact is that the slope of the hill became far more steep than it had been originally.

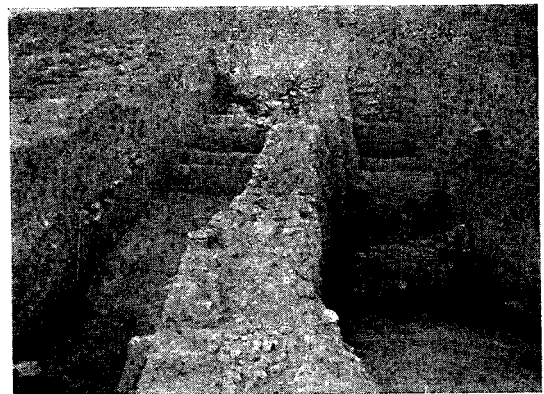
Res. 14

ression (Fig. 16) we followed a double criterium: taking advantages of the fact that the buttress wall in its descent divides the SLT lengthwise at approximately the middle (Fig. 14). South of the buttress wall we completely uncovered the Southern side of the wall itself and we proceeded to empty out the embankment up to a point where we succeeded in tracing the original slope, which belonged to the very period in which the enclosure wall was built. The traces of this slope were clearly indicated (Pl. IV) on one hand by the buttress wall foundations and on the other by a continuous oblique strata of very dark earth (a = T) (Pl. V). The summit of the embankment, instead, concerning phases b 1 and b 2, was indicated on one hand by the top of the buttress wall and on the other by a clearcut white line of closely packed earth (which is a characteristic factor of those surfaces which have been subjected to exposure for a long period of time). We were also able to ascertain the procedure followed by the ancient workmen in filling the embankment, which evidently was effected from the bottom upwards through superimpositions of horizontal layers, or layers actually inclined towards the inside. This denotes, above all, the unitarian quality of the work and the consequent chronological unity of the finds. However, we must keep in mind that these were not living stratifications but rather artificial fillings because here the earth was brought in from somewhere else and although, presumably, it came only from superficial stratas and the nearest areas possible (we must not forget that the rampart completely encircled the hüyük!) it could easily contain material deposited there a long time before the construction of the wall.

We were obliged to use another expedient as regards the buttress wall. Once we had established the value and decided upon the need to preserve in its entirety the structures relative to S level, which included the buttress wall – unique for its dimensions and function – we also verified the impossibility of keeping it completely uncovered (to be more explicit: free from the embankment) owing to the slenderness of its width (about 40 centimetres) and the general irregularities of its structure, justified by the fact that the wall was originally planned to remain embedded in the embankment (Fig. 14).

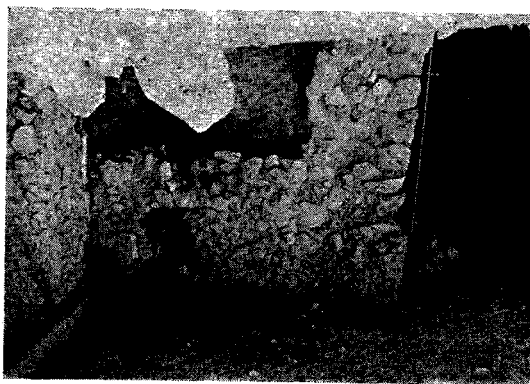
Res. 16

In the North portion at an altitude of - 20,65, a large wall came to light, built in a parallel direction to the great enclosure wall of S level (Pl. III; Figs. 15, 16). This wall is of *e* type¹², and formed of the same large stones as the others, summarily squared off. Owing to the fact that only its East facing appeared in our transverse cut on this North portion, we were unable to measure its width. We trust that we shall be able to make a further report on this subject in our next Field Expedition. But the dimensions of the stones and the concordance in orientation make us think that this is another enclosure wall, of a more simple workmanship and of an inferior size than the preceding one.

In the successive U level and the one right under it (V) that we started digging, painted pottery of the Phrygian type disappeared completely and only the other remained (Figs. 25, 26). U level consists of a large wall, 1 metre 40 wide, which appeared at the foot of T wall (Figs. 15-16), and followed the same course. Would this be another enclosure wall? Perhaps so, but of a still more simplified type for its dimensions and its structure: two facings of masonry in large stones, summarily squared, containing double facings full of smaller stones and mud. Inside, the remains of a pavement and of a smaller wall on which T leans.
