RESTORATION WORK IN THE ODEON OF ANEMURIUM, 1969

Altan AKAT

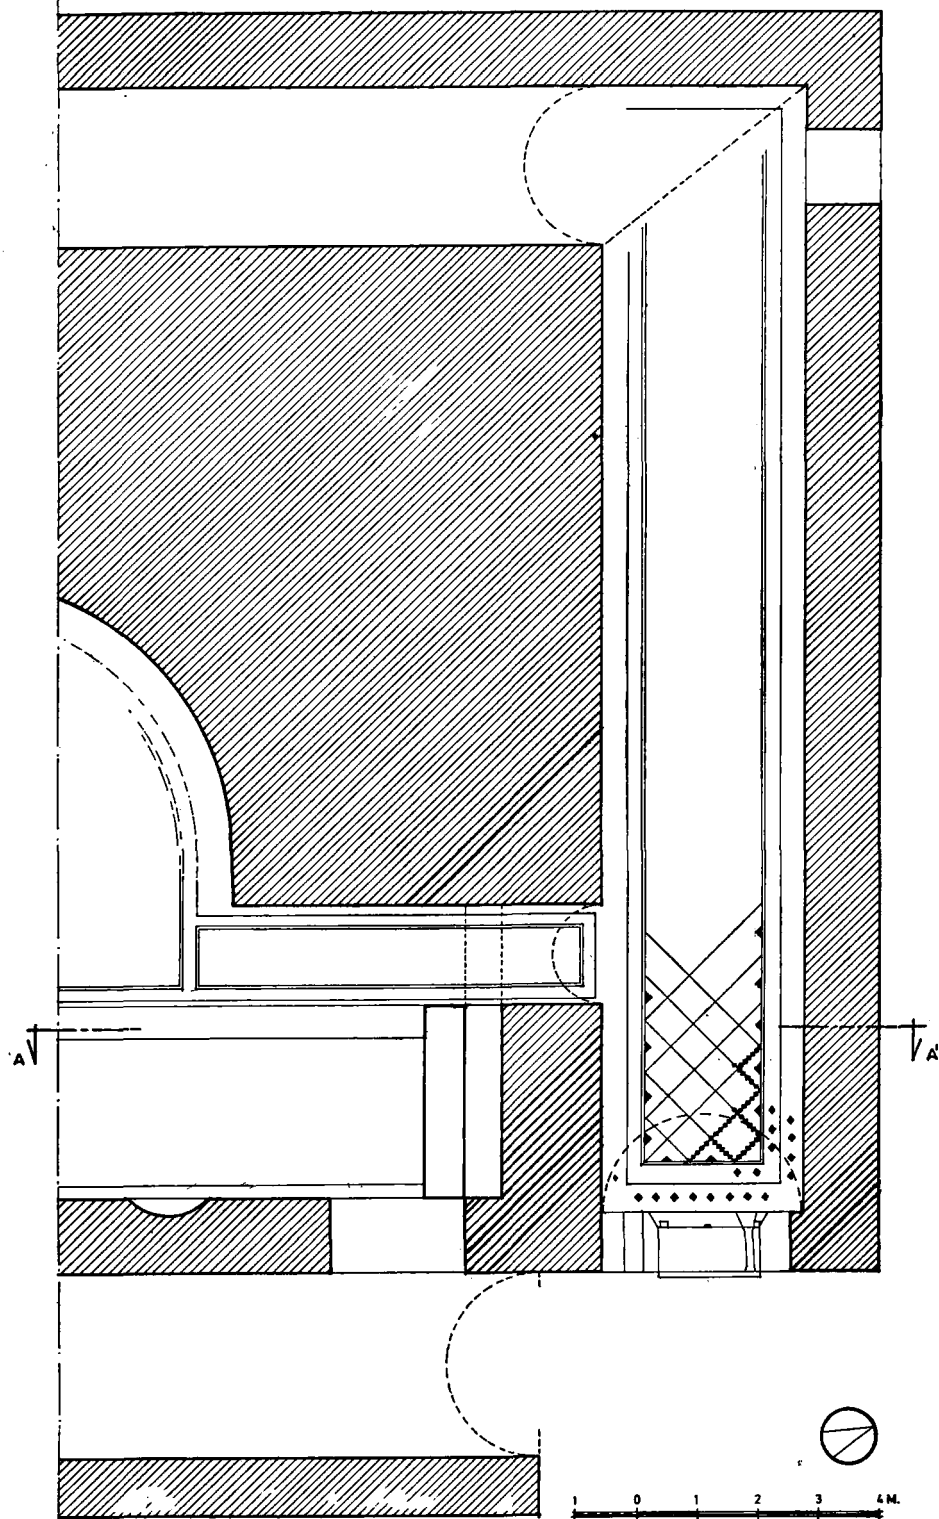
FIG 1. PLAN OF ANEMURIUM ODEON (II 9 D).

A speciality of the Anemurium odeon is the vaulted tunnel that serves as a substructure of the seats (Plan 1). The width of this tunnel is 3.13 m., and the length of its north tract is 18.62 m up to the entrance arch. The interior walls have a coat of coarse plaster, and the floor is covered with mosaics of a simple geometric design (Fig. 2). The soil that had accumulated in the tunnel to about one meter in height protected the mosaics so that they emerged practically undamaged when the soil was cleared away.¹ There are arched entrances to the tunnel on either side of the *skene*, and there are also arched doorways leading into the orchestra (Plan 1). The latter is semicircular in shape and its floor was paved with mosaics. The *scenae frons* has three doors and four niches, the two smaller of which were probably for statues (plan 2). The stage building is the worst destroyed part of the Odeon. It has two passageways leading outside to the right and the left. The barrel-vaulted ceiling has completely collapsed, but the supporting east wall is still standing although not to a great height.

Another notable feature of this tunnel entrance is the use of large limestone blocks ($50 \times 75 \times 50$ cm.) at the sides and above the arch. Two of these blocks are still *in situ* on the left and on the right. (Plan 1-2-3). One of them contains fossilized sea-shells, and it is possible that these stones were quarried elsewhere and transported to Anemurium². The use of large stones is rare at Anemurium, and thus, their occurrence in the Odeon may be of significance.

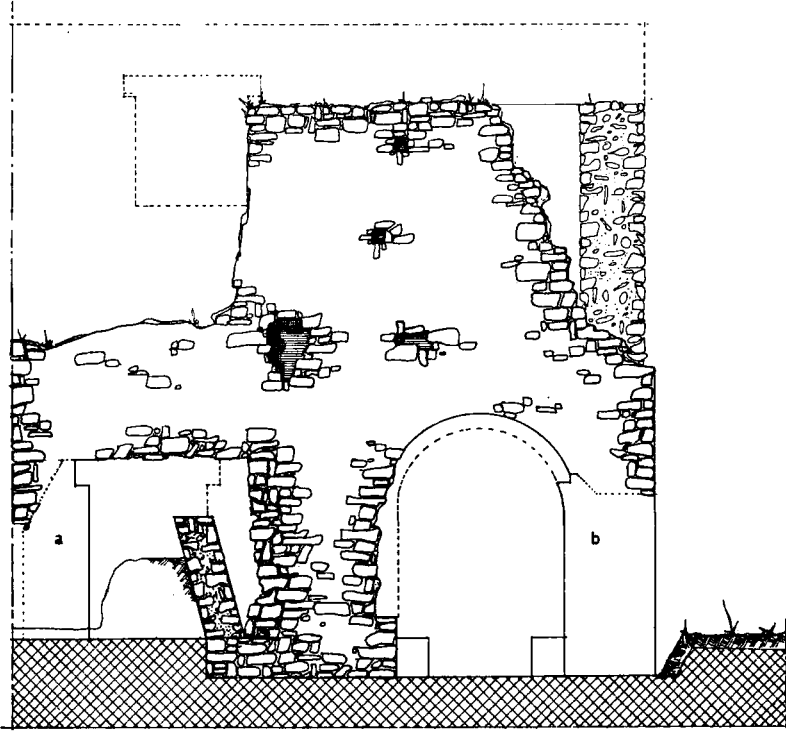
Plânş 2

3 - EAST FRONTAGE OF ANEMURIUM ODEON

In this part, some dangerous damage was repaired: on the south frame of the north door, which is surmounted by a false arch, and on the north side of the niche south of it. The south frame of the door (which is 2.70 m. high) was restored up to the springing of the arch (Plan 2-3 a) in the building technique current at ancient Anemurium and using only limestone from the ruins without breaking or in any way working them. The facing stones—all rough-dressed—were laid horizontally; the same kind of stone was used for the fill, and for bonding cement mortar was used (Fig. 3). Care was taken to preserve the recess into which originally a beam or a lintel was fitted.

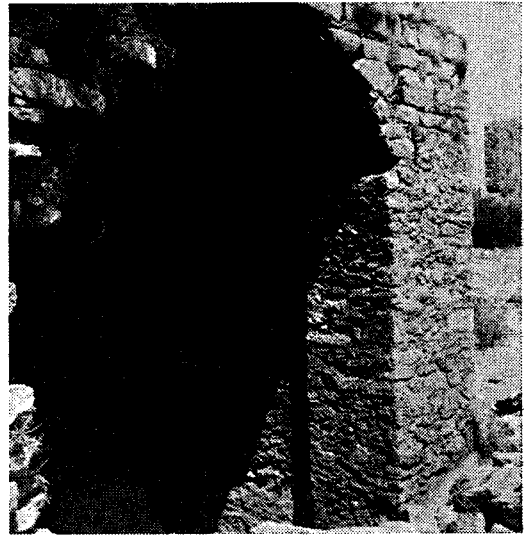
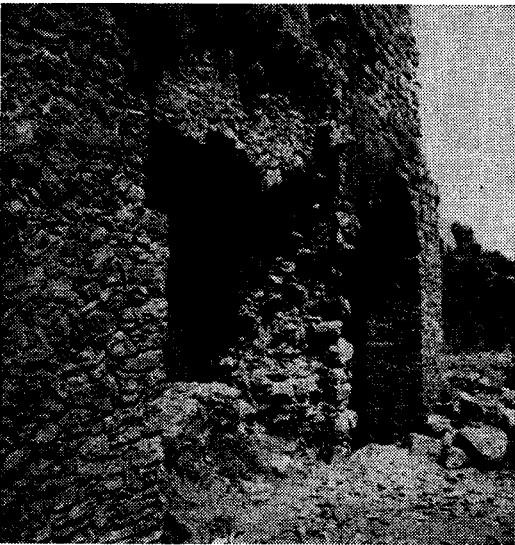
The second point, where some restoration was carried out, is at the entrance to the north track of the tunnel supporting the seats. The north corner of this entrance was found to be hollowed out to a depth of 2 m., and thus it was feared that it would not be strong enough to carry the weight of the wall on top. For the repair, original stones from the site were used, bonded with cement mortar. The facing, up to the springing of the vault (2.50 m from the ground), was made again by horizontal courses of this stone, and for the filling, the same

technique was used as on the *scenae frons* (Fig. 4-5-6).
