## ABRASION EFFECT OF FLOW ON PIPES

M. Baduna Koçyiğit <sup>a</sup>, Ö. Koçyiğit <sup>a\*</sup> and A. Şafak <sup>b</sup>

<sup>a</sup> Gazi University, Faculty of Engineering, Civil Engineering Department, 06570, Ankara, Turkey

### Abstract

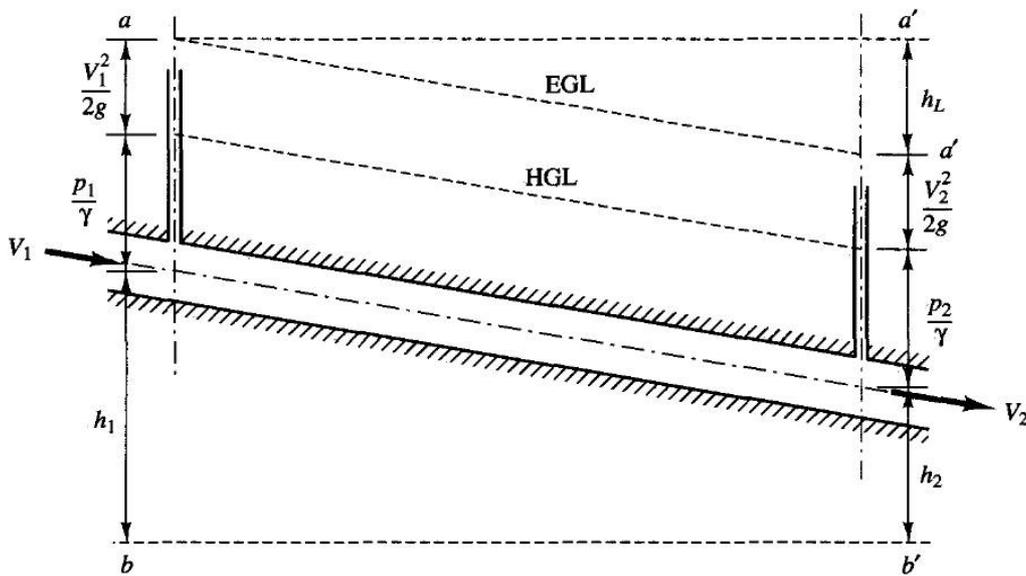
Figure 1: Energy head and head loss in pipe flow [21]

However, a certain amount of energy loss in Eq.(2) occurs when the water mass flows from one section to another. Figure 1. shows, schematically, the energy heads at two sections along a pipeline. The difference in elevations between points  $a$  and  $a'$  represents the head loss,  $h_L$  between sections 1 and 2. The energy relationship between two sections can be written in the following form in Eq (3) [21]:

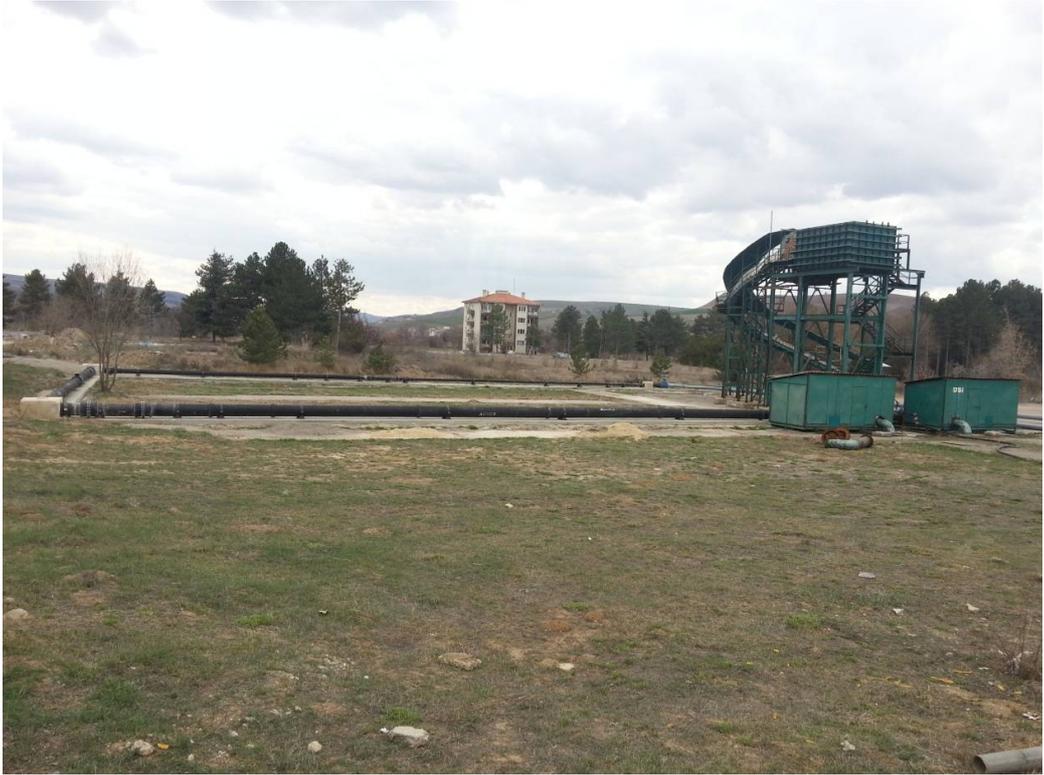
Figure 2: Experimental set-up [22]

Experimental setup was constructed at the General Directorate of State Hydraulic Works Water Supply Department within the scope of Research Project within DSI TAKK Department. In this set up a flow of 440 l/s provided by 4 pumps to a pipe system having different diameters with ductile concrete lining was circulated for 3 months at low and high flow velocities. The pipe system is a loop system in which pipes with 4 different diameters are interconnected. The intention of setting up such a system was to have 4 different flow velocities within the same system [22].

From Eq. (8)  $L_e = 49.39 \times D$  is determined. Length of an edge is taken as  $L_e = 60 \times D$  to stay on the safe side of the cycle. The minimum pipe lengths should thus determined as 27 m, 24m, 18m and is 12 m respectively for pipe diameters 450 mm, 400 mm, 300 mm and 200 mm, respectively, in order to obtain uniform flow (Fig.2). Ductile pipes were obtained and the experimental setup was established by taking into consideration of those values. 4 pumps of 50 kW power each were connected first two series with the two pumps each and then these two series were connected in parallel pumping a discharge of 440 l /s flow to a height of  $H_m = 28$  m, thereby circulating water from the pipe with diameter  $\varnothing$  450 mm to  $\varnothing$  200 mm and then back to water tank. In order to measure the discharge passing through the system as accurately as possible a flowmeter was fitted on pipe of diameter  $\varnothing$  400 mm (Fig.3). The water velocity in each pipe was determined after discharge reading from flowmeter and using the continuity equation as  $V = Q/A$ . Furthermore, measurement pipes of 2 m in length were attached at the end of aforementioned pipe lengths and at the end of each month these pipes were removed from the set up to enable the measurement of the thickness of the concrete lining. Installation of ductile iron pipe connections was first made by bellmouth fittings, however due to the difficulties in re-installation of the measurement pipes to the system pipes, flange connection was later adopted. Two control valves, one located at the output of pumps and the other located in front of the flowmeter were installed to enable air release from the system. Thus, a proper operation of the pumps is enabled giving the opportunity to take accurate measurements from the flow meter. Moreover, two pressure gauges attached one at the beginning and one at the end of the line to measure the pressure in the system.

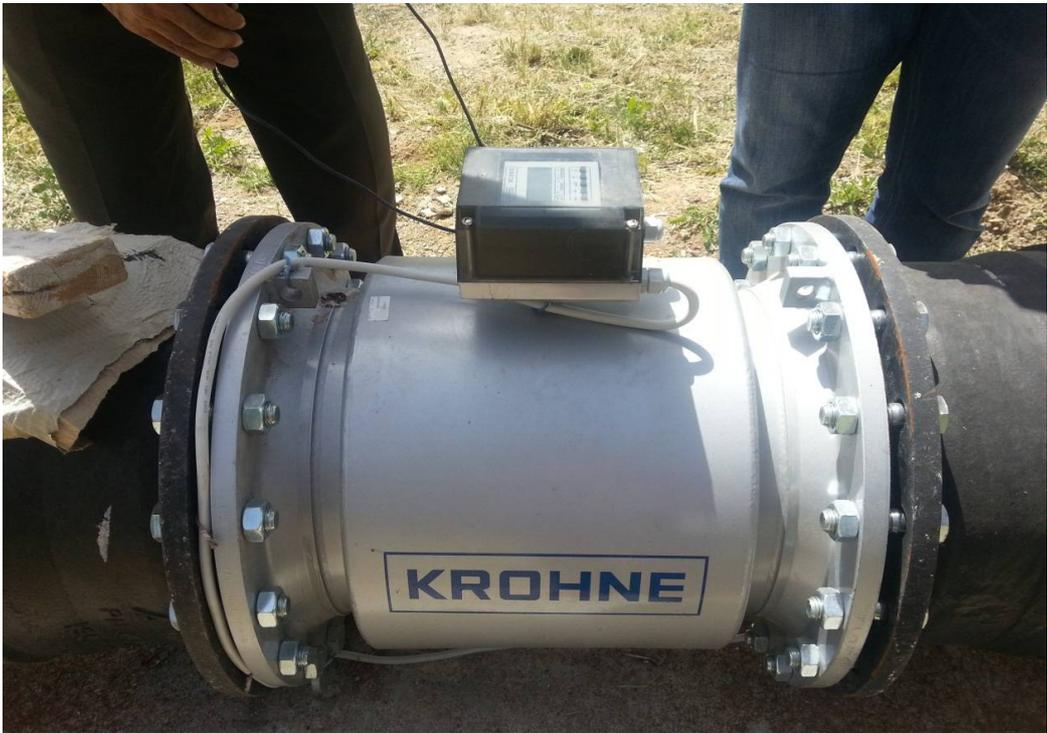
Figure 3: Flowmeter [22]

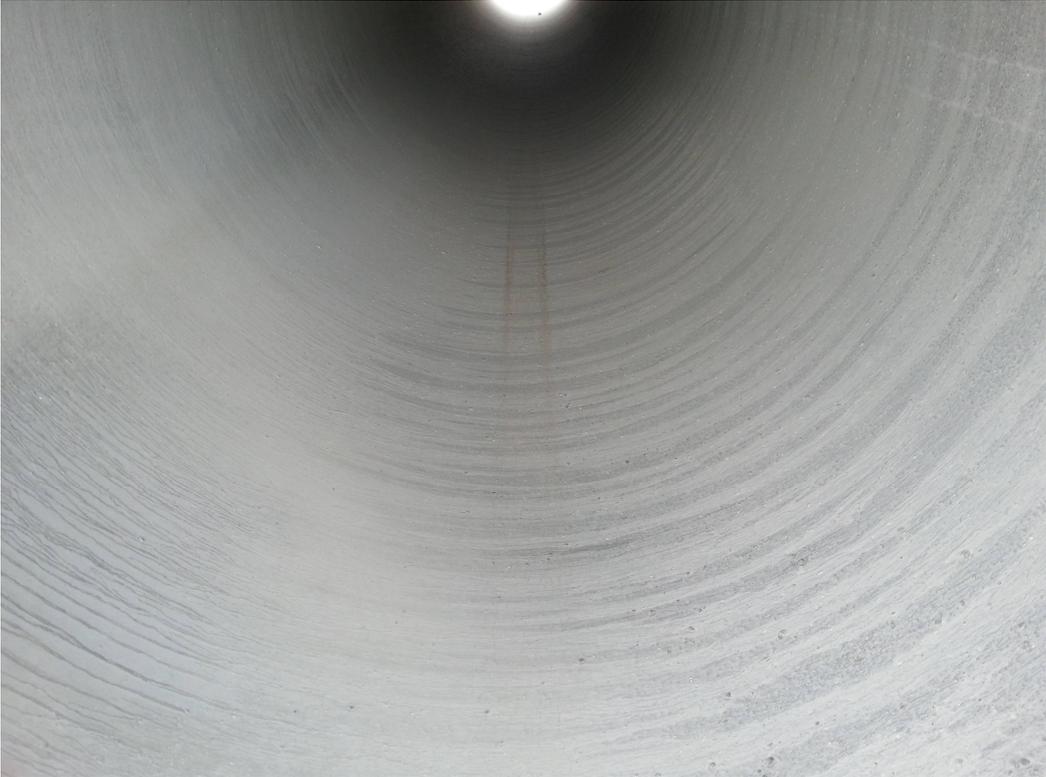
Figure 4: Interior concrete lining of the pipe from factory,[22]

Concrete lining measurements are taken from four points around the pipe section, from both inlet and outlet parts of the pipes and at a distance of 40 cm from the inlet of the stationary pipe. Measurements taken by the ultrasonic thickness measuring device has a sensitivity value of 1: 1000 millimetres. The study herein is aimed to investigate the effects of high flow velocities on the concrete lining of pipes by using concrete lined ductile pipes with four different diameters. Examples of changes on interior concrete in the operational period (before and after the experiment) are given in Fig. 4-7 [22].

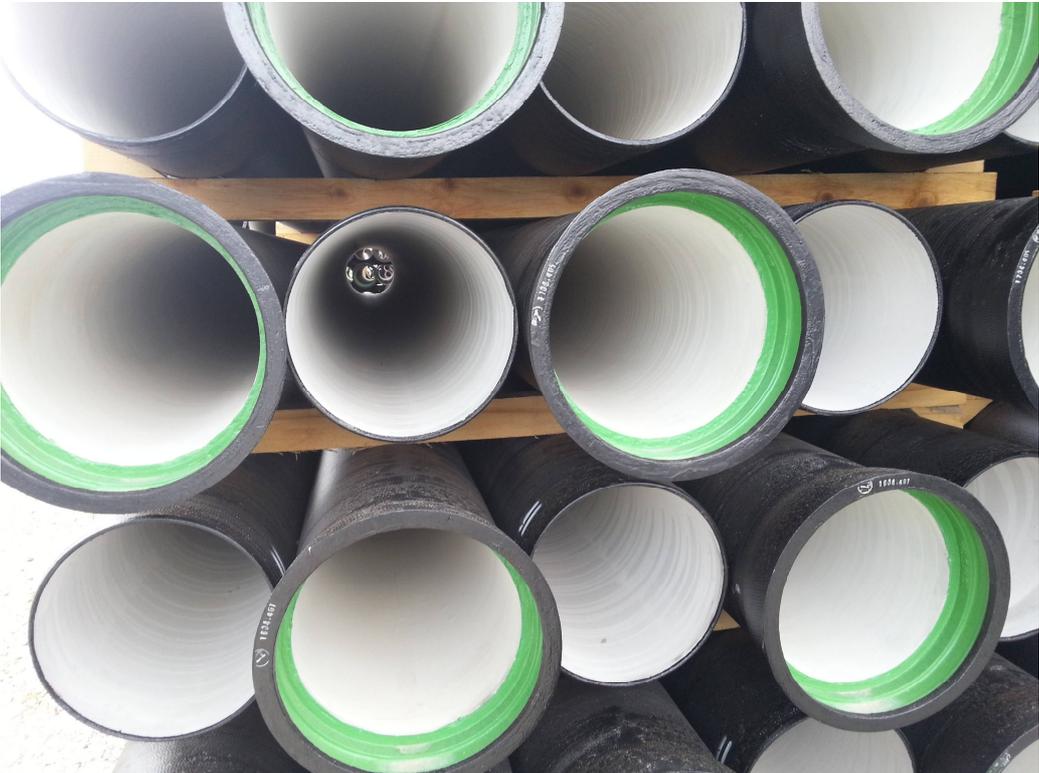
Figure 5: Concrete lining from factory,[22]

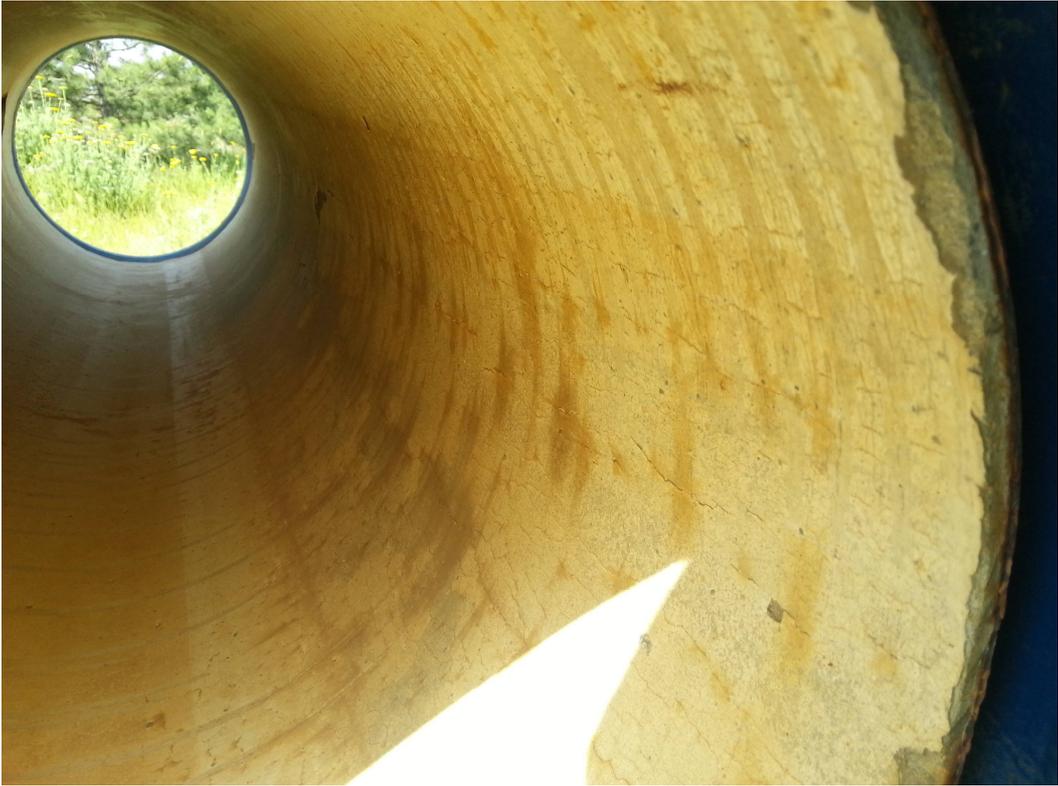
Figure 6: Inner concrete lining after three months test ( $\text{Ø}400$ )  $V=3.45$  m/s, [22]

As a result of water velocity experiments performed in ductile iron pipes, some damages on the inner concrete lining of the ductile pipes occurred, as seen in Fig.6 and Fig.7. For instance, the initial manufacturing cracks (see Fig. 4 and Fig.5) present on the concrete coating at different locations of the pipes were seen to get enlarged, while places of abrasion and loss of concrete were seen on a thin layer of cement accumulated on the outer surface as in the process of concrete pouring by centrifuged (tossing) method and especially at locations close to pipe entrance and around cracks, formation of partial rust thickness and change in color of the surface of the concrete to a yellowish color were observed. Causes of the formation of those damages were investigated by using previous conducted studies and interviews with related manufacturers, implementation engineers and academics. Causes of the formation of cracks in the concrete lining may be caused by a number of reasons. For example, cracks may occur on the inner lining of the pipe due to the external factors (such as temperature differences etc.) because of the difference in elasticity of the pipe lining material from the elasticity of the concrete used in the inner lining of the pipe. Another reason for these cracks is thought to occur due to the non-fulfillment of the concrete curing conditions during manufacturing of the concrete. Because those cracks are longitudinal cracks, which are likely shrinkage cracks that occurred during concrete curing. Moreover, it is likely that the pipes would be exposed to tensile stress during transportation of the manufactured pipes from factory to the location where the field experiments were conducted and during assemble of the pipe system. Since the inner lining concrete is very suitable to cracking and breaking, it can be considered that the circular cracks of the aforementioned ones to be formed as a result of exposure to tensile stress. Although the longitudinal cracks on the inner lining of the pipes were observed frequently, the same can not be said for the circular cracks.

According to the observations, it was concluded that the water in the pipe penetrated to the concrete lining through cracks present in the coating, reaching up to the ductile material where corrosion started on the ductile pipe extended to the concrete surface through the same cracks and thus forming a rust layer. From the interviews and information exchanges with manufacturers and construction engineers working on site it was concluded that during the preparation of the inner lining of the concrete the additives (AGAPOL) used only enhanced adhesion and accelerated hardening of the concrete whilst not any measurements were taken to evaluate whether it has any concrete strength-enhancing feature or not. Properties of the additive (AGAPOL) can be found from [24].

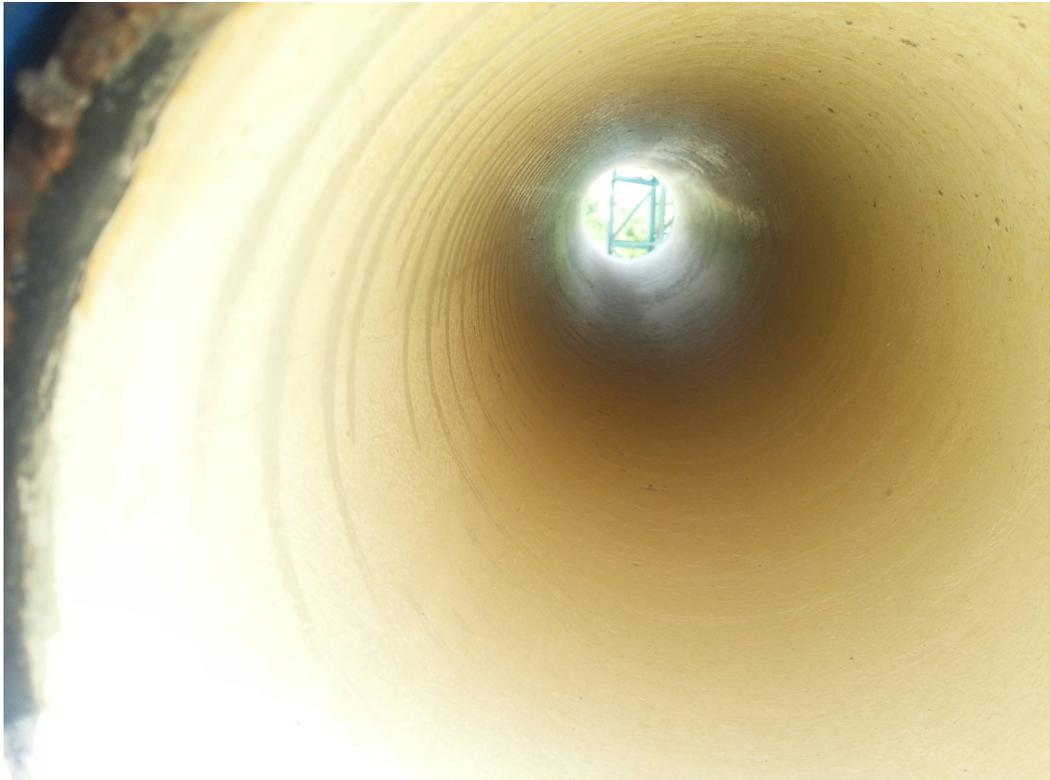
Figure 7: Inner concrete lining after three months test ( $\text{Ø}200$ )  $V=13.81$  m/s, [22]
