Finite Element Analysis of Safety Pin in Snowplow Equipment

Snow plow equipment is produced with chassis connections suitable for trucks, pickup trucks, tractors, construction machines and pick-ups and mounted in front of the vehicles. In this study, the stress and deflection values of the safety pin used in snow plow equipment will be examined by testing with finite element analysis. In this study, a damaged safety pin was analyzed numerically. The damaged safety pin was modeled with Solidworks package program and stress analysis was performed by ANSYS Workbench package program. In this analysis, the properties of the safety pin made of St37 steel were used. As a result, it was observed that the safety pin was damaged due to the stress distribution.

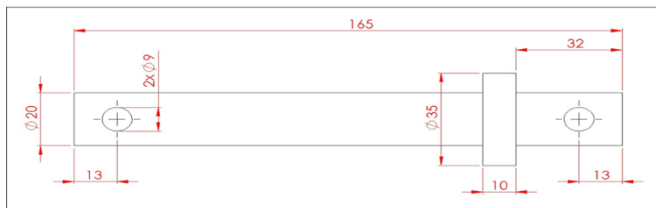
The carbon ratio of St 37 steels is around 0.20 maximum. It is the softest of the hot rolled steels. St 37 quality steels are known for their features such as being easy to process, welding and cutting without problems. It is one of the most preferred types of steel construction structures. St 37 (s235) quality class steels come first among the commercial grades of structural steel construction profiles and sheets [13]. The 3D redesign was made for the safety pin by reverse engineering with the help of Solidworks design program as shown in Figure 1. Dimensions were detailed in the technical drawing section.

Figure 1. Technical drawing of safety pin

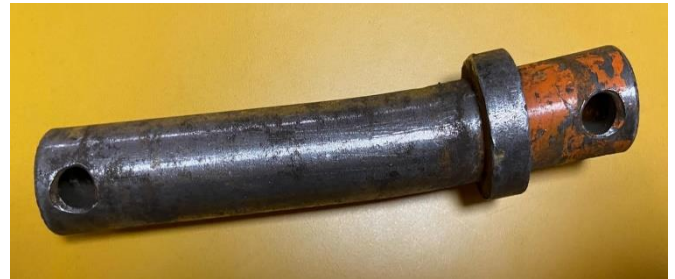
After using the snowplow equipment for a certain period of time, bending of the safety pin was observed as shown in Figure 2. After this stage, the use of the pin was not considered appropriate.

Figure 2. Bending condition of the safety pin after use
