# A Case Report of Metal Induced MRI Accident and Diagnosis by Ultrasonography

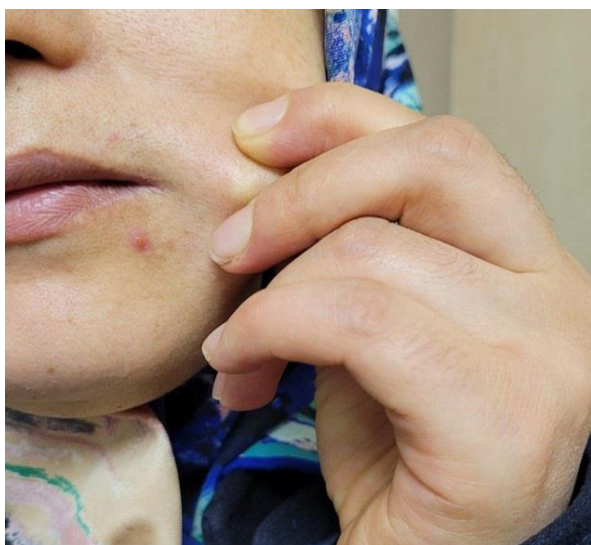
In the clinical bi-digital examination of the patient's cheek, we felt a hardness in that area (Fig. 1). On panoramic radiography, the object was not noticed at first because it was superimposed on the left mandibular first molar with metallic filling (Fig. 2). A metallic object was observed in the periapical film taken in the superior direction, but the location of the object was not fully discernible (Fig. 3). It was decided to take extra-oral and intra-oral USG from the patient for further examination. USG was applied using an Aplio-300 device (Toshiba Corporation, Tokyo, Japan) and 12 MHz linear probe used for extra-oral USG and 18 MHz Hockey stick probe used for intraoral USG. Metallic foreign body was clearly observed in both techniques.

**Figure 1.** Clinical examination of the foreign body in the cheek.

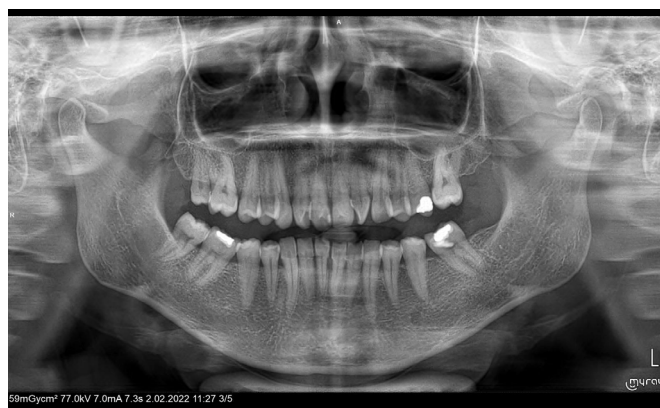
**Figure 2.** The metallic object superimposed on the left mandibular first molar with metallic filling is observed on the panoramic radiography.

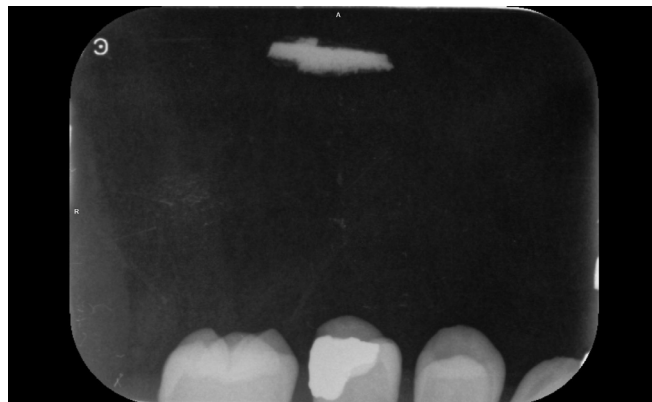
**Figure 3.** The periapical radiographic image of the metallic object.

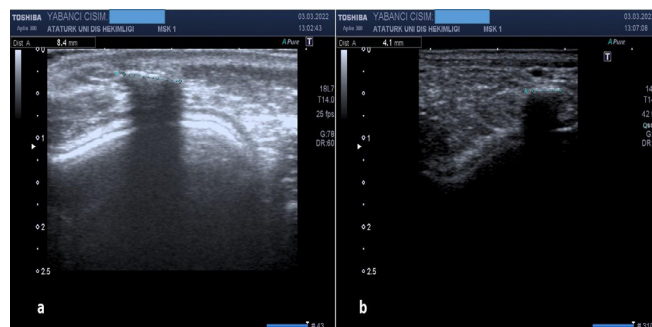
**Figure 4.** The ultrasonography of the metallic object revealed a hyper echogenic foreign body with posterior acoustic shadowing. a: Trans cutaneous-approach, b: trans-oral approach.

Extra-oral USG examination revealed an 8.4 mm foreign body with posterior acoustic shadowing in the subcutaneous area (Fig 4). In the intra-oral USG examination, a foreign body with posterior acoustic shadowing of 4.1 mm was observed in the submucosal area (Fig 4). Later, the patient was referred to the surgical service for the removal of this object. The body was removed by intra-oral intervention under local anesthesia (Fig 5). Afterwards, the patient was called for control post-operatively. When there was no problem, the patient was referred for MRI again after the post-operative edema and pain subsided. Afterwards, the patient was able to have an MRI without any problems.

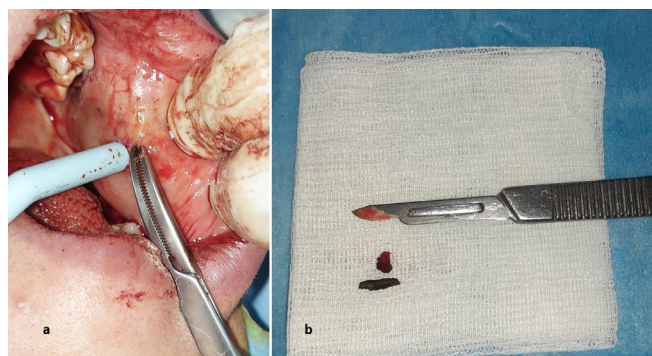
**Figure 5.** Removal of the metallic object by intra-oral intervention under local anesthesia. a: The operation, b: The extracted metallic object.
