## **Investigation of the Historical Harput Ulu Mosque**

**Keywords:** Harput ulu mosque, Restoration, Structural deterioration

In this article, the history, design, materials used and the causes of structural deterioration of the Great Mosque in the province of Elazig-Harput were investigated and some suggestions were presented as a result of these examinations.

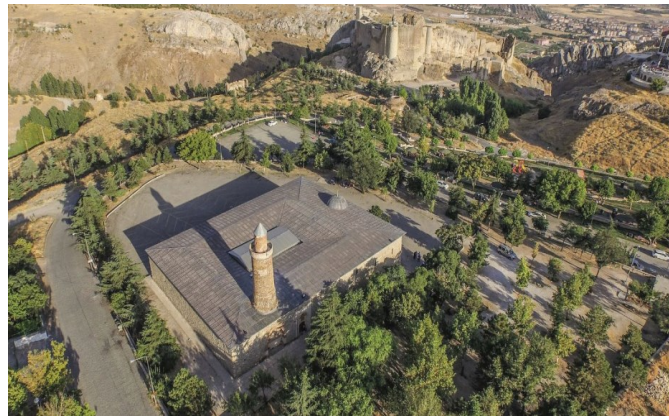
Figure 4.1. Ulu Mosque and its surroundings [8].

Harput Ulu Mosque is built on an area of 2000 square meters in the Old Mosque Kebir District in Harput. Harput Ulu Mosque is one of the oldest Turkish mosques in Anatolia. The mosque was restored in 1899, 1905 and 1996. The interior of Harput Ulu Mosque consists of three parts. These; inner courtyard, narthex and inner mosque. Its rectangular planned walls are made of rubble stone. The dome arches and minaret are built of brick. The mosque has two doors [8]. The Ulu Mosque and its immediate surroundings are shown in Figure 1.

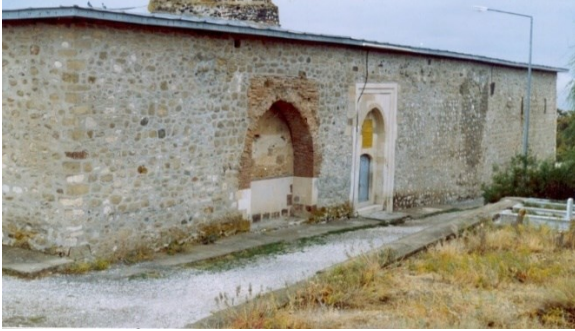
**Figure 4.4.** Ulu Mosque-West Arched Door [15].

The building has a small courtyard in portico-iwan layout. Cut stone was used in some parts of the mosque, rubble stone was used in the walls, and brick was used in the support and cover system. The mosque has a rectangular plan and looks different from the mosques built during the Artuqid and Seljuk periods with its architectural structure. Here, the plans and shapes of the Seljuk and Iranian mosques were combined and a structure specific to Anatolia was introduced. Harput Ulu Mosque is closed to the outside and its outer walls are extremely thick. There are two crown doors to the mosque in the east and west. Of these, the west gate is placed in a higher and rectangular frame. The western wall, which is the main facade, has a pointed arch door that took its current shape in the last restoration and an arch opening showing the minaret base. The arches of the eastern gate are closer to the pointed arch and are bounded by two round pillars and rectangular frames [16].

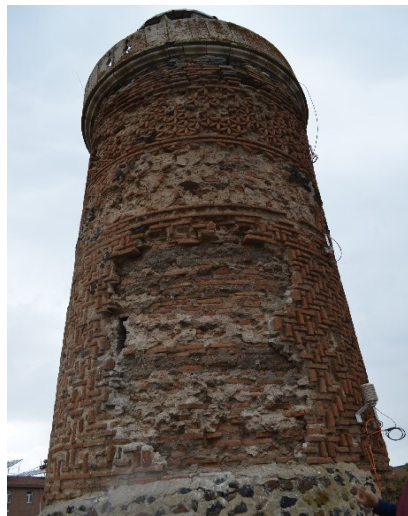
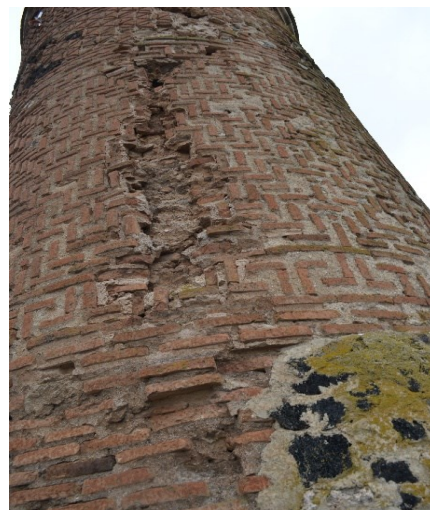
**Figure 4.8-9.** Harput Ulu Mosque minaret current situation [15].

One of the most interesting aspects of the Harput Grand Mosque is its minaret. The minaret, which is located in the northwest of the mosque and consists of a square base and a cylindrical body, is bent eastwards. It is interesting in that its minaret is curved and its bricks are used as decoration elements. (It is claimed that the minaret of the mosque, which varies between 3 and 7 degrees, that is more than the Leaning Tower of Pisa.) The interlaced six-pointed stars and knitted motifs wrapped the entire minaret body so that it does not leave any space. The upper part of the minaret above the balconies is quite long, narrow and cylindrical. The minaret is reached through the mosque and a staircase built later. Cheers are unadorned, so it differs from the other buildings of the Artuqid [16].

After the previous restorations, no collapse was detected in the existing structure. Particularly, some spills were detected in the brick parts of the minaret. Spills were detected in the joints between bricks. The peculiar inclination of the minaret is valuable in terms of tourism. Therefore, it should be preserved as it is. Moreover, it was not damaged in the earthquake that took place recently.

It is known that an average of 83.6 days of frost occurs in Elazig throughout the year. Due to freezing and subsequent thawing, structural deterioration and crustal spills have occurred on the surface of the building. Especially in the minaret section, structural defects have occurred over the years due to the dislocation of the bricks and the damage caused by pigeons.

4. Especially the gaps in the minaret section can be re-knitted by selecting the materials that are suitable for the original with point interventions, and if necessary, the brick minaret can be reinforced with fiber polymer composites [17].
