Remote Sensing Monitoring and Assessment of Silk Road in Turkey: Integrating Drone Systems with GPR and RM

Gökhan Kılıç^{1*}

¹Izmir University of Economics, Faculty of Engineering, Department of Civil Engineering, 35330, İzmir/Türkiye.

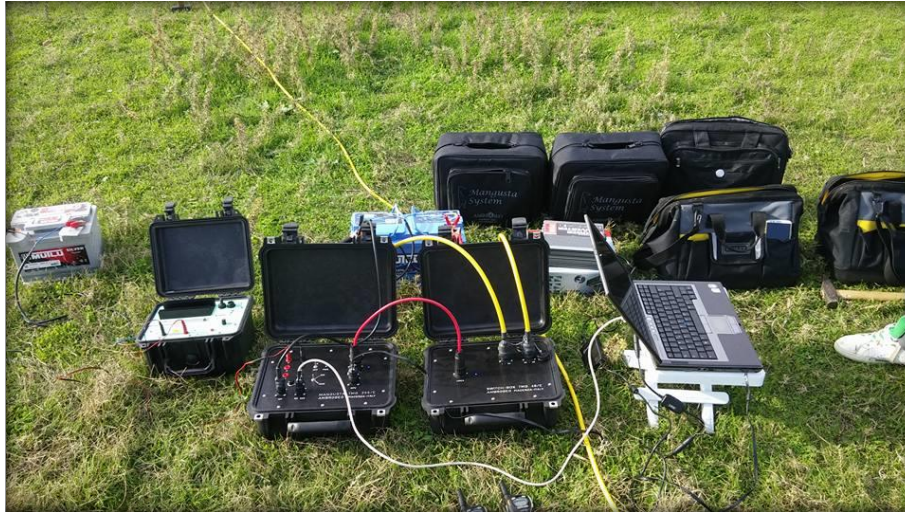
Resistivity was measured by a Wenner series of electrodes, most of which were mounted in small holes drilled in gaps in the Silk Road to ensure good contact. Resistivity was determined by passing an AC current through the two external electrodes and measuring the tension between the two internal electrodes (potential difference). To improve its precision, this method was repeated several times in various locations (Cavalcanti et al., 2018; Diallo et al., 2019).

Figure 4. Ambergeer brand, Mangusta TMG 255 E model multi-electrode (48 electrode capacity) resistivity tomography device

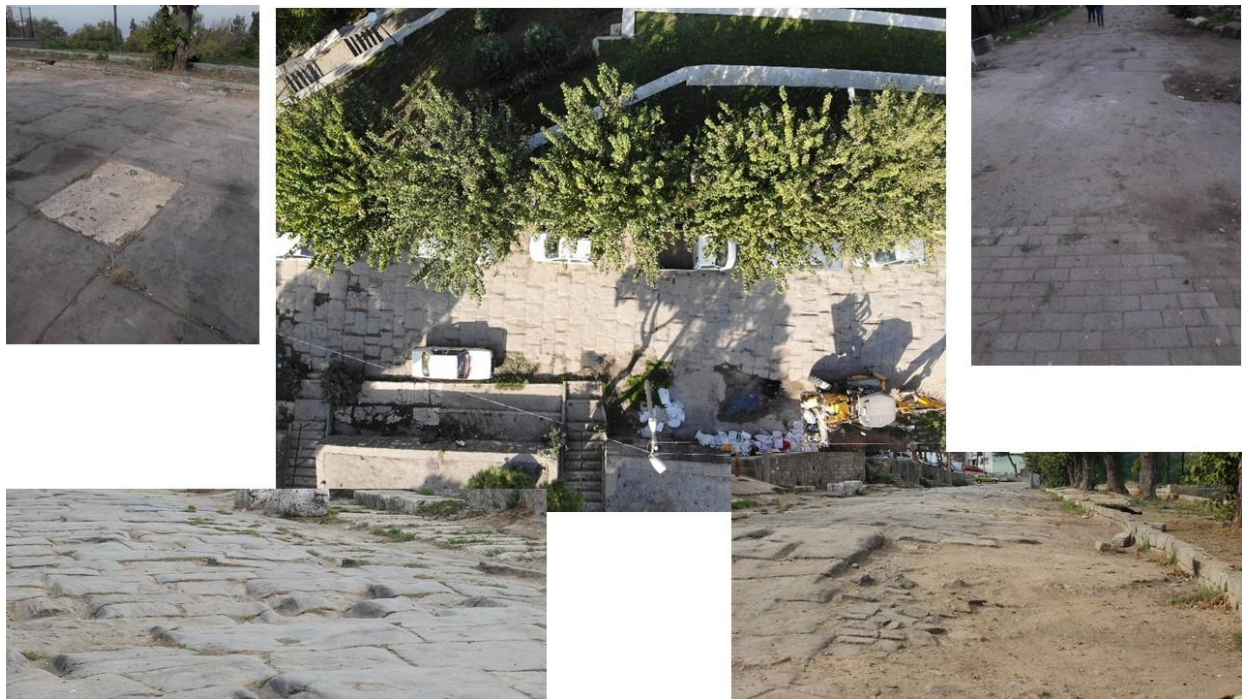
Regarding the history of a site, the design, materials, and construction technology used are as important as buildings, structures and landscapes themselves. In some historical settings, the design and development represent a utilitarian and vernacular use, while others represent a passion for a particular architecture, intricate theories relating to landscape and scenery, or the application of advances in civil engineering. The developed visual evaluation of the Silk Road consisted of external inspections, integrated with a high-definition drone camera to assess condition of the heritage. There were reports of several defects requiring extensive routine maintenance due to weather, temperature and use. Surfaces erosion and degradation is caused surface water, rain and ice. In addition, vegetation growth obscures what is often an indistinct line across the countryside. Figure 6 presents photos from the visual inspection.

Figure 6. Silk road visual inspection results

The initial visual inspection of the investigated potholes was conducted along a significant portion of the Silk Road. The combination of GPR, RM and IRT allowed the collection of detailed internal data on the exact nature and extent of the defects, and the overall condition of the examined heritage. Typically, single NDT procedures are used, but the current study clearly shows the benefits of integrating methods and the combined use of multiple techniques in maximizing data, both quantitatively and qualitatively (Sbartai et al., 2007; Pellicer and Gibson, 2011; Fernandes et al., 2015; Zeybek and Biçici, 2020; Biçici and Zeybek, 2021; Zeybek and Biçici, 2021).
