Assessment of Compressive Strength Variations of Concrete Poured in-Site of Residential Buildings in Isoko District, Delta State, Nigeria

Concrete with appreciable compressive strength is required for building constructions, to minimize the occurrence of building failures. Determination of the compressive strength of in-situ concrete produced in Isoko region of Nigeria was carried in this study. Concrete used for the construction of foundation wall footings for twenty residential buildings were sampled in the study. The compressive strength of the in-situ concrete was determined in accordance with ASTM standards. Field survey depicted that most (60%) of the concrete quality production process fell below the approved standard of 17 MPa, for residential buildings. The findings of the study revealed that the compressive strength of the in-situ concrete varied between 8.1 MPa and 19.8 MPa. Furthermore, the result of the compressive strength test showed that most (70%) of the in-situ concrete failed to meet the NIS recommended standard. Also, it was observed from the findings that proportionally, the concrete produced by conventional building/construction engineers was of a higher comp

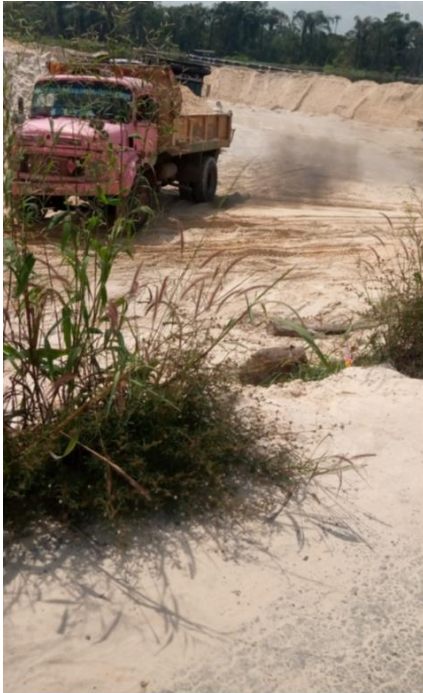
Borrow pit sharp sand (Figure 1) is majorly used for civil engineering and building construction works in the region, however, a few site managers employ river bed sharp sand for their construction work. Geographically, Isoko experiences two major seasons (wet and dry). The wet season occurs between March and September, with temperatures of $24\pm 4^{\circ}\text{C}$ while the dry season occurs between September and March, with a temperature range of $31\pm 4^{\circ}\text{C}$. The study was carried between August 2021 and January 2022 - involving the two climatic seasons (wet and dry seasons).

Figure 1. Point of collection of borrow pit sharp sand.

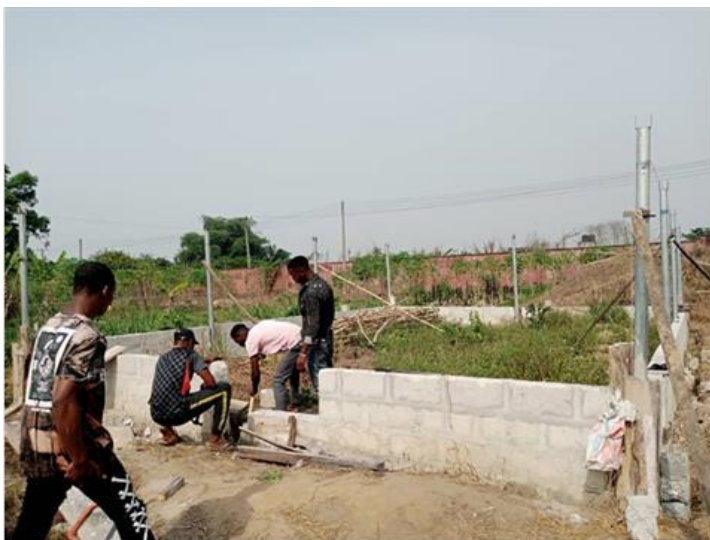
Twenty (20) residential/commercial structures and construction sites (one shown in Figure 2) were visited for the purpose of this study. The sites were selected randomly, but were evenly distributed across the Isoko metropolises to present a fair representation of building population in the region. The sampling number adopted was fairly representative of the number of site managers (masons and engineers) actively available on building projects within the region. A mason here is considered to a site manager without formal tertiary engineering education, but responsible for the construction; while an engineer is the site manager with such formal education, and also responsible for the construction. Double counting was strictly avoided, as only one building site was selected per site manager captured in the study. For uniformity, only single and two storey reinforced concrete structures were captured for this study.

Figure 2. A typical building construction site.

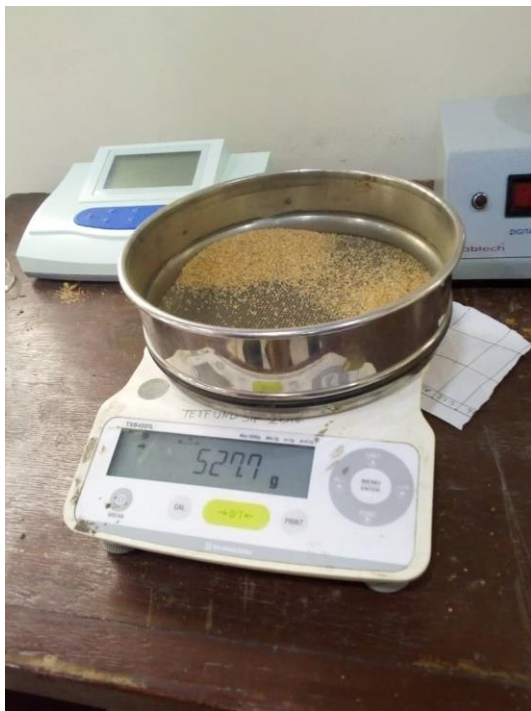
The sieve analysis of the fine aggregate used for the concrete production was done in accordance with NIS-87 procedure. 500 g of dry sand (fine aggregate) was poured into a pre-arranged set of sieves, arranged in a descending order. The sieves were shaken vigorously for 15 minutes, and allowed to stand for another 10 minutes, so that the fine particles can settle. Then, each sieve was removed from the set, starting with the uppermost one, and weighed with a digital weighing balance (Figure 3). A particle size distribution curve was plotted as described by (Odeyemi *et al.*, 2015), and the coefficient of uniformity (C_u) was calculated using the expression given in Equation 1 (USCS, 2015).

Figure 3. Weight of the sand retained in the sieve.

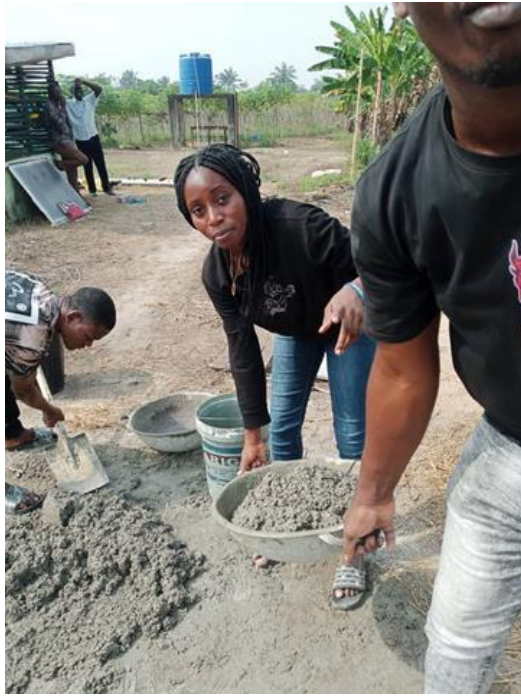
At each building site, four (4) concrete cubes were made, in accordance with ASTM International standard, from the fresh concrete collected from the various construction sites (Figure 4). During concrete cube production; freshly mixed concrete was poured into standard moulds in three equal layers, rammed thirty-five times per layer, and then flattened on the exposed surface with a hand trowel in order to produce a fairly flat surface finish.

Figure 4. Taking of fresh concrete for laboratory analysis.

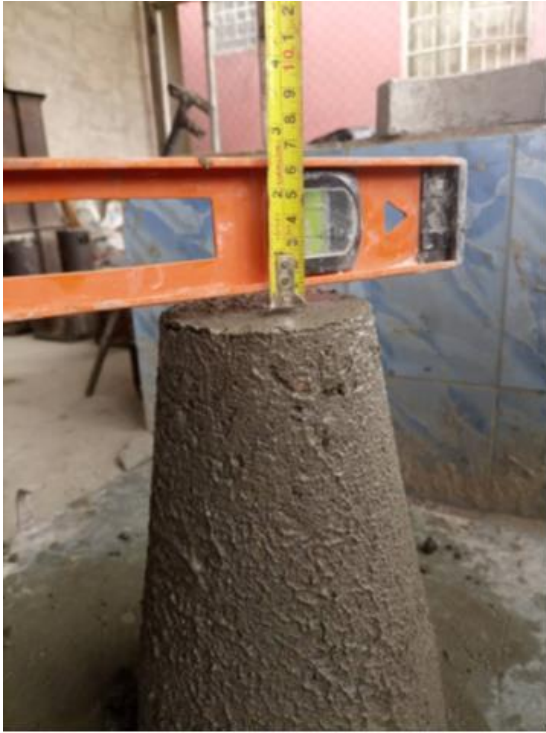
At each sampling site, the slump test was used to determine the concrete's consistency. The general procedures for concrete slump testing were performed in accordance with ASTM International standards (Figure 5).

Figure 5. Taking of the slump measurement.

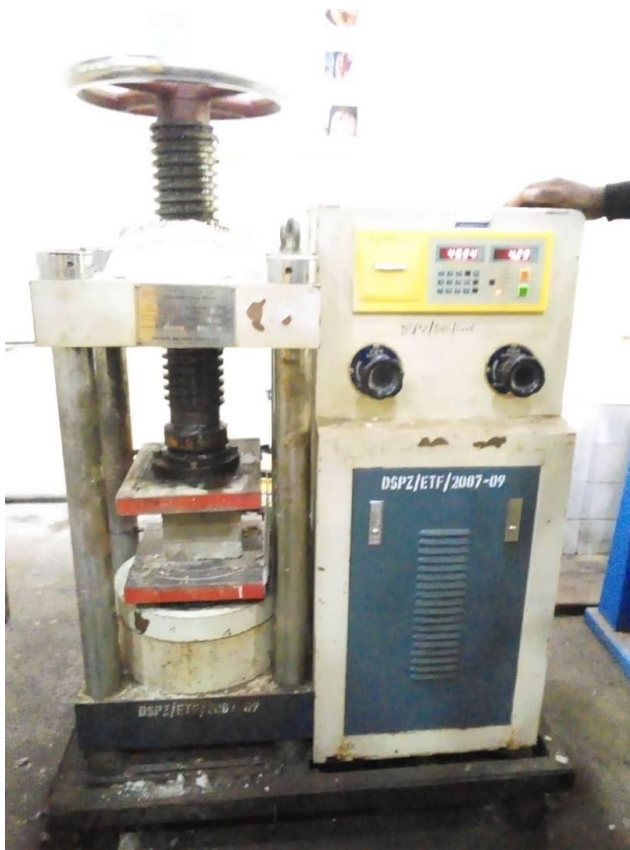
The crushing force of concrete was measured in accordance with procedures set by [ASTM C109/C109M \(2020\)](#), using a concrete crushing machine (Figure 6). Four concrete cubes were tested for each construction site, and the average recorded.

Figure 6. A concrete cube undergoing compression testing.
