Determination of Rockfall Risk Using Fine-Kinney Methodology for Bitlis Downtown Area, Eastern Türkiye

Keywords: Rockfall, East Anatolia, Fine-Kinney method, Risk, Natural disaster

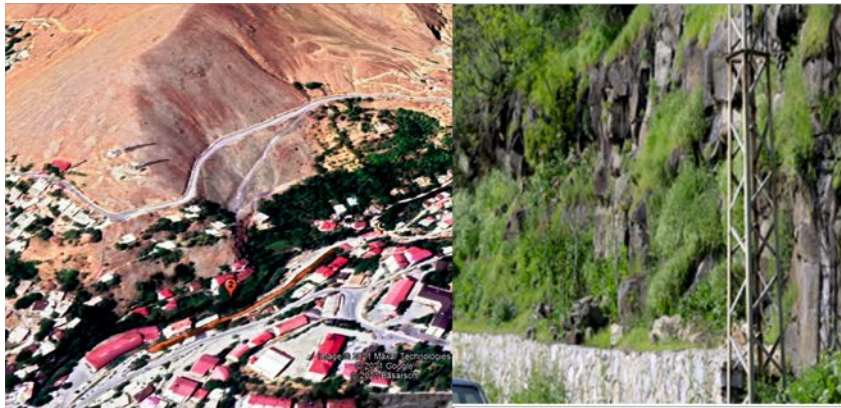
Figure 9. Position and images of Location-2

There are ignimbritic rocks along Mermutlu Street, which is approximately 250 m in line length (Figure 9). Segregation along the discontinuity planes was observed in the rocks. The discontinuity ranges somewhere between 1-3 cm. There is no housing to be affected by the rockfall event, but the event has a serious effect on the main arterial roadway and on the pedestrian path under the slope (Figure 9). There is danger of loss of life and property.

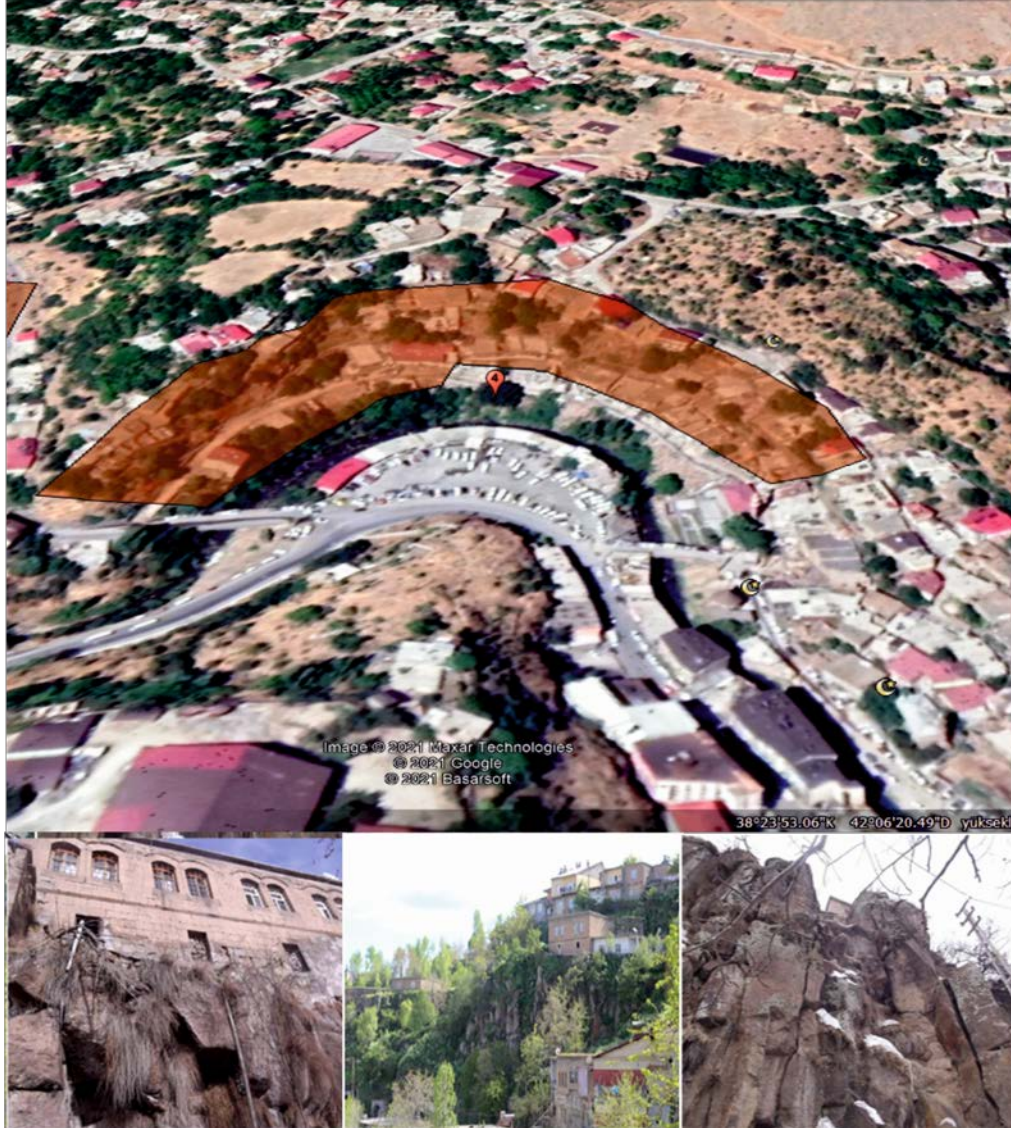
Figure 11. Position and images of Location-4

The area behind of the Şerefiye Külliye was named as Muştakbaba District Area 1 with an approximate length of 140 m (Figure 11). This area contains ignimbrites from the volcanic units which are the product of the Nemrut volcanism. The area with a line length of approximately 140 m was observed along the planes of discontinuity in the rocks. The discontinuity ranges from 5-10 cm in some places. There are 2 shops with about 12 buildings that can be affected by the rockfall incident at the first degree. There is danger of loss of life and property.

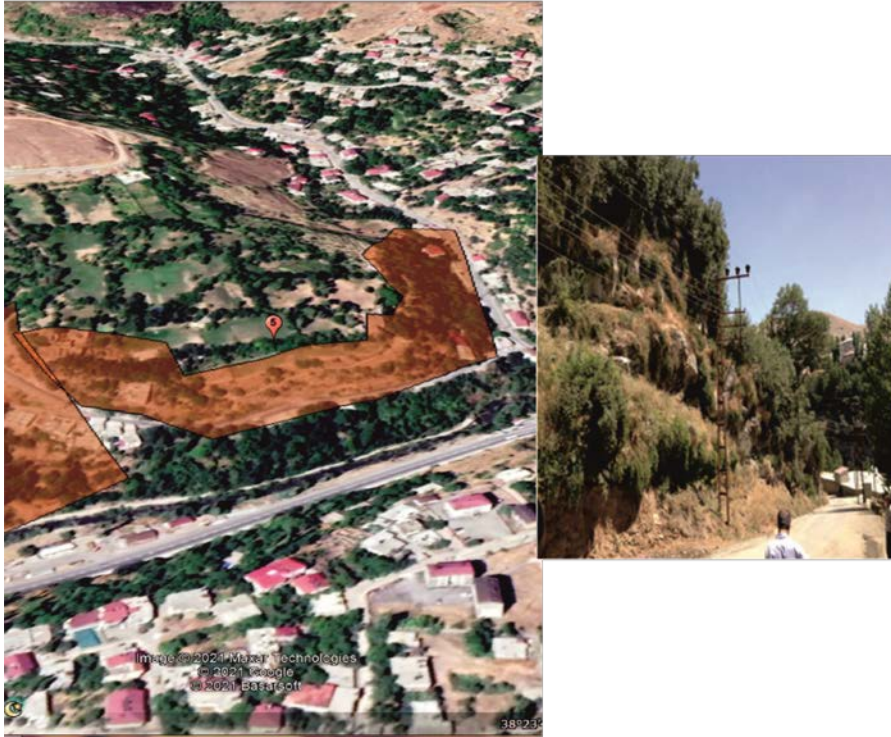
Figure 12. Positions and images of Location-5

Alemdar Street, approximately 468m long, located behind of the old industrial area, was named as Mustakbaba District Area 2 (Figure 12). There are ignimbrites from volcanic units of the Nemrut volcanism. Segregation along the discontinuity planes was observed in the rocks. The discontinuity ranges from 20-30 cm in some places. There are about 42 buildings that can be affected by rockfall incident (Figure 12). There is danger of loss of life and property.
