## Removal of a Broken Pathfile: Case Report

Case Report (HRU Int J Dent Oral Res 2022; 2(2): 142-144)

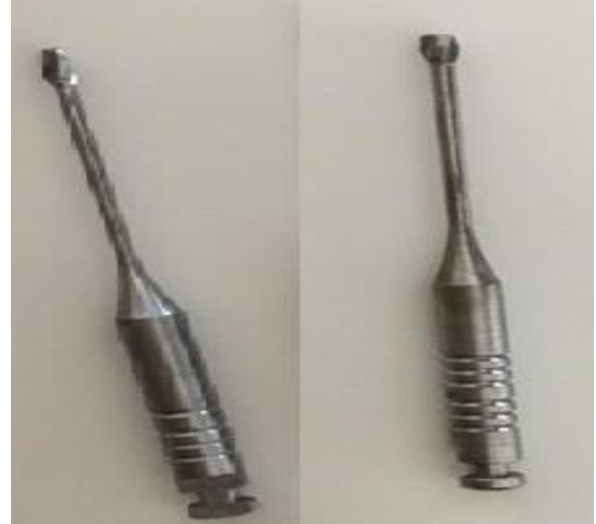
**Figure 2.** Modified Gates-Glidden burs.

Attempts to by-pass the broken file with #6, #8, #10 K-files have been failed. At this point establishing a direct access to the broken file has been decided. For this purpose, #4-6 Gates-Glidden burs have been modified(Figure2). Gates-Glidden burs used at 1000rpm carefully until the broken file has been reached. Copious irrigation with NaOCl have been applied to avoid debris blokage. At this point dental loupes light power have been set to maximum and the broken file has been detected visually. After visual detection, attempting to by-pass the file have been decided.

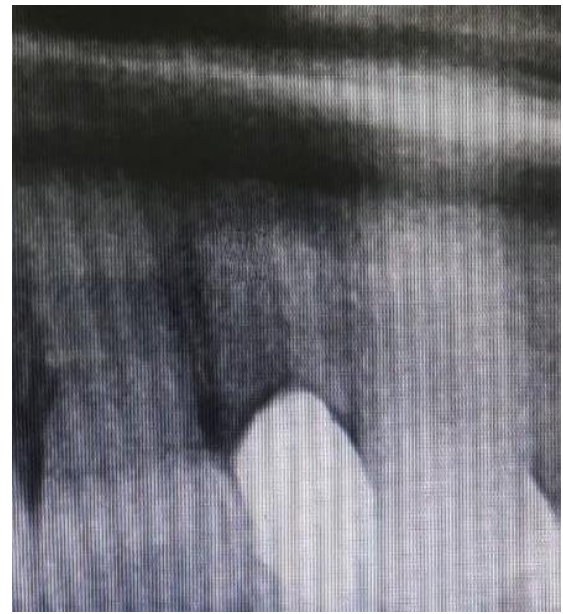
**Figure 3.** Radiograph after file removal.

But the by-pass attempts failed again. After this using endodontic ultrasonic tip LM,EN-11(LM Dental,Parainen,Finland) to remove the broken file have been decided. Under magnification x4.3, the ultrasonic tip has been used counter clockwise around the broken file. The broken file have been removed during irrigation and unintentionally have been aspirated by suction. Then an intraoral radiography taken to confirm the absence of the broken file (Figure3). Then the working length determined by using an apex locator Propex Pixi (Dentsply-Maillefer, Ballaigues, Switzerland) and chemomechanical preparation have been made to an apical size of F3(F3 of the ProTaper system; Dentsply Maillefer, Ballaigues, Switzerland). Then %17 EDTA
