## EVALUATION OF THE HISTORICAL İPLİKÇİ MOSQUE ACCORDING TO DBYBHY 2007 AND TBDY 2018 REGULATIONS

In this study, the Historical İplikçi Mosque in Konya was modeled with the finite element model in the SAP 2000 program. On the model, earthquake resistant design rules and calculation methods were compared according to the Regulation on Buildings to be Constructed in Earthquake Zones (06/03/2007) and Turkey Building Earthquake Regulation (18/03/2018). As a result of the study, it was seen that the calculation methods used with TBDY 2018 and the rules to be followed have changed and new building types were added. As a result of the analyzes obtained from the examined structure, it was seen that the structure did not meet the DBYBHY 2007 principles, but the TBDY 2018 principles.

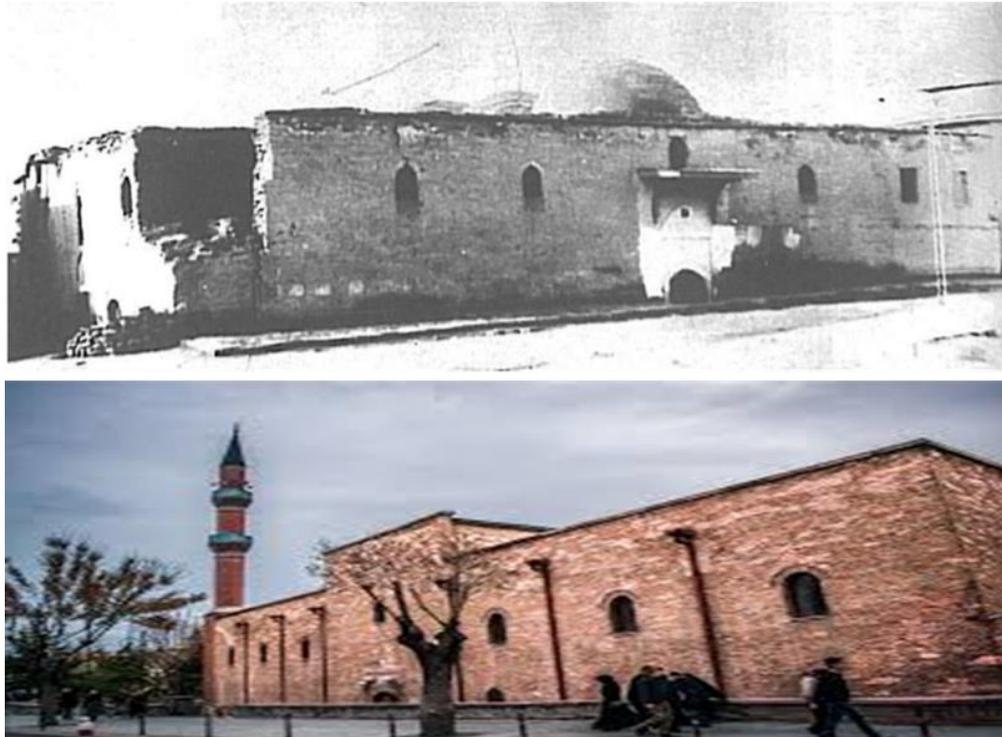
Figure 1. North side of Iplikçi Mosque

Mosque; it consists of 32 column, 44 arches, 4 domes and 32 strut elements. The external appearance of the mosque, which has been renovated and taken its current form, is misleading compared to its former form. In Figure 1 and Figure 2, external images of the old and new state of the building are given. In Figure 3, there are images of its current state.

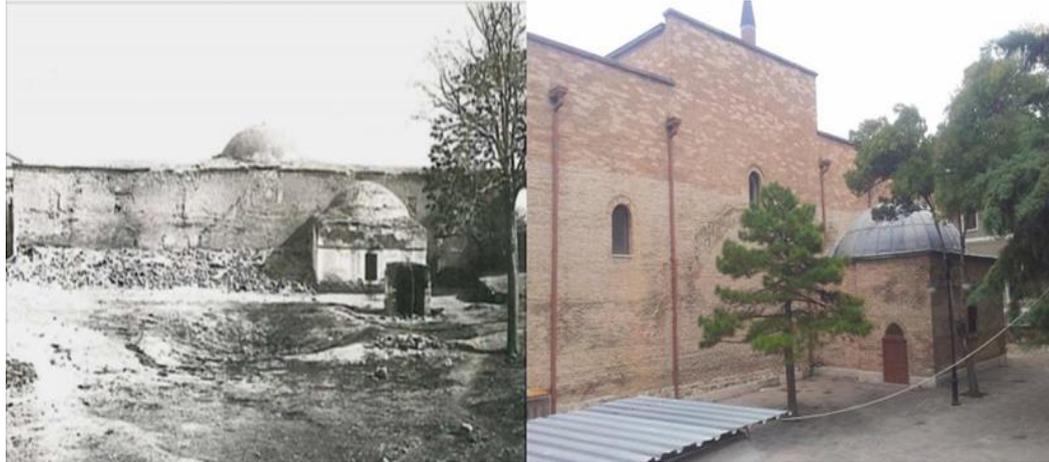
Figure 2. South side of Iplikçi Mosque

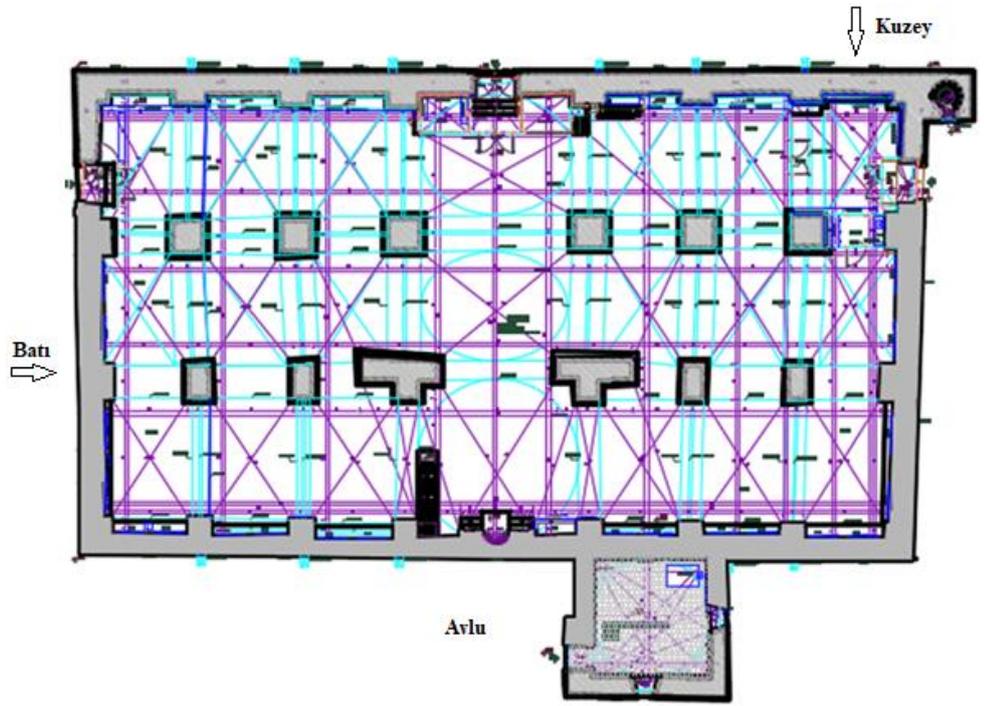
**Figure 4.** İplikçi mosque survey

Considering the survey of the building given in Figure 4, the wall thickness was taken as 1.07 m in the modeling. The dome of the heating room on the south side of the mosque, which has 4 domes in total, has a thickness of 76 cm. The thickness of the remaining 3 domes is 50 cm. While the building was being repaired in the 1940s, the domes were surrounded by walls. The top of the mosque is filled with a prism 8 meters wide and 4 meters high. Since the domes are in a rectangular prism, they are not visible when looking at the structure.

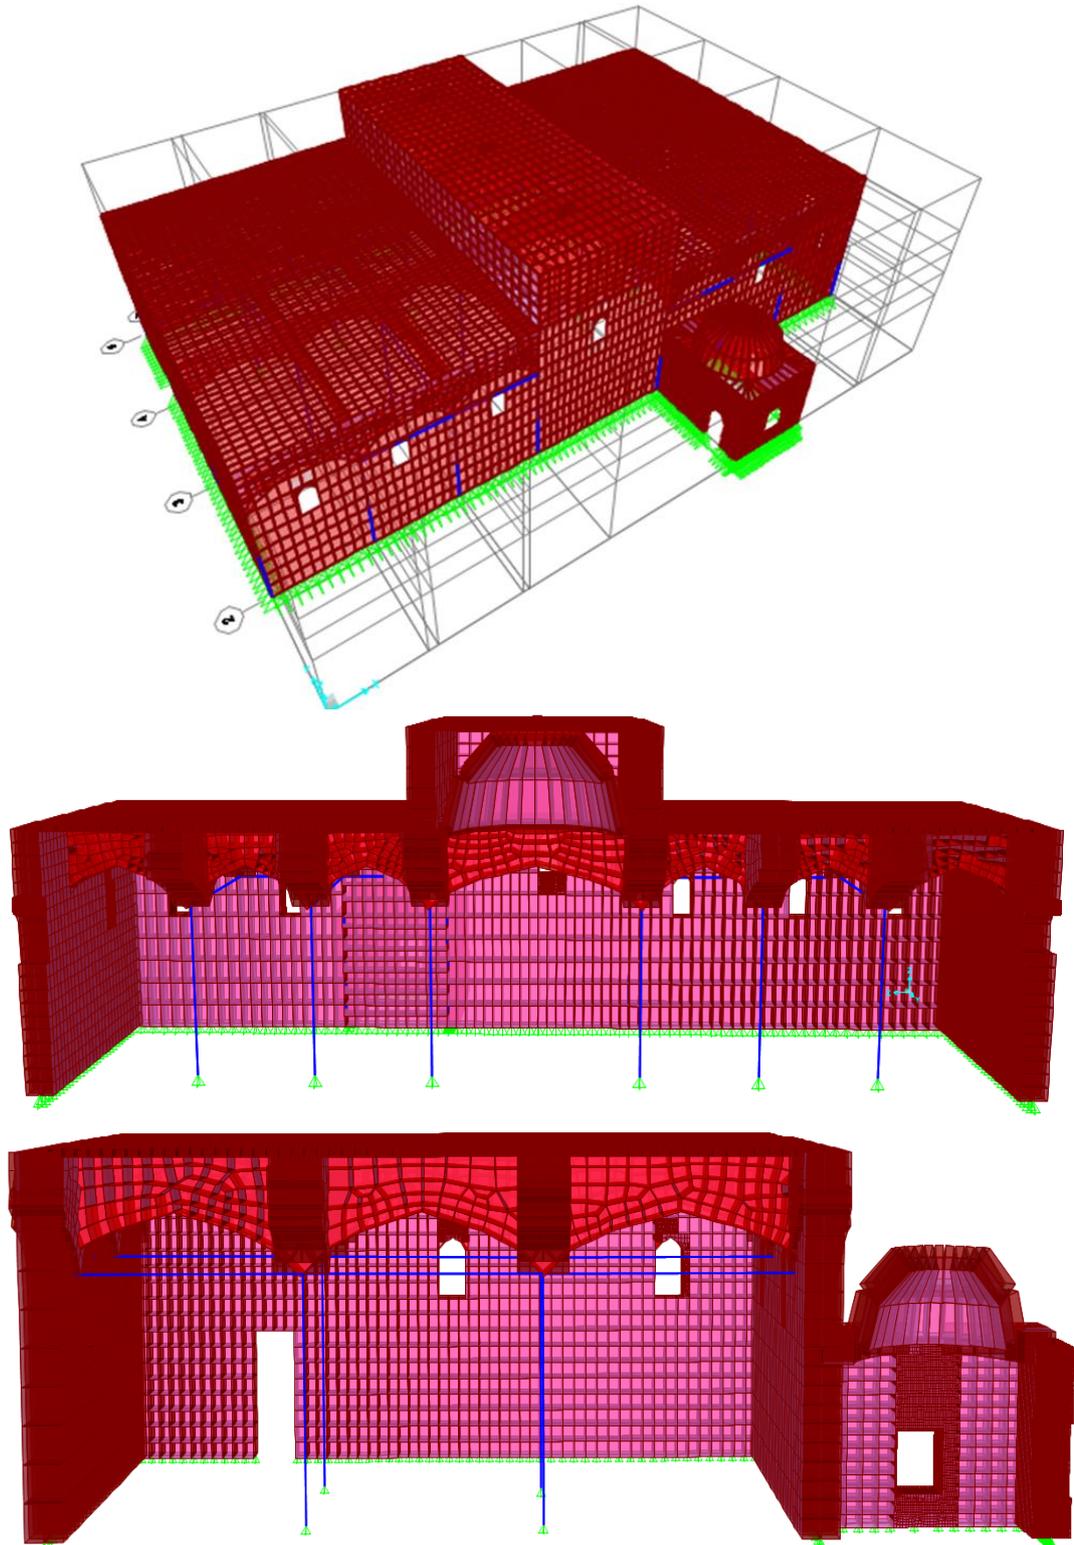
**Figure 5.** Structural modeling of the Iplikçi Mosque

Brick material is defined for walls and domes, stone material for column and arches, and wood material for braces. The properties of the materials are given in Table 1. In the model (Figure 5), column and arches from the bearing elements of the structure are defined as frames, and other bearing elements are defined as shells. 17332 nodes were used in the modeled structure. A total of 15057 shells were created. In the model, 359 fixed bearings are defined at the points transferred to the ground.

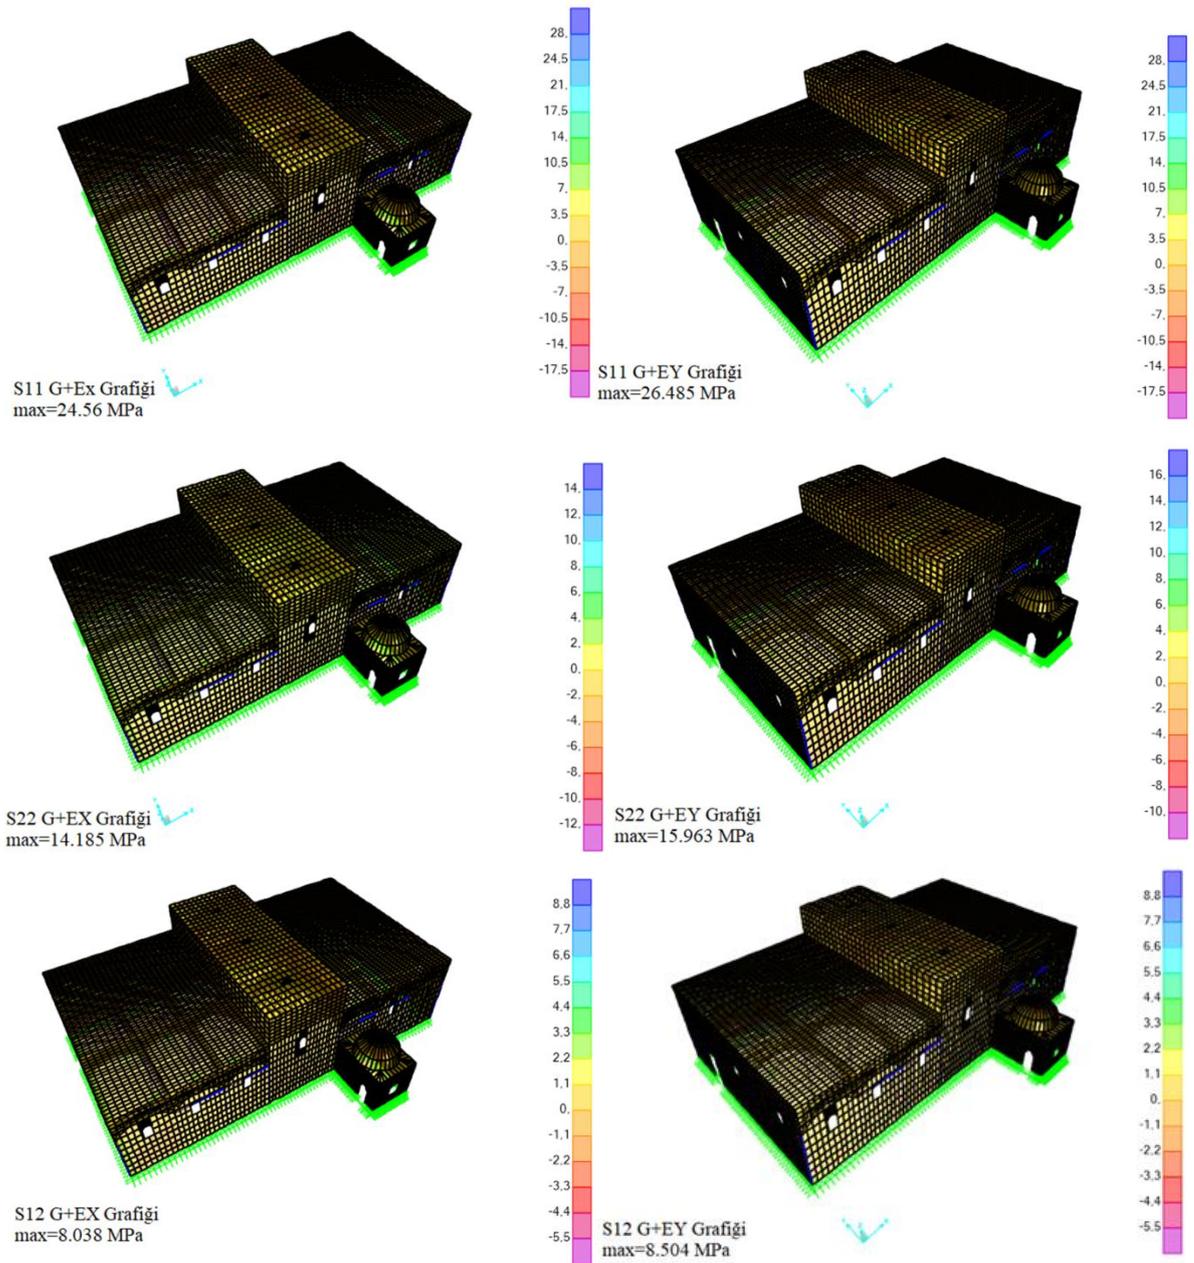
Figure 6. Stress distributions in load combinations for DBYBHY 2007

High stresses were obtained in the finite element model created using the SAP2000 program of the structure (Figure 6). These stresses exceeded the safety stresses calculated in the regulation. The 2007 earthquake regulation did not meet the boundary requirements.

- According to DBYBHY 2007, the investigations made using the safety stresses calculation method and the stresses obtained from the finite element model created using the SAP2000 program of the structure were compared. These stresses exceeded the safety stresses calculated in the regulation and did not meet the principles of DBYBHY 2007.

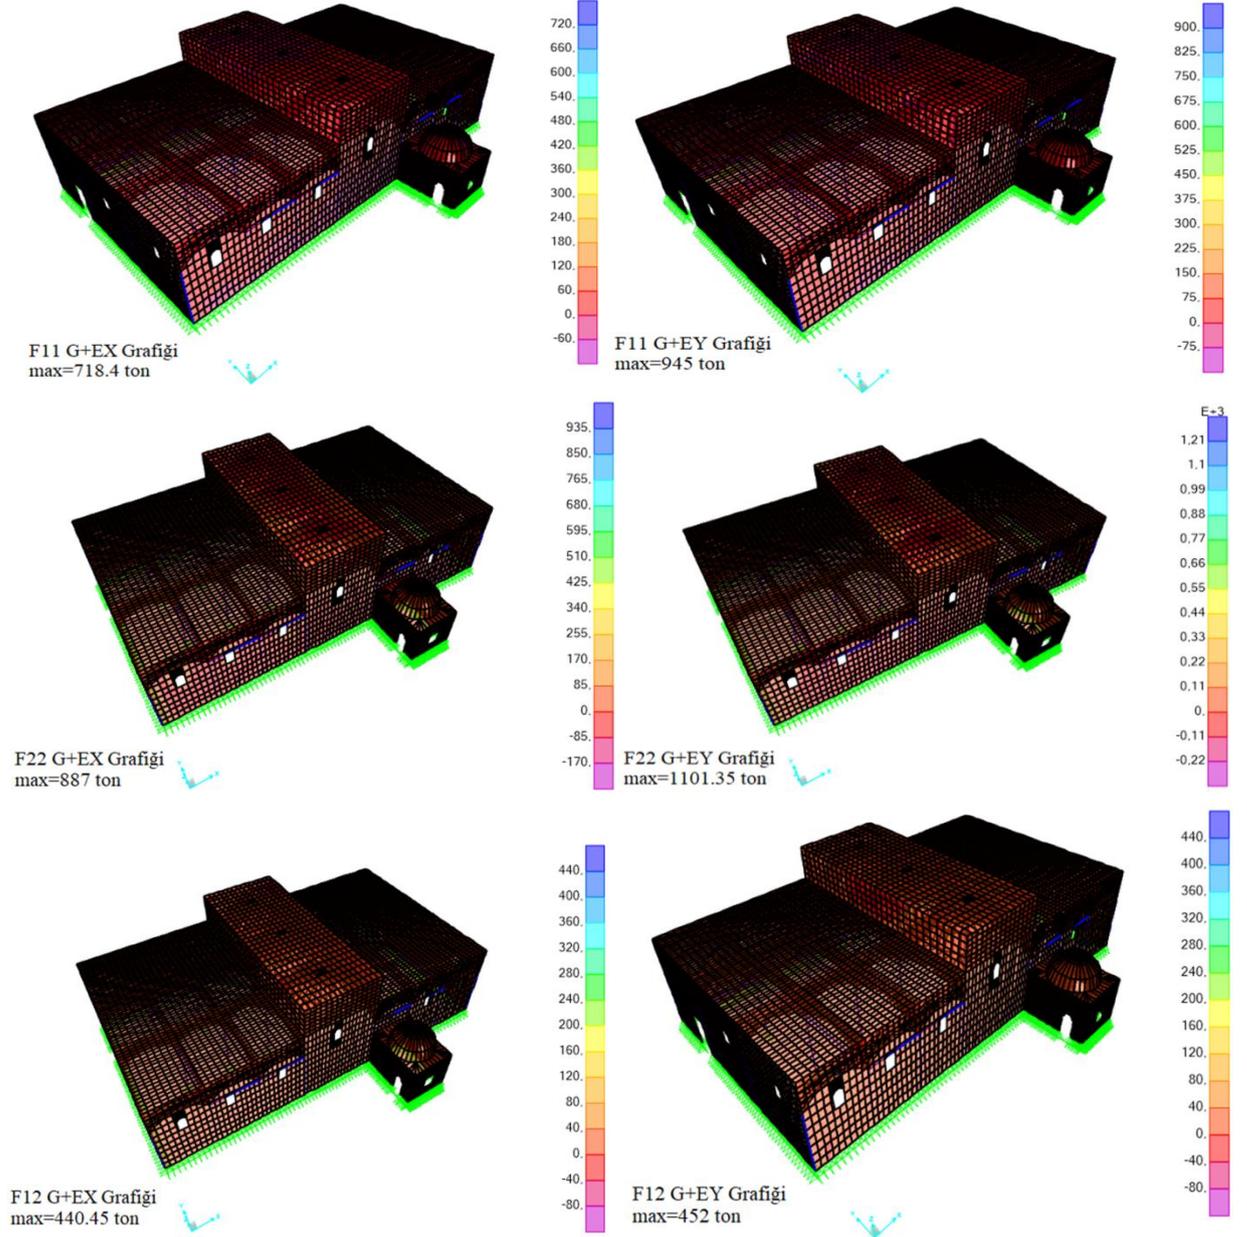
Figure 7. Force distributions in load combinations for TBDY 2018

From the calculations made according to TBDY 2018, the vertical load design strengths and design shear force strengths of the Historical İplikçi Mosque were obtained. As stated in the regulation, these calculated design strengths are above the design force and design shear force values (Table 4). This suggests that the accounts meet the principles of TBDY 2018. It was also observed that the forces obtained in the finite element model created using the SAP2000 program of the structure (Figure 7) did not exceed the forces calculated in the regulation.

- According to TBDY 2018, the investigations made using the bearing power calculation method and the forces obtained from the finite element model created using the SAP2000 program of the structure were compared. It was observed that these forces did not exceed the strengths calculated in the regulation and met the principles of TBDY 2018.

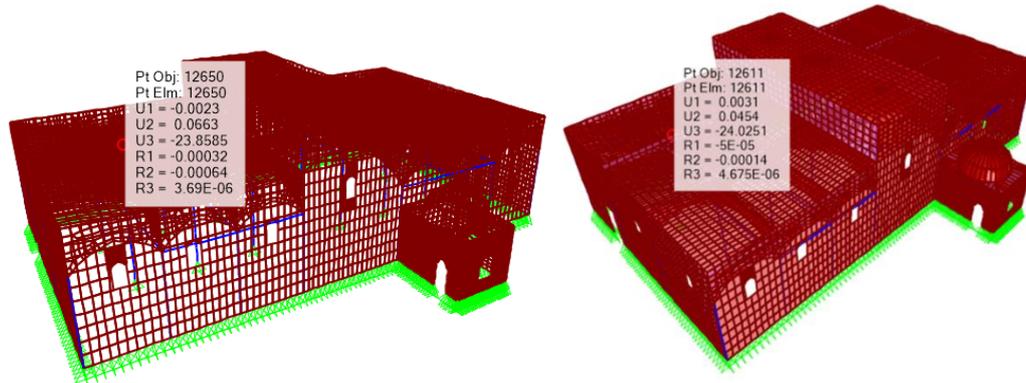
**Figure 8.** Maximum displacement under G loading (mm) for DBYBHY 2007 and TBDY 2018

In both regulations, both in the control of constant load (Figure 8) and in the displacement control according to combinations (Figure 9), the most displacement occurred in the upper floor (roof).

- In both regulations, it was seen that the most displacement occurred in the upper floor (roof) in both constant load control and displacement control according to combinations.
