JOURNAL OF ENGINEERING SCIENCES

Structural Behavior of Steel Bolted Connections having Different Types of Corrosion Damage

Yasin Duysak^a, Günnur Yavuz^b

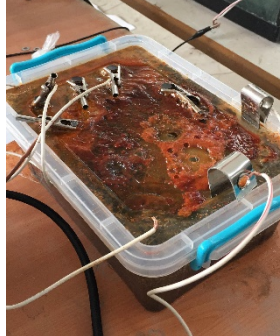
Figure 2. Appearance of bolts in solution

The accelerated corrosion formation test setup and the appearance of the bolts after they are placed in the solution are shown in Figure 2. In the second type of application, considering that corrosion causes mass loss in metals, artificial corrosion application was performed by mechanically reducing the bolt cross-section as shown in Figure 3. Corrosion damage on the bolts was applied so as to have 10% loss in mass.

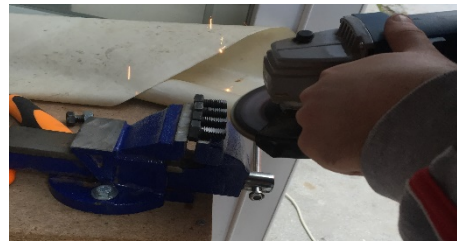
Figure 3. Artificial corrosion application

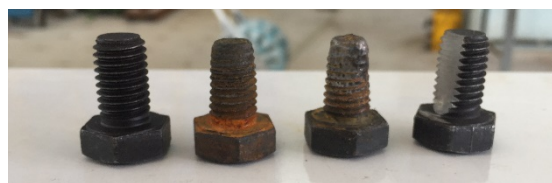
In the artificial corrosion application, after calculating the amount of weight to be corroded, the bolt masses were reduced by 10% (in the amount of 2 grams) with the help of a grinding machine so that the surfaces of the cut parts in the threaded shank part of the bolts were to be flat (Figure 4).

Figure 4. Accelerated and artificial corrosion of the bolts

A total of 8 test specimens were produced, two each the corrosion-free reference specimens and the test specimens with artificial and accelerated corrosion applied. The thickness of bolted joint plates made of S235 steel is 6 mm. Reference (corrosion-free), accelerated corroded and artificially corroded

bolt specimens are shown in Figure 4. Grade 8.8 M12 bolts were used in bolted connections.
