# Unfortunate Fate, A Lost History: The Complex of Grand Vizier Halil Hamid Paşa in Isparta

Sevil Derin<sup>1</sup>

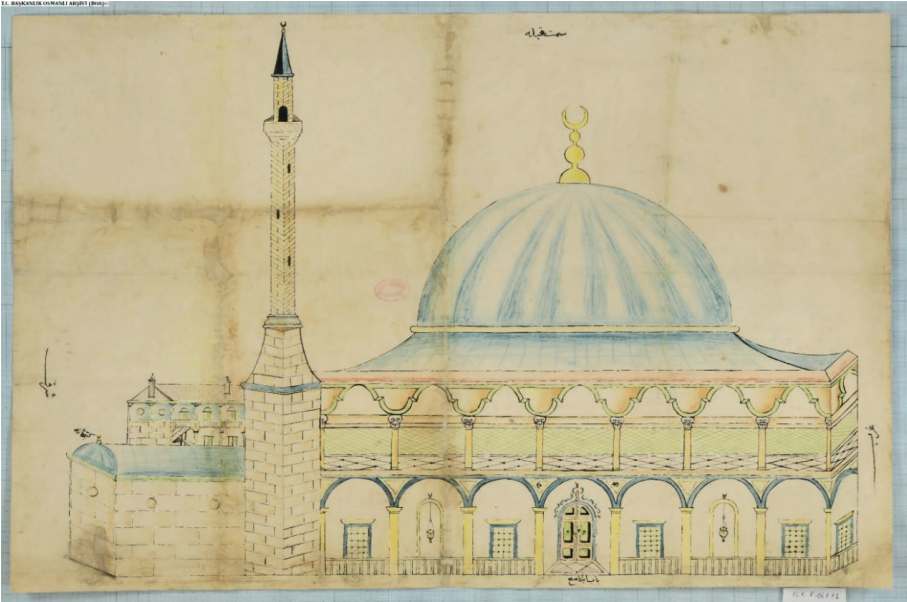
**Figure 2:** Drawing Indicating the Halil Hamid Pasha Mosque and Library.  
(BOA. PLK.p., 6771-1).

The drawings on the first three pages at the beginning of the document were made by the survey committee to determine the condition of the buildings at the time. The first drawing (F. 2) shows Abdi Pasha Mosque, which was extended by Halil Hamid Pasha and a library was added to the east. In the drawing, which has no scale, the mosque is depicted from the north façade, and perspective is used to show the west façade and the library. There is a minaret between the mosque and the library. The pulpit of the minaret is made of ashlar, and it is probably square. A wide transition segment on the pedestal that is narrow and curves upwards provides a transition to the angular body. The body is made of ashlar and formed

with a herringbone pattern. The upper part of minaret body is also made of stone and the spire is covered with lead. There is a two-storey porch on the north façade of the mosque, and it is covered with a lean-to roof. On the upper floor of the porch, the wooden portico array is supported by columns with ion imitation capitals. The arches of the portico have a curved appearance with concave and convex structures. On the ground floor, there is also a portico array, but its form is different from the upper floor. Columns with simple capitals connect eight round arches. The entrance of the building is in the center of the north façade. The door has a simple round-arched span and there are geometric decorations on the wooden wings. The elaborate “S” and “C” shaped decorative elements, probably made of plaster, over the span attract attention. There are two simple rectangular windows to the east and west of the door, a mihrab between these windows, and an oil lamp motif in the center of the mihrab niches. The mosque is covered with a lead-covered dome. Above the dome, there is a large gilded *alem* (end ornament). The library, which is on the east of the mosque and adjacent to it, is a small-scale building made of ashlar with a barrel vault.

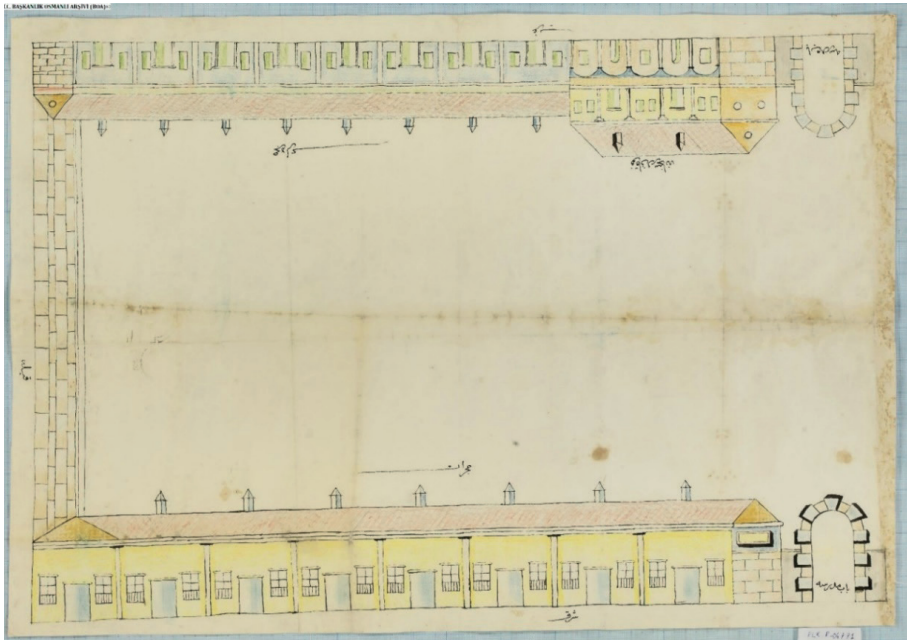
**Figure 3:** Drawing Indicating the Halil Hamid Pasha Madrasa Cells and Classroom. (BOA. PLK.p., 6771-2).

Document number two depicts a U-shaped complex with a courtyard where eight madrasa cells lined up on the east and west sides and are restricted by an ashlar wall on the south side (F. 3). At the northern end of the western cells is a two-storey building with a hipped roof labelled two-storey school (*fevkani dersane*). The building has similar features with the mosque in terms of façade arrangement. The cells of the madrasah are single-storey simple stone buildings with hipped roofs. The northern ends of the east and west sides of the “U” shaped courtyard are restricted by round-arched madrasah gates made of ashlar. No structure or wall is shown to border the courtyard from the north. However, since there are gates at both ends, there must be another structure limiting the madrasah courtyard.

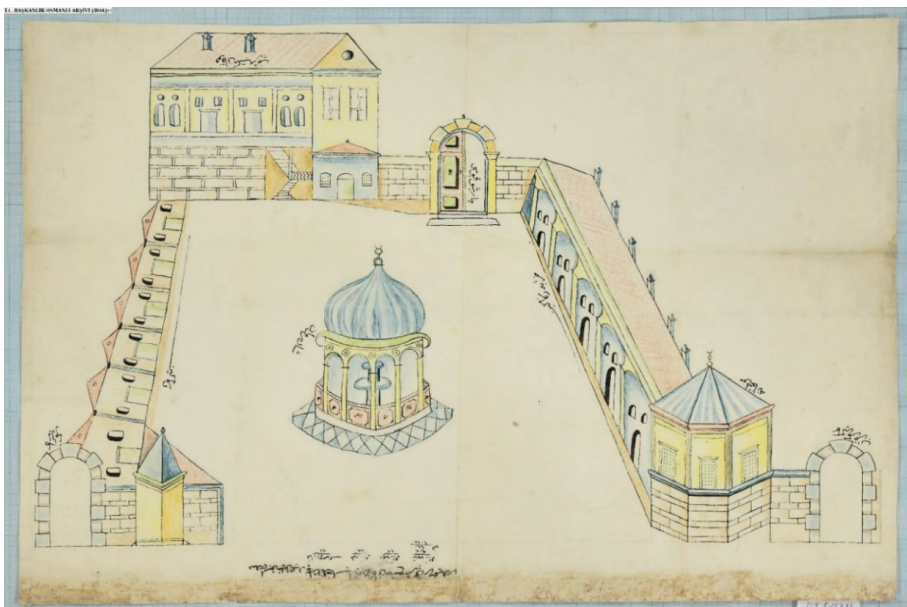
**Figure 4:** Drawing Indicating the Halil Hamid Pasha Shadirvan, Muwaqqithana, School, and Shops. (BOA. PLK.p., 6771-3).

Drawing number three (F. 4) shows shops along two long and opposing sides, in the center of which there is the two-storey school (*fevkani mektep*) on the short side. Next to two-storey school there is the gate of the bazaar with a round arch made of ashlar supported by small columns. These buildings surround the courtyard, and there is an elegant shadirvan in the center of the courtyard. Each unit of the shops on the right side is placed in a perpendicular position, while those on the left side are placed in a horizontal position. Thus, the front facades of the buildings are shown on both sides. In front of the shops on the right side, there is a warning that they are dilapidated. The shops are bounded on both sides by ashlar doors, which are stated to be bazaar doors, showing the same characteristics as the madrasah door in picture number two. There is also a statement saying that the door on the right wing is ruined. Muwaqqithana is located between the gate and the shops. Three front façades of the muwaqqithana, covered with a lead cone, are pictured. Opposite this, in the left corner between the gate and the shops, there is an unidentified structure resembling a tower. The shadirvan in the center of the courtyard is covered with an onion dome, and its two sides and five columns are pictured. The columns are combined with round-arches, and there is a floral motif on the corners of

the arches. There are taps on the corners corresponding to each column, and a water jet is visible under the dome. The shadirvan has an oriental appearance with its dome and concave curving eaves under the dome.

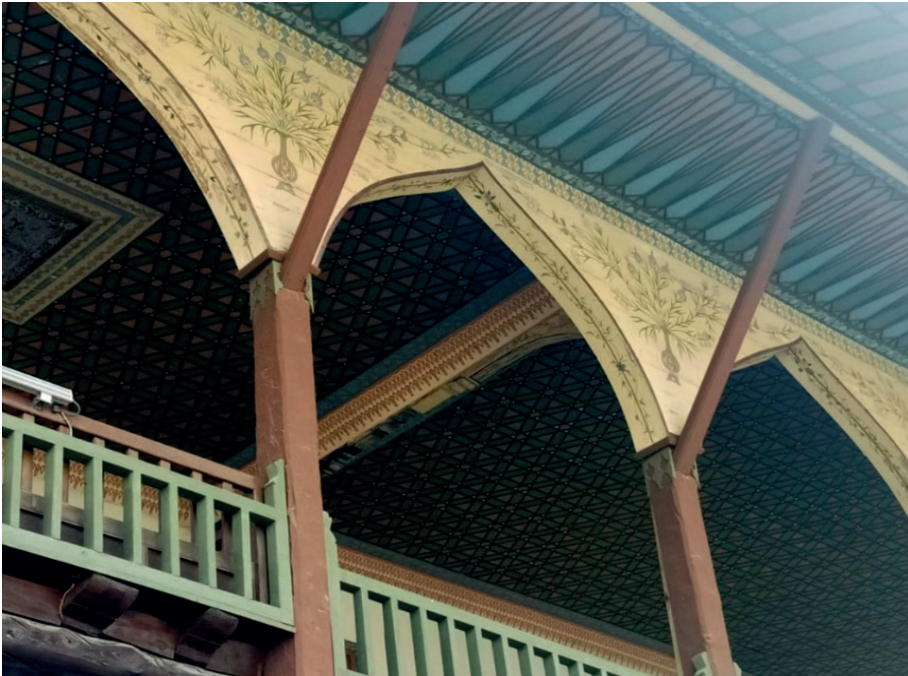
**Figure 6:** Detailed View of Baki Bey Mansion Decorations (S. Derin, 2022).

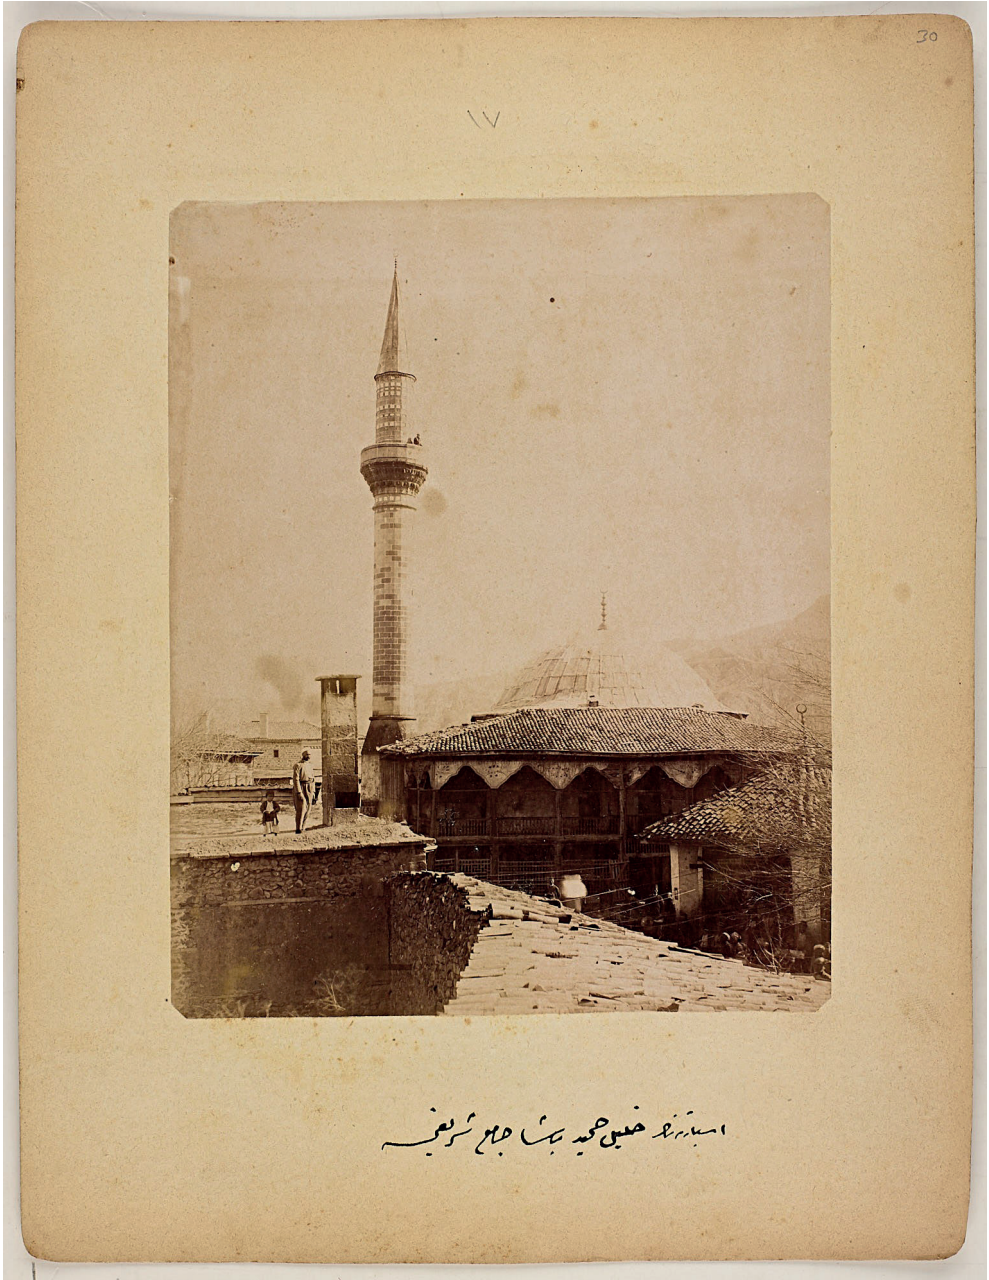
Figure 7: Photograph of the Halil Hamid Pasha Mosque in Isparta in the Early 20<sup>th</sup> Century.

43 In the photograph, it can be seen that the wide eaves around the dome are covered with tiles. However, in the sources mentioned earlier, it was seen that this area was covered with lead. It must have been covered with tiles during one of the later repairs.

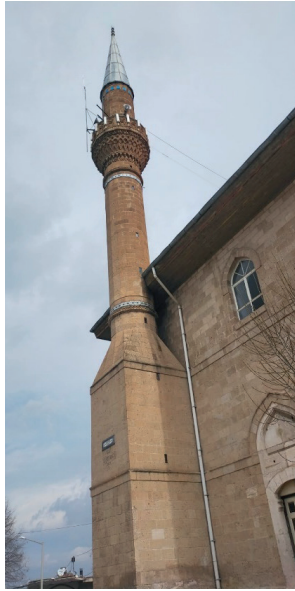
**Figure 8:** Minaret on the West Side of Burdur Ulu Mosque (S.Derin, 2022).

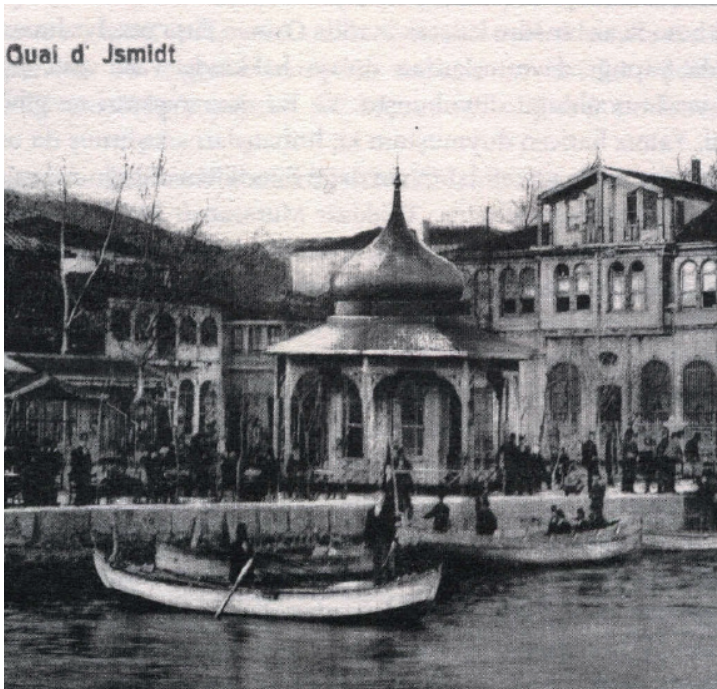
**Figure 9:** Square Shadirvan Built in Izmit in the 19<sup>th</sup> century That No Longer Exists (cited by A. Oral, Ş. Kaya, 2008).

Witnesses also declared the şadirvan in the drawings to be a monumental building. The şadirvan is in the orientalist style, which is similar to others built in the same period. The great<sup>57</sup> and small<sup>58</sup> şadirvan in Balıkesir (1898), which were repaired during the reign of Abdülhamid II, are similarly covered with a dome. A square fountain in Izmit, which is thought to have

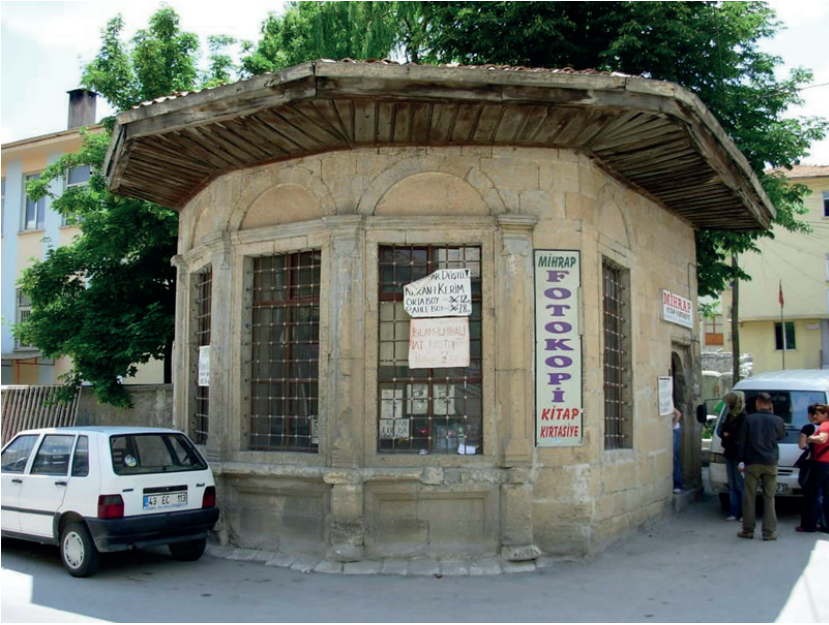
**Figure 10:** Muwaqqithana in Kütahya. (E. Z. Tomar, 2011).
