Determination of Road Functionality for Küçükçekmece District Following a Scenario Earthquake for Istanbul

Betül Ergün Konukcu^{1,*}, Himmet Karaman¹, Muhammed Şahin¹

¹ Istanbul Technical University, Faculty of Civil Engineering, Department of Geomatics Engineering, Istanbul, Turkey

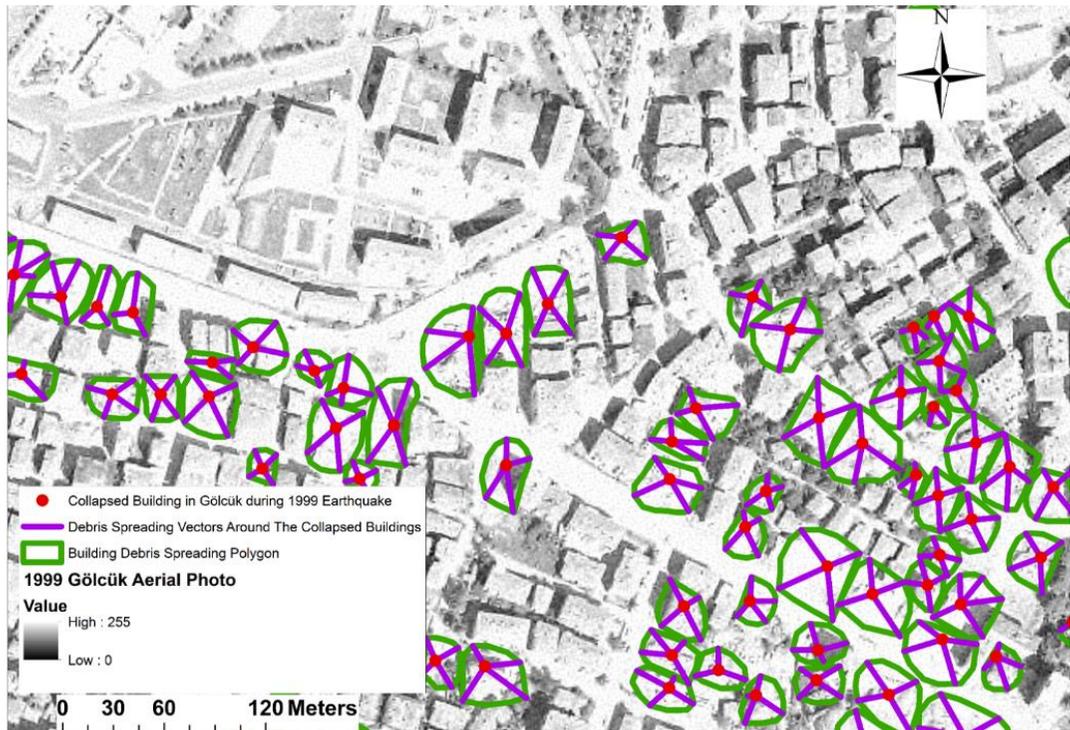
Fig 4. Building Collapse Directions in Gölçük

calculated by studied Gölçük collapsed building. 80 collapsed buildings were chosen in Gölçük. Debris spreading lines were drawn in all directions around the collapsed buildings in Gölçük. As a result 317 debris spreading e vector in every direction were obtained (Figure 4).

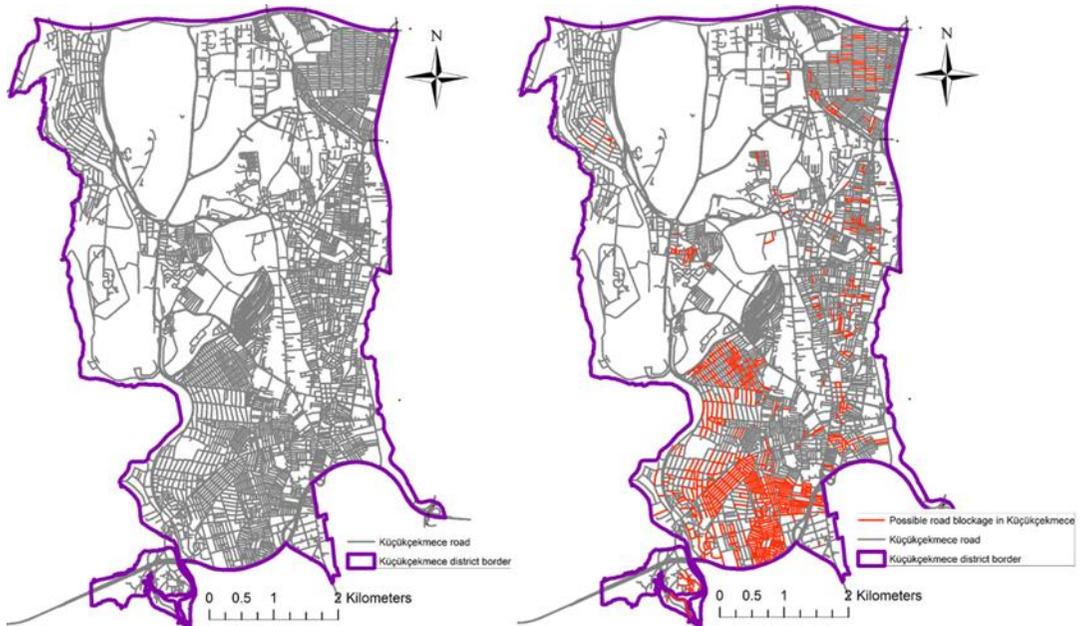
Fig 8. Road blockage in Küçükçekmece

Within the context of this study, it is accepted that potential collapsed building in Küçükmece could cause debris around it about 17.45 m that obtained from Gölcük collapsed buildings during the 1999 Kocaeli earthquake around it. Because of this debris, the road around the potential collapsed building could lose their functionality. The length of current road in Küçükçekmece is 714743 meters. Because of the debris, 91787 meters road lose their functionality (Figure 8).
