Kırıkkale’de Bulunan Hasan Ali Yücel İlkokulu’na Uygulanan Güçlendirme Yönteminin Analizi

Analysis Of Building Reinforcement Method For Hasan Ali Yücel Elementary School In Kırıkkale

In this study, the building reinforcement provided for Hasan Ali Yücel Elementary School located at Kırıkkale province has been analyzed. The aim is to examine the current status of the school and the work carried out, and to minimize the impact on the architecture of the building and the users. As a result of the study, it has been seen that cast-in-place curtain wall application has been selected for the reinforcement of the school. The building has 4 cast-in-place curtain wall applications, 2 30x200 and 2 30x400 cm. The application has been repeated on all floors in the same number and in the same place. Furthermore, wet floors and corridors, floor coverings, ceiling and wall paints have been renewed.

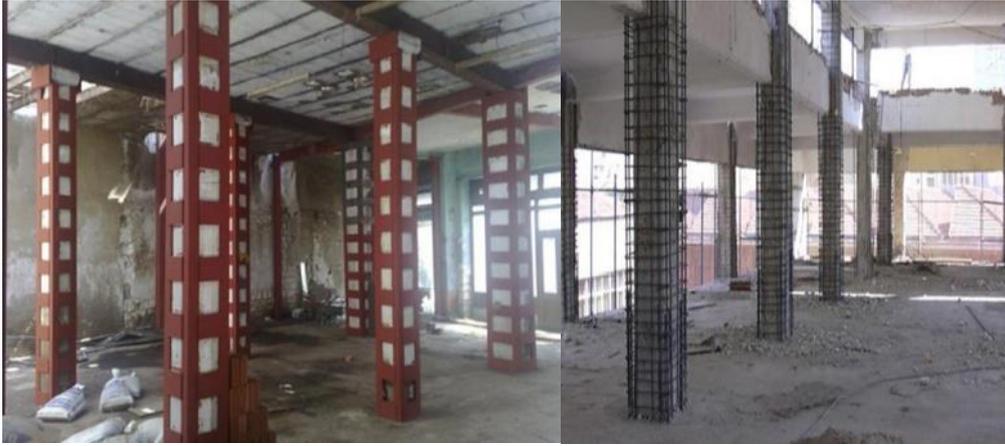
Figure 2. Reinforcement of Columns

Columns need to be reinforced so that the damaged column can resist possible loads and increase its load carrying capacity (Ayaz, 2020). An example of column reinforcement is given in Figure 2.

Columns are reinforced as follows;

- With steel caging
- With sheathing
- By coating with fibrous polymer
- By adding wings.

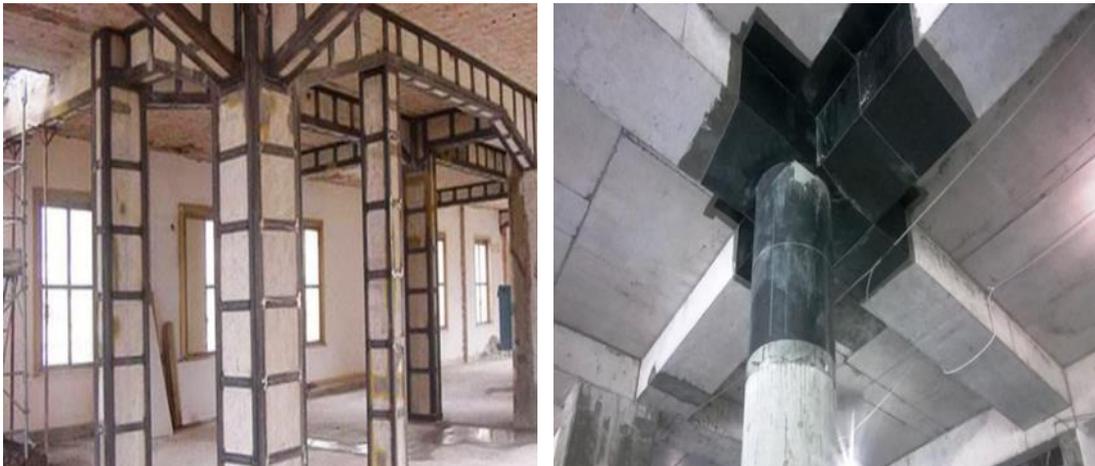
Figure 3. Reinforcement of beams

Another reinforced structural element is the beams. Reinforcement of reinforced concrete beams are conducted as follows (Figure 3);

- Reinforcement of beams by coating them with steel plates,
- Reinforcement of beams with sheathing,
- By coating with fibrous polymer.

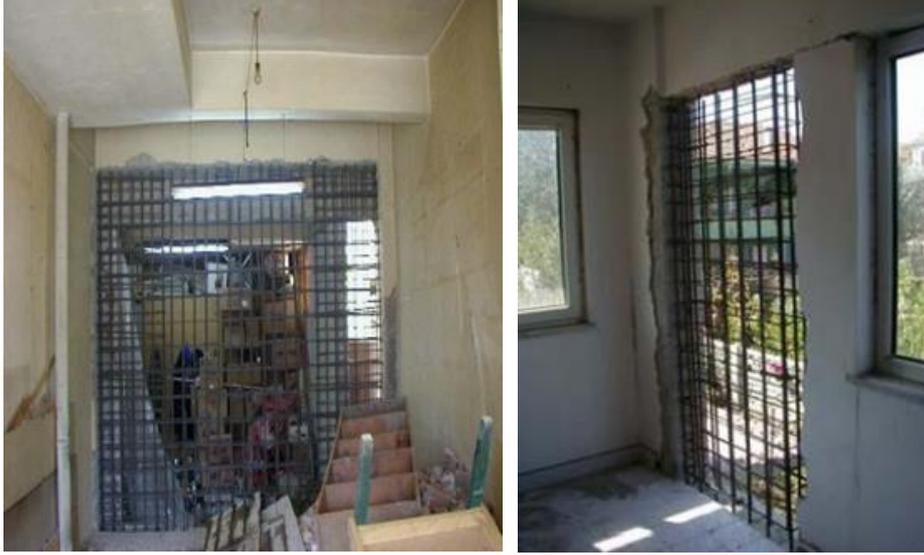
Figure 6. Reinforcement of reinforced concrete frames with cast-in-place curtain walls

This method, which is used in cases where the rigidity and strength of the structural system is not sufficient, is the most widely used method due to its low cost and wide usage area. The biggest disadvantage of the method is that the curtain wall must be constructed along the entire wall (Figure 6) (Gündüz, 2019).

Reinforcement of reinforced concrete frames with cast-in-place curtain walls is applied as follows;

- By adding reinforced concrete curtain wall inside the frame plane
- By adding reinforced concrete wall adjacent to the frame plane.
