Exploring structural deterioration at historical buildings with UAV photogrammetry

Germus Church
UAV
Photogrammetry
3D modelling
Digital documentation

Research Article

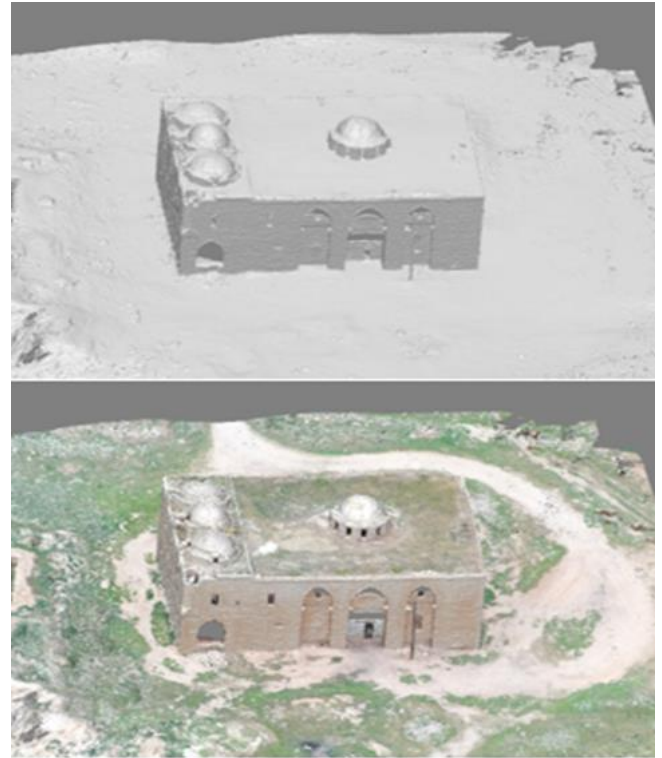
7,800,413 points. The colorless and colored form of the generated point cloud is given Figure 4.

Figure 4. The generated point cloud

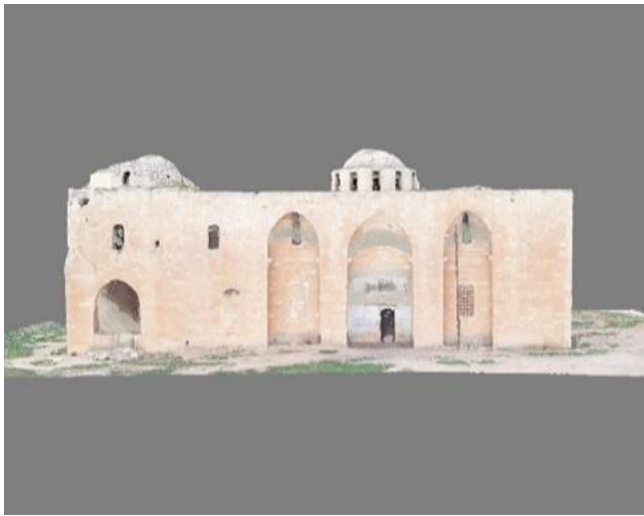
Figure 6. Colored 3D solid model of Germus Church

When evaluating the generated 3D model and the fieldwork, it is clearly visible that the domes of the historical church have collapsed and the side facades have suffered damage. The deformed parts of the historical church are indicated on the 3D model.

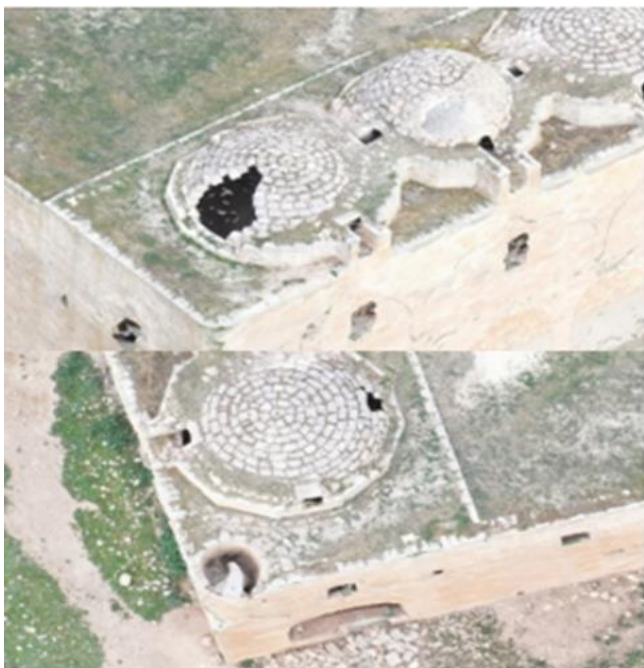
The damaged domes made of knitted stone pose a high risk due to falling stones. Figure 7 shows extensive damage to the dome, completely opening it up and causing stones to fall. The unstable structure increases the danger, as each dislodged stone increases the chance of further collapse. Urgent action is needed to stabilize the remaining sections, ensure safety, and restore the domes to their former glory.

Figure 7. The deformed dome.

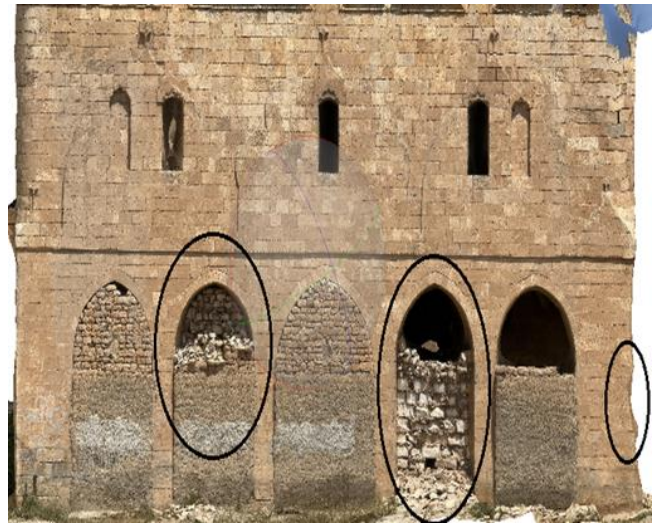
The building's exterior walls exhibit significant wear, a result of aging, decay, and human-induced damage. Over time, the elements have taken a toll, causing cracks

and faded paint. Additionally, poorly constructed masonry walls and graffiti further mar the surfaces. Figure 8 highlights some of these damages, emphasizing the need for restoration and preservation efforts.

Figure 8. The deformed walls

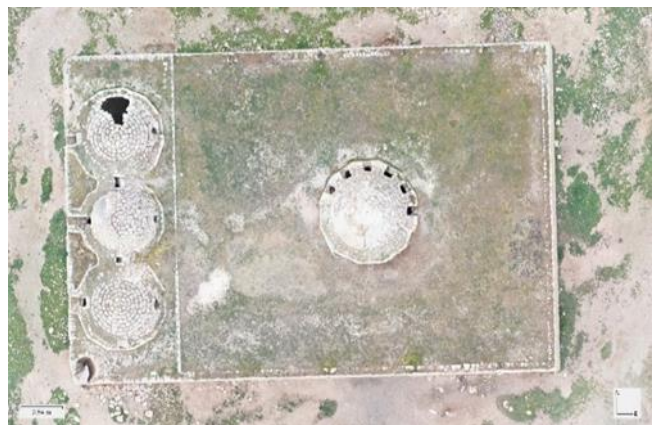
The presence of grass and weed plants on the building's roof, as shown in Figure 9 is a cause for concern alongside the structural damage. The accumulation of soil can lead to long-term structural issues. Over time, the roots of the plants can penetrate the roof's surface, compromising its integrity and creating pathways for water infiltration. The weight of the soil and vegetation can also strain the supporting elements, increasing the risk of collapse. To address these risks, regular maintenance and cleaning are necessary to remove the soil and vegetation, while implementing drainage systems and reinforcing the roof structure can help mitigate the effects of moisture and soil accumulation.

Figure 9. Soil accumulation and grass on the roof of the church

The accumulation of soil and growth of grass and weed plants on the building's roof pose potential risks. The roots can compromise the structure and lead to water infiltration, while the added weight can strain the supporting elements. Proper maintenance, including regular cleaning and drainage systems, along with reinforcing the roof structure, can help mitigate these risks and preserve the building's structural integrity.
