Verifying reports of collapsed buildings from twitter aftermaths of earthquakes: A case study from Turkey

Şeker, A. (2023). Verifying reports of collapsed buildings from twitter aftermaths of earthquakes: A case study from Turkey. *Turkey Geographic Information Systems Journal*, 5(2),77-84

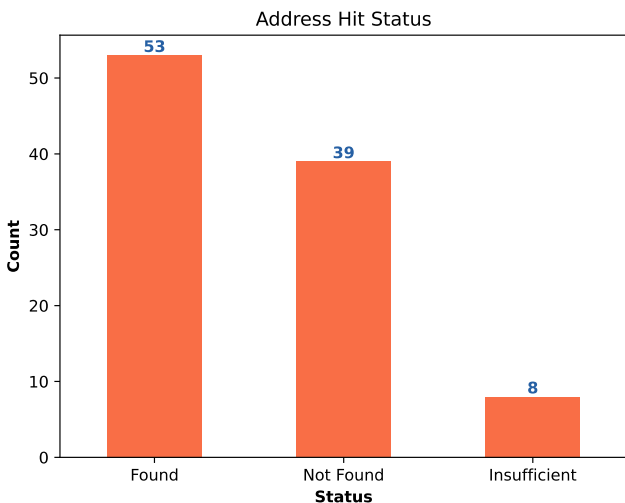
Figure 3. The reported address hit status from related text.

The address statistics for the first 100 reports of collapsed buildings are presented in Figure 3.

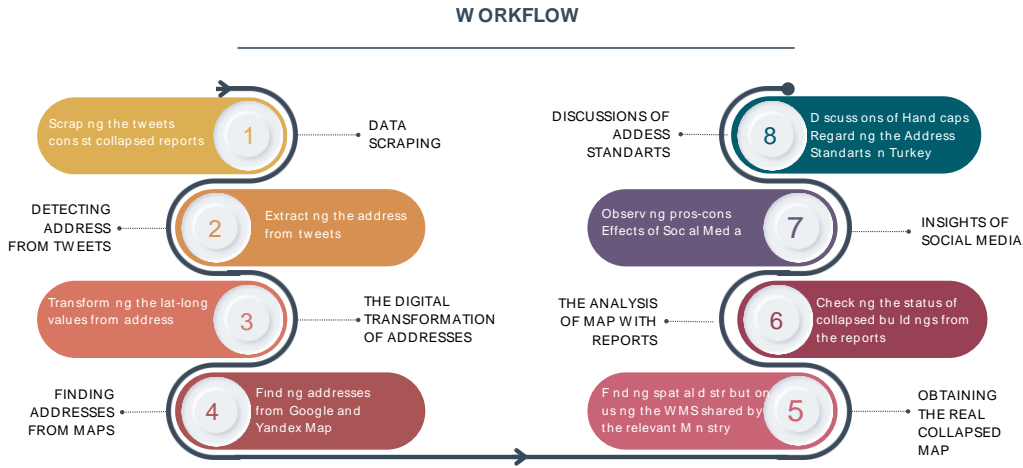
Figure 4. The workflow of the study

The general workflow followed in the study is illustrated in Figure 4.

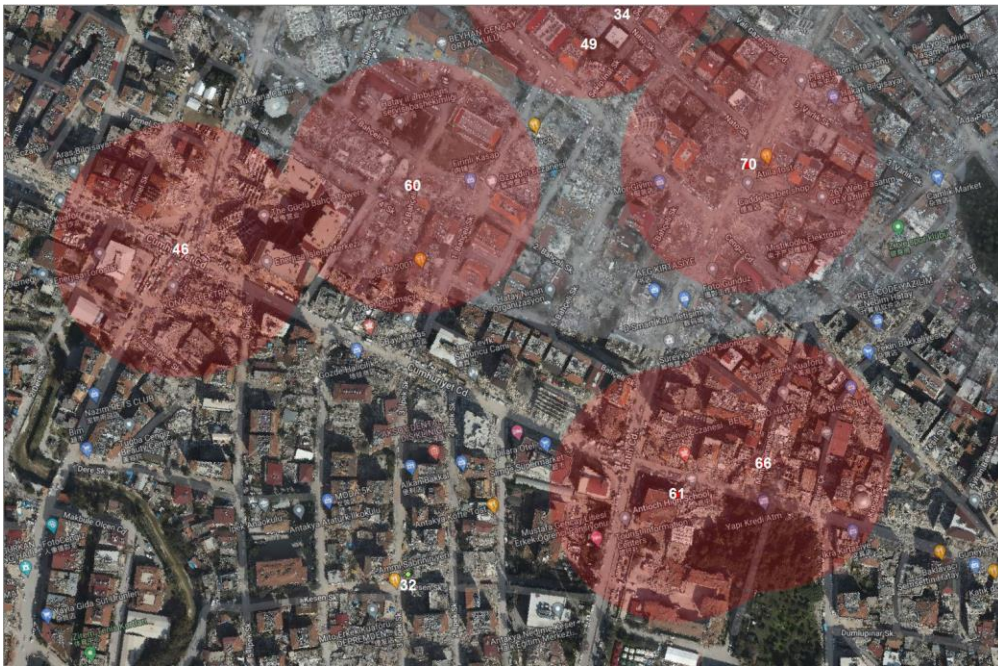
Figure 7. The annotated visual of post-earthquake map reports (from Hatay city center)

For example, as seen in Figure 7, it was determined that the structure in the 32nd address had collapsed. In the regions marked as "insufficient" (highlighted in red) in the 34th, 46th, 60th, 61st, 66th, and 70th reported addresses, a significant number of debris can be observed.

Moreover in Figure 7, as seen in the 49th and 34th reported addresses, some reports indicate close or overlapping areas. In this context, common marked areas can be observed in the provided images.

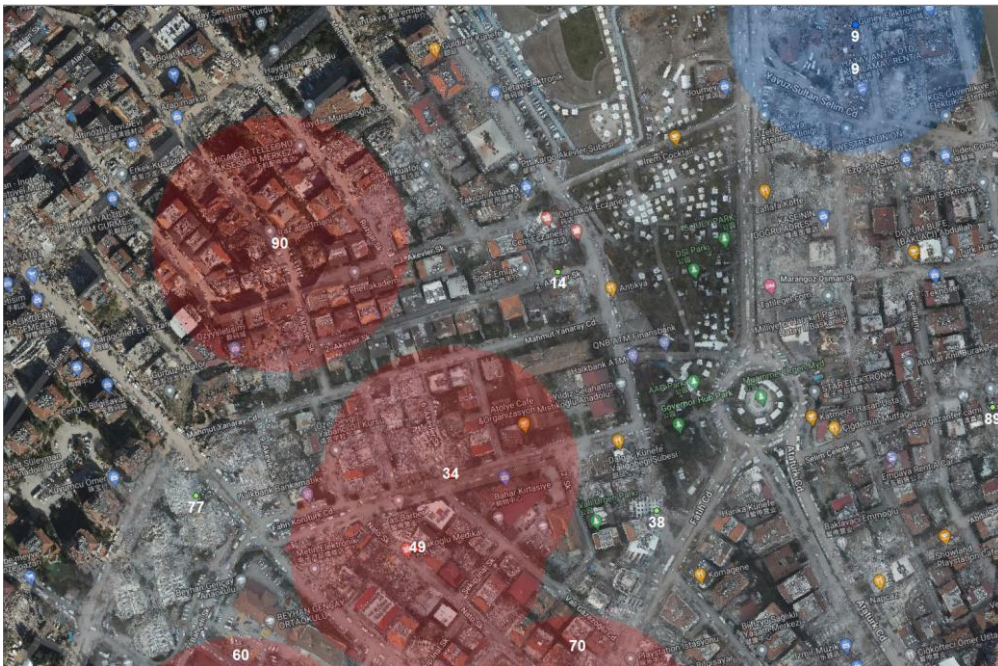
Figure 8. The annotated visual of post-earthquake map reports - 2 (from Hatay city center)

In Figure 8, it can be observed that the buildings in the addresses 14, 38, 77, and 89 have collapsed. The 9th reported address, provided as "kışlasaray 1 hatay," was marked as insufficient, and the corresponding area within a 100-meter radius (highlighted in blue) centered around the general region was shown. Again, destruction can be seen in that area.
