Evaluation of the Accessibility of the Disabled in Urban Areas on the Sample of the National Library

3.DISABLED ACCESS TO LIBRARIES FROM URBAN SPACE: THE EXAMPLE OF THE NATIONAL LIBRARY

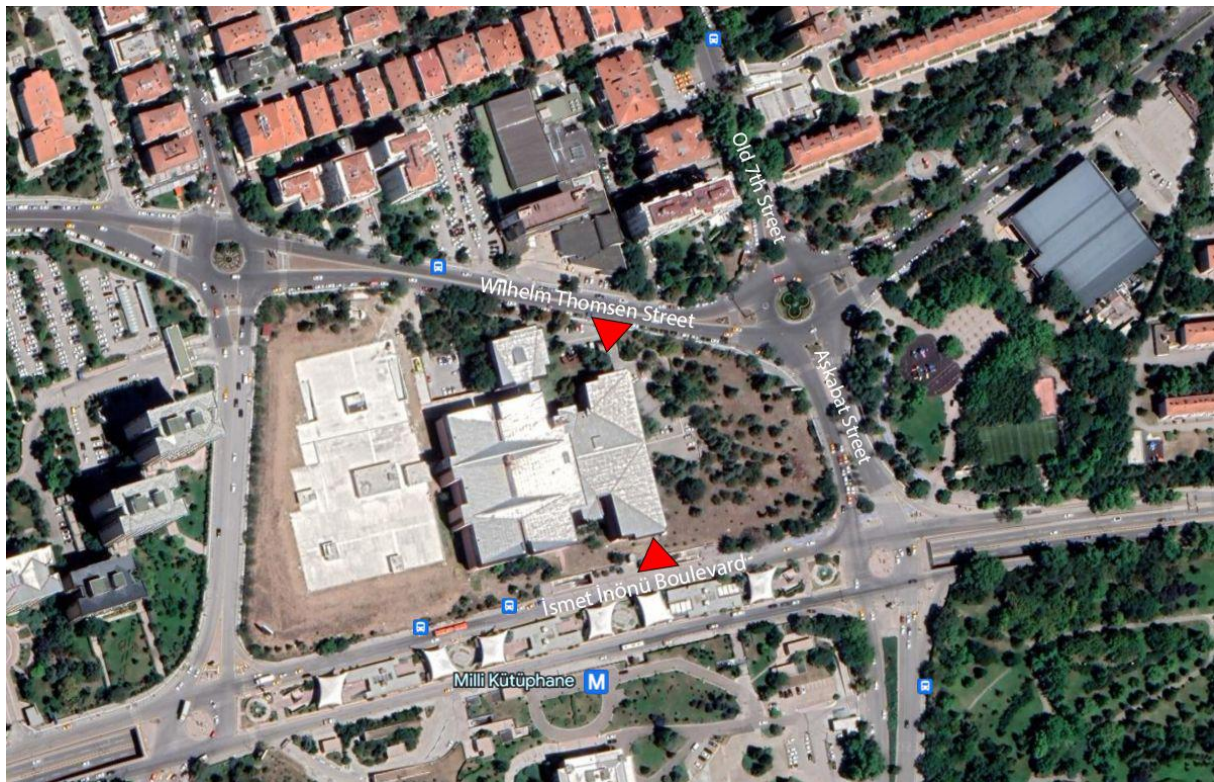
Figure 2. The relationship of the National Library with public transport stops

The National Library is located in Bahçelievler, in the area between Wilhelm Thomsen, Aşkabat, Hakkı Turaylıc Avenues and İsmet İnönü Boulevard. There are two bus stops and a metro stop in the immediate vicinity. Wilhelm Thomsen Street, Aşkabat Street and İsmet İnönü Boulevards are used extensively to access the library building. Therefore, the study focused on these three avenues. The building has two garden entrances on Wilhelm Thomsen Street and İsmet İnönü Boulevard (Fig 2).

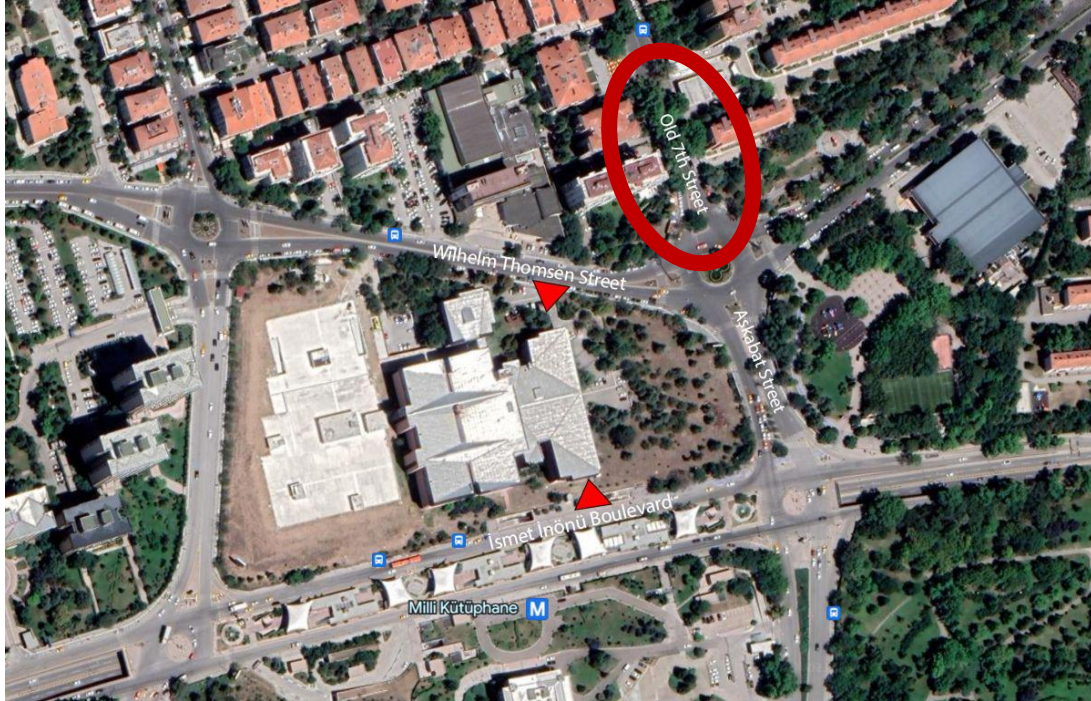
Figure 3. Road relationship between the National Library and the stop on Old 7th Street

The main garden entrance with vehicular and pedestrian access to the national library is located on Wilhelm Thomsen Street. The nearest bus stop to this entrance is on the route of Aşkabat Street known as Old 7th Street (Fig 3). Since the cafes and shops on this street are located in the other direction of the stop, pedestrian traffic in the direction of the National Library can be described as low density.

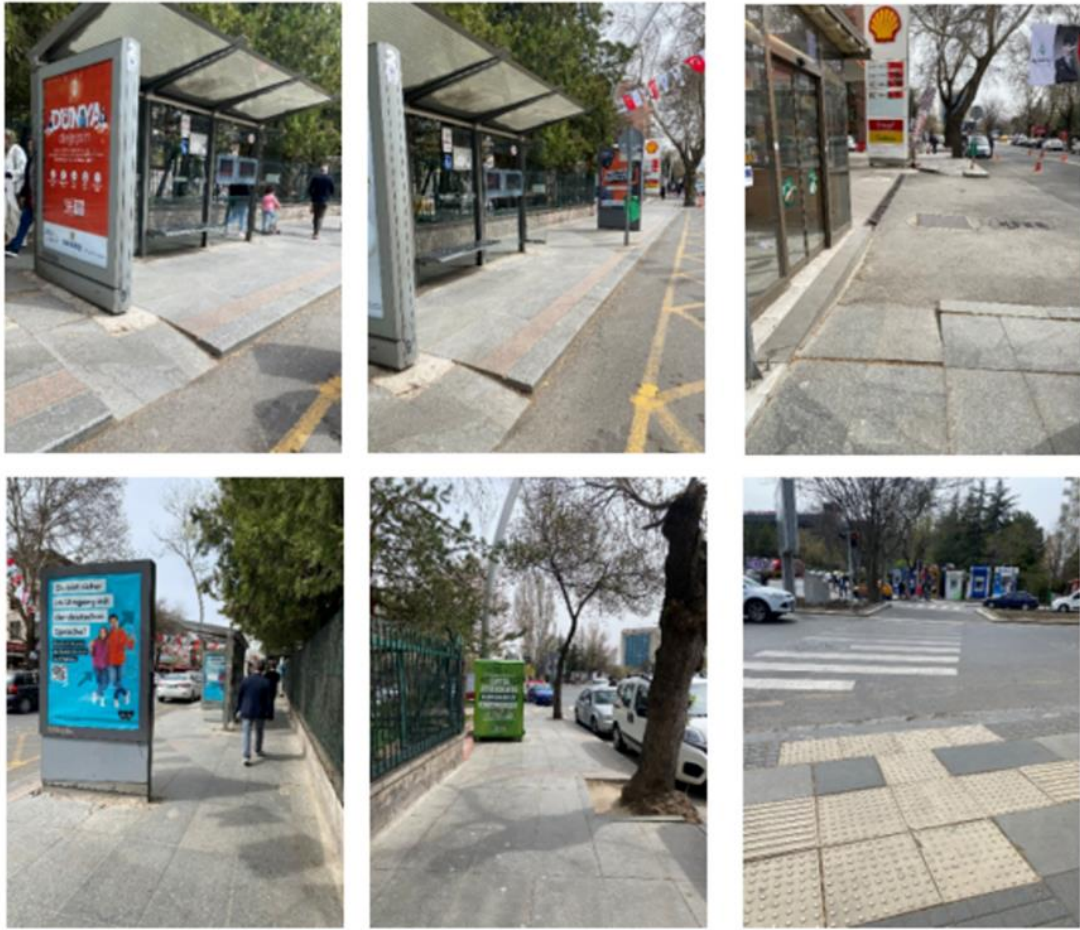
Figure 4. Stalls and sidewalks on Old 7th Street

The width of the pavement from the stop on the old 7th Street to Wilhelm Thomsen street is 350 cm and meets the minimum 200 cm measurement required for a pavement with low density. The height of the pavement from the road is measured as maximum 15 cm and it is in the appropriate standard. It is forbidden to park vehicles on the sidewalks and it was observed that no vehicles were parked in these parts during the periods examined within the scope of the study. There are no bulletin boards on the corners that block the view. There is a billboard, a clothes box and trees on the pavement. However, the width of the pavement where the boards are located is 185 cm, and the width of the pavement at the place where the clothes piggy bank is located is 200 cm. The trees are enclosed in a 120x150 cm frame and there is a distance of 240 cm from the garden wall. In this case, it has been observed that even if there are elements on the pavement, the disabled individuals do not restrict their passage. Since the manhole covers on the sidewalk are at the same level with the floor, they do not constitute an obstacle for the wheelchair. Rainwater grates are positioned on the vehicle road. The pavement is made of non-slip material and is suitable for wheelchair movement. The difference in elevation between the pavement and the property border was eliminated with a garden wall and railing. There are curbstones in different colors so that the road can be noticed on the sidewalk. However, the walking strip, which was glued to the floor for the visually impaired to find their way, was dismantled in most places and its continuity was broken. The lines at the pedestrian crossing are fixed, visible and permanent in accordance with the standards. Therefore, visually impaired people crossing the road can distinguish between the road and the pavement. Opposite ramps that provide transitions between pavements are suitable in terms of width (100 cm) and slope (7-8%). There is no problem in the beginning and end of the ramps. The ramp cannot be used due to the fact that the stop on the 7th Street was later placed on the disabled ramp. Instead, it is possible for those getting off the bus to walk along the sidewalk in the direction of the library. There are audible signals for the visually impaired at the illuminated pedestrian crossings for crossing. There are also sufficient lighting elements for night vision (Fig 4).

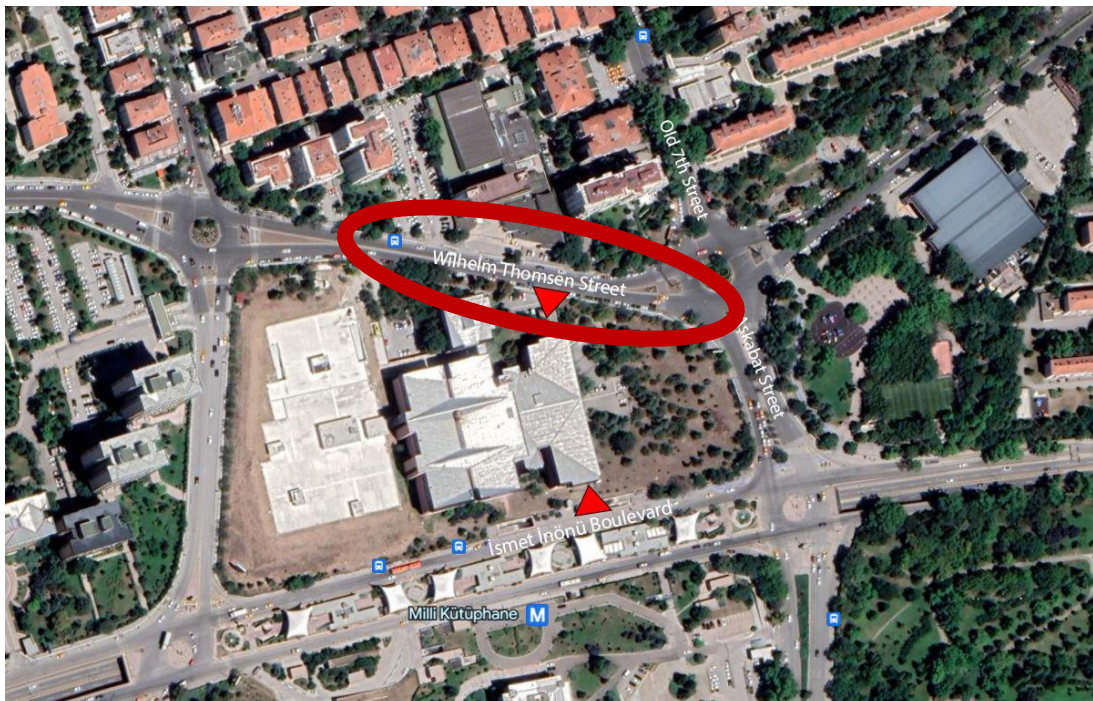
Figure 5. National Library and Wilhelm Thomsen Street

Wilhelm Thomsen Street, which is the main garden entrance to the north of the National Library, has low pedestrian traffic on the National Library side (Fig 5).

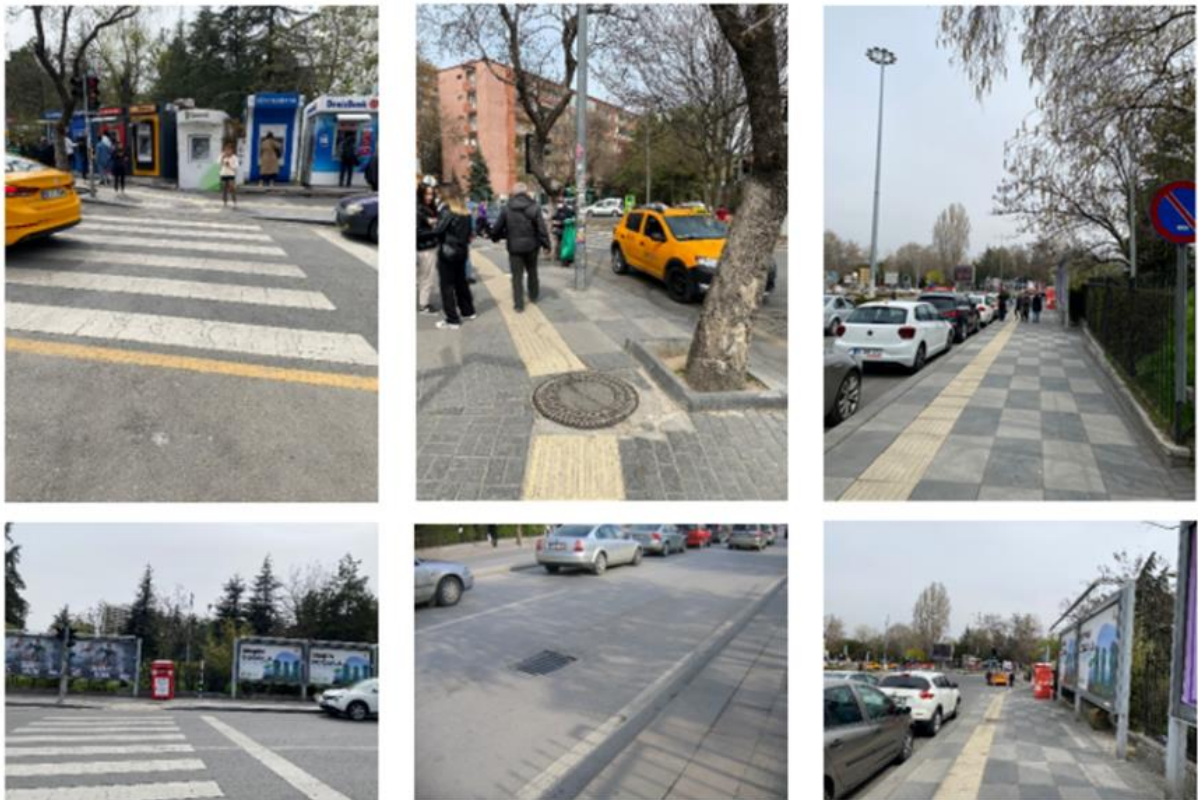
Figure 6. Wilhelm Thomsen Street

When the section of Wilhelm Thomsen Street between the National Library entrance and 7th Street is examined, the following conclusions are reached: The pavement on the street has a width of 380 cm and the min. required for a low-density pavement. It meets the 150 cm requirement. The difference between the pavement curbstone and the road level, which should be 15 cm according to the standards, is appropriate on this street. Parking on the sidewalks is prohibited and there are no cars on the sidewalks. There are no bulletin boards on the corners that block the view. Along the sidewalk, there are no trees, signboards or boards that will pose an obstacle for wheelchair users or pose a danger to the visually impaired. The clothes piggy bank and billboards on the road are located on the side of the pavement and the remaining distance (270 cm) does not constitute an obstacle for the disabled passage. There is no rainwater grid on the pavement. The rainwater grid is on the road. The manhole covers on the pavement are at the same level with the ground. The pavement is made of non-slip material and is suitable for wheelchair movement. The difference in elevation between the pavement and the property border was eliminated with a garden wall and railing. The walking lane attached to the floor is suitable and continuous for the visually impaired to find their way. However, there is no curbstone application of different colors that needs to be done in order for the road to be noticed at the side of the pavement. The lines at the pedestrian crossing are fixed, visible and permanent in accordance with the standards. Therefore, visually impaired people crossing the road can distinguish between the road and the pavement. Opposite ramps that provide transitions between pavements are suitable in terms of width (100 cm) and slope (7-8%). There is no problem in the beginning and end of the ramps. There is an illuminated pedestrian crossing about 30 meters from the garden entrance of the National Library. There are audible signals for the visually impaired at the illuminated pedestrian crossings for crossing. However, it is not working properly. For night vision, it has been evaluated that the environment is perceptible in observations made at night. In this direction, it can be said that there are sufficient lighting elements (Fig 6).

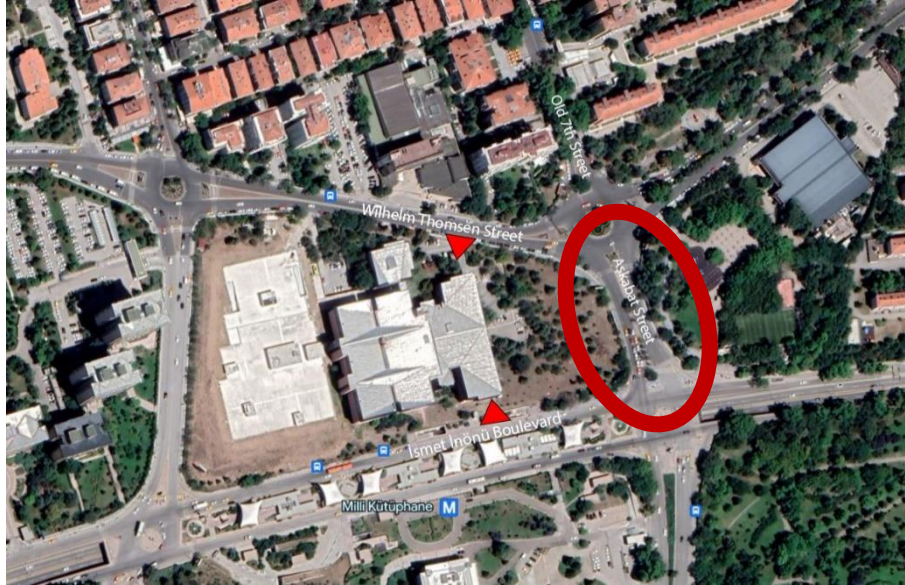
Figure 7. The relationship between the National Library and Aşkabat Street

Wilhelm Thomsen Street is connected to İsmet İnönü Boulevard by Aşkabat Street (Fig 7).

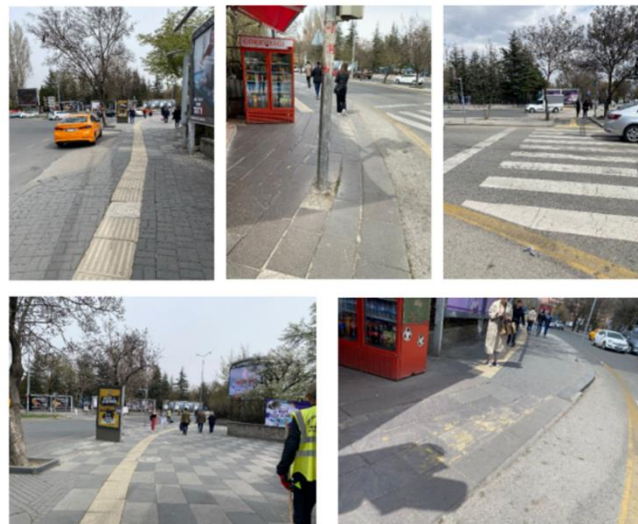
Figure 8. Aşkabat Street

When the pavement of Aşkabat Street on the side of the National Library is examined, the following observations were made: The width of the pavement on Aşkabat Street varies between 230 and 360 cm. The remaining distance for pedestrians from the billboards on the sidewalks has been measured as 260 cm. The distance between the narrowest place, which is at the intersection of the street with İnönü Boulevard, and the traffic light in front of it, is 120 cm. It is suitable for wheelchair access. The difference between the pavement height and the road level is 15 cm, which complies with the standards. There are no cars parked on the pavement. The pavement is made of non-slip material and there is no obstacle manhole cover on it. There is a garden wall separating the pavement and the garden of the National Library. There is no curbstone application on this pavement, which should be made in a different color so that the pedestrians can easily perceive the road and the sidewalk. The walking lane attached to the floor is suitable and continuous for the visually impaired to find their way. The lines at the crosswalk are fixed, visible and permanent. However, on one side of the opposite sidewalk, the disabled ramp and pedestrian crossing lines do not coincide. This situation does not constitute an obstacle for the wheelchair, but it can be misleading for the visually impaired following the pedestrian crossing lines. Opposite ramps that provide transitions between pavements are suitable in terms of width (200-220 cm) and slope (7-8%). There is no problem in the beginning and end of the ramps. There are audible signals for the visually impaired at the illuminated pedestrian crossings. There are sufficient lighting elements for night vision (Fig 8).

- In some of the pedestrian crossings with refuge (Aşkabat Street and İsmet İnönü Boulevard), it should be rearranged for the visually impaired as the flooring does not have a separate material texture from the vehicle road.

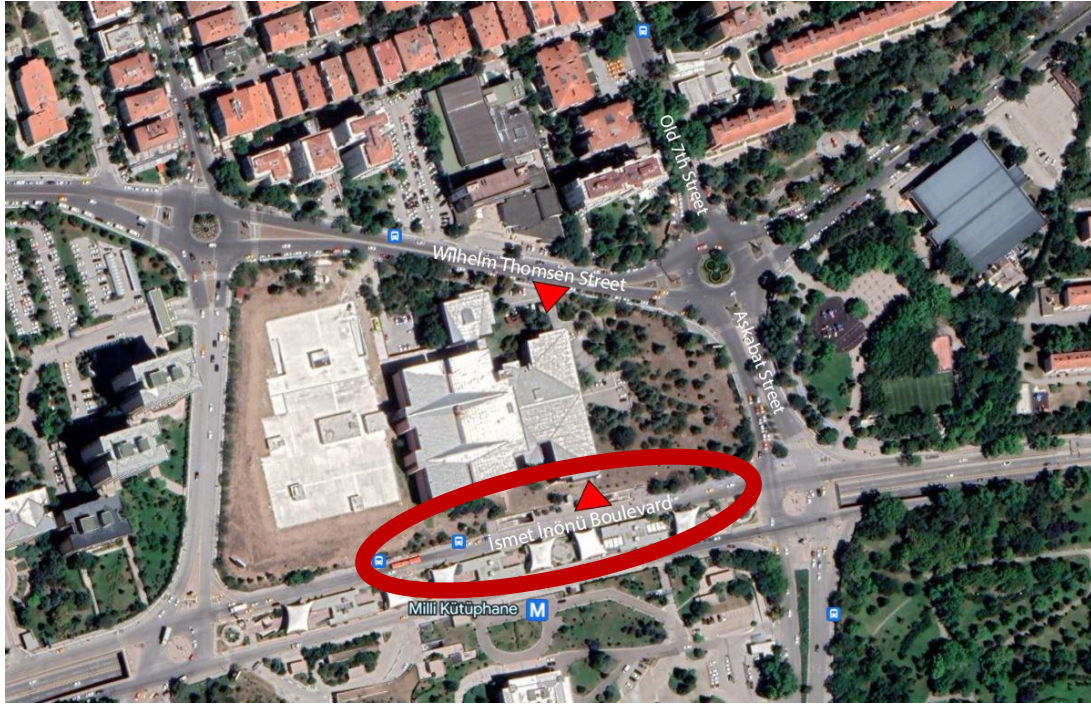
Figure 9. The relationship between the National Library and İsmet İnönü Boulevard

There is a subway exit on the sidewalk of İsmet İnönü Boulevard on the library side, and the second garden entrance of the library is located right next to it (Fig 9). Therefore, it is used extensively by those who come to the library.

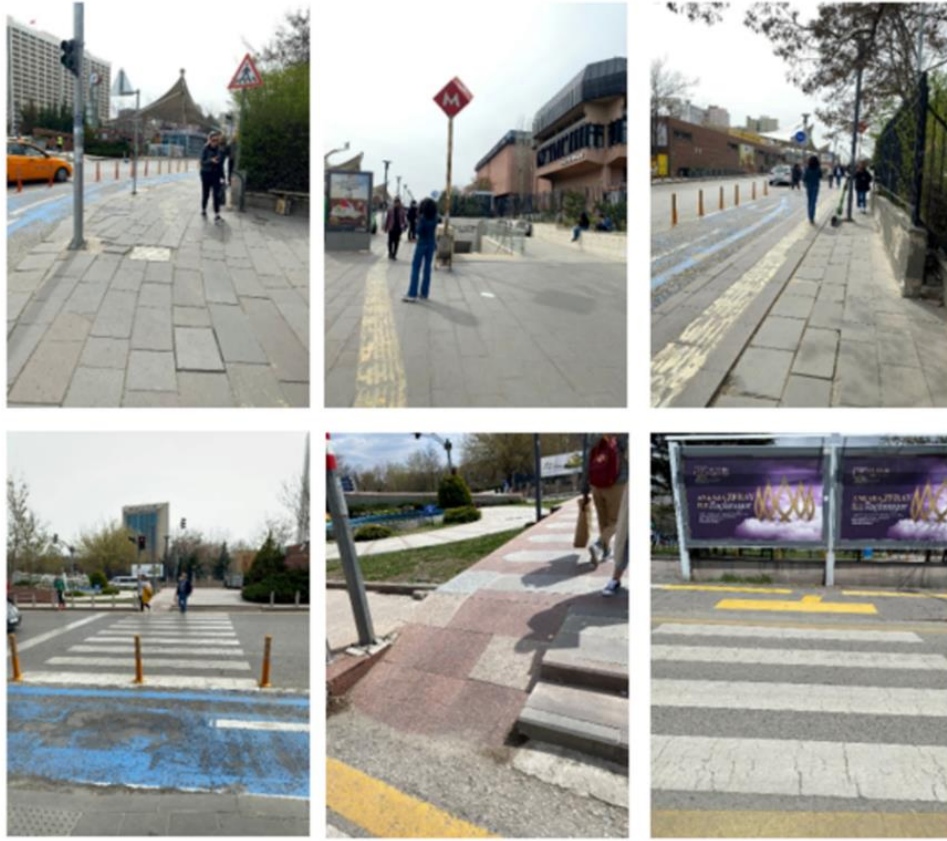
Figure 10. İsmet İnönü Boulevard

The minimum width remaining after the billboards on İsmet İnönü Boulevard is 230 cm. In other parts, the width of the pavement was measured as standard 310 cm. There is a billboard right next to the subway exit. However, since the distance is measured as 210 cm, it does not constitute an obstacle. The difference between the pavement height and the road level is 15 cm. There are no vehicles on the pavement. Advertising boards do not obstruct the view at the corners. There are no trees on the sidewalks and the existing electricity poles do not hinder the use of the sidewalk. The lighting pole on the sidewalk divides the sidewalk into two. However, although the distance between the lighting pole and the garden wall is 82 cm, it is suitable as the road side is measured as 150 cm at the narrowest place. Sidewalks seem suitable because they are made of non-slip material, manhole covers do not pose a danger to people with disabilities, and there are no barriers on them. The garden wall surrounding the national library provides a suitable environment as it prevents the level difference between the sidewalk level and the garden level. However, the walking strip pasted on the floor has been removed so that the visually impaired can find their way. There is no curbstone application that needs to be made in a different color in order for the pedestrians to perceive the road and the sidewalk easily. The lines at the pedestrian crossing are fixed, visible and permanent in accordance with the standards. Although the ramp on the sidewalk on the library side of the street is suitable in terms of width, slope, beginning and end, the ramps located in the middle median are suitable in terms of width (137-148 cm), but steep in terms of slope (15% and 19%). This creates a negative situation for the wheelchair user who wants to cross the street. There is no audible signaling for the visually impaired at traffic lights. There is sufficient illumination for night vision (Fig 10).

It is seen that the slopes of the ramps in Fig 10 are very dangerous for the disabled. According to the relevant standards, the suitability and dangerousness of the ramp slopes are shown in Figure 11.

- Starting from the metro exit on İsmet İnönü Boulevard, the sidewalk on the library side is suitable from every angle. However, it is not useful for wheelchairs who want to come from the opposite side of the road, as the slope of the ramps on the sidewalks and the median is very steep (15-19%). These ramps need to be rebuilt.

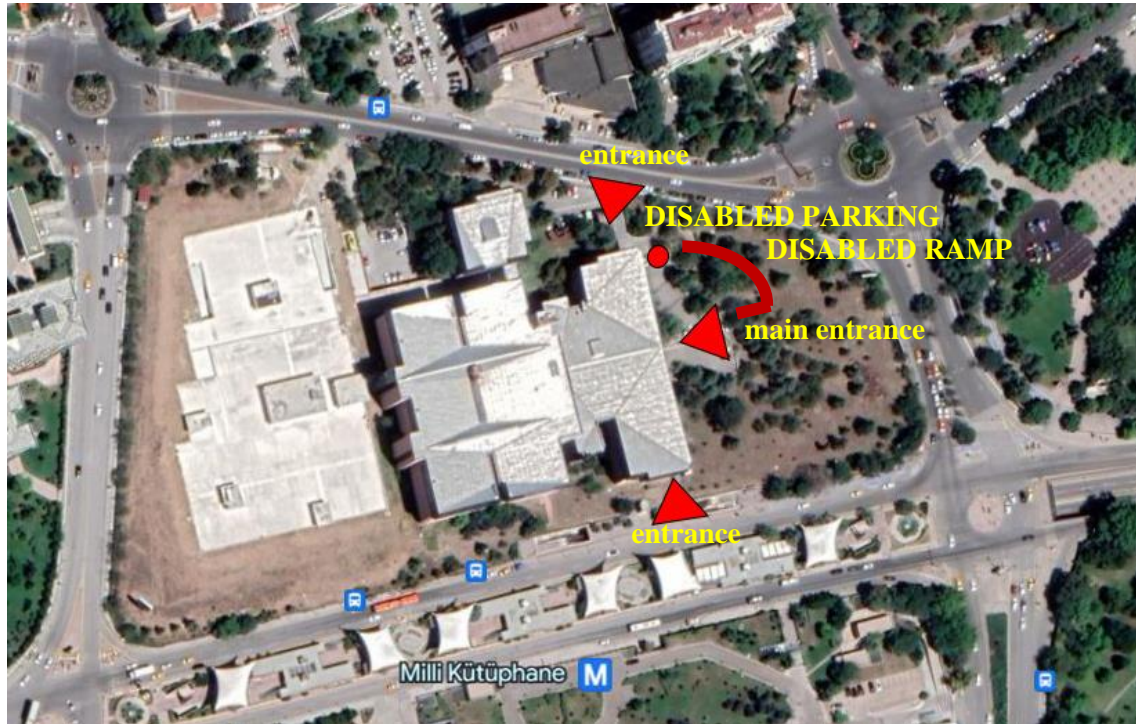
Figure 12. Satellite photograph of the National Library site plan

In order to evaluate the accessibility of the disabled individuals to the library building, another evaluation was made within the building block. Here, open car parks, garden entrances, garden paths and ramps belonging to the building were evaluated (Fig 12). There are two pedestrian and one vehicle entrances from Wilhelm Thomsen Street and one pedestrian entrance from İsmet İnönü Boulevard to the garden of the National Library.
