# Khan al-Wazir and Merzifonlu Kara Mustafa Paşa's Endowed Buildings in Aleppo: History, Architecture, and State of Conservation

Architectural Heritage,  
Ottoman Architecture,  
Khans,  
Aleppo,  
Damage Assessment

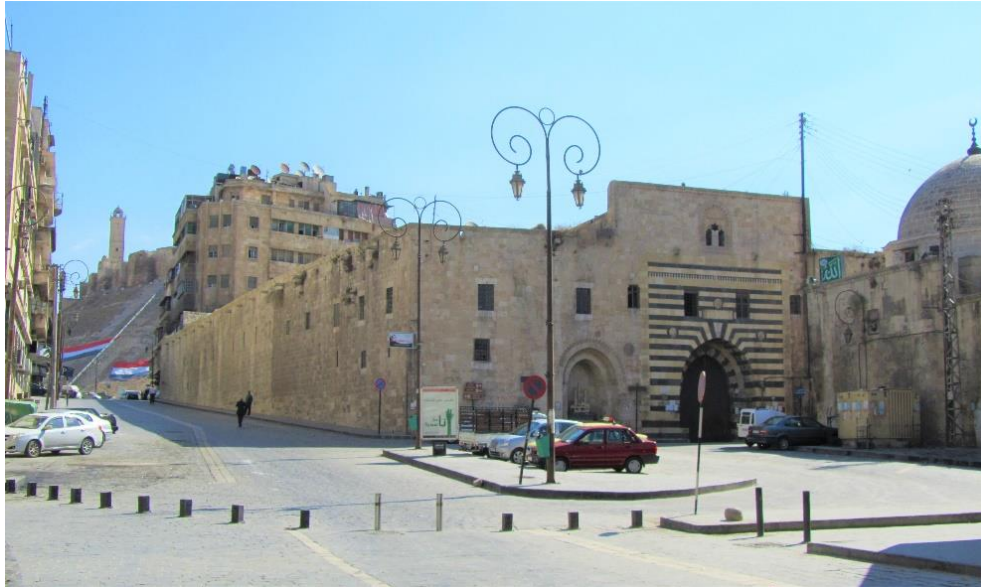
*Figure 2. A General View of Khan al-Wazir from Northwest (Kasmo, 2010)*

Nasr Gate “*Bab al-Nasr*” (Figure 1). This axis was one of the most vibrant urban nodes of the city since medieval times and continued to develop well through the Ottoman period [15]. The khan itself is surrounded on three sides by alleys and on the south by Khan al-Kittan, Qaysariyya al-Kittan and other structures (Figure 2).

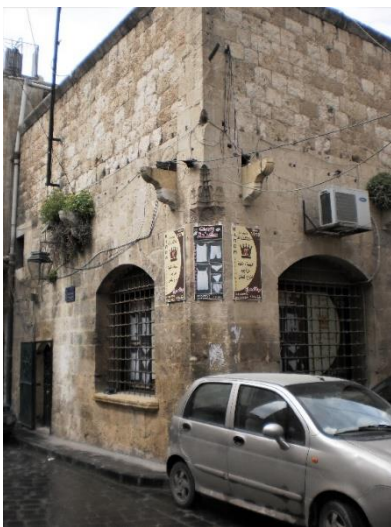
**Figure 4.** *The Sabil (Kasmo, 2010)*

The deed lists two water facilities attached to the khan; a public fountain beside the entrance on the khan’s western wall, and a sabil at the khan’s southeastern corner [9] (Figure 1). The public fountain is set within a double niche surmounted by three carved pointed arches and flanked by two decorative shields (Figure 3). The sabil has a prominent location at the beginning of the thoroughfare that connects the citadel’s perimeter to Al-Nasr Gate in the north. It is entered through a modest arched doorway and has two large grilled windows facing the street. The sabil’s façades are entirely built with finely cut limestone ashlar. The corner is chamfered and crowned with delicately carved muqarnas. Above each window are two stone consoles that once supported wooden canopies that no longer exist (Figure 4). According to the deed, the two facilities were regularly supplied with water from the city’s main canal [9]. Unfortunately, both are no longer functional. The sabil is now a shop, while the fountain was renovated in 2006 with a calligraphic statue installed within.

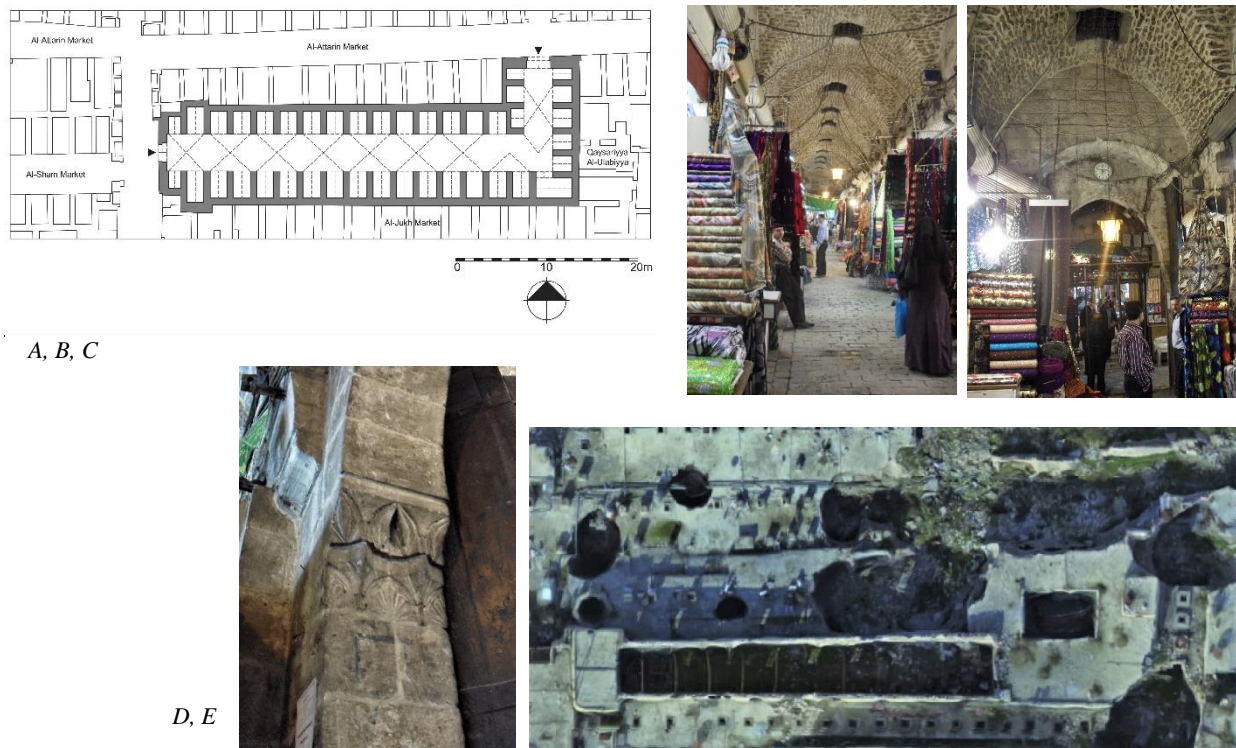
**Figure 6.** The Old Istanbul Market: A. Plan (by author), B. A General View (Kasmo, 2011), C. The Northern Entrance (Kasmo, 2011), D. Decorative Details (Kasmo, 2011), E. Damages as appear in 2014.

The market, known locally as Old Istanbul Market (*Suq Istanbul al-'Atiq*), was devoted to textile products and was one of the busiest in the central commercial zone. It is located to the south of the Great Umayyad Mosque, adjacent to Suq al-Jukh and Qaysariyya al-Ulabiyya, both of which are part of Dukakinzade Paşa's complex (1556) (Figure 1). The (L)-shaped market extends mainly along the east-west directionality and consists of a central pathway covered by cross vaults and two rows with a total of 40 shops (Figure 6). The market's two entrances are topped by pointed arches with muqarnas carvings on their impostes. The market was heavily damaged during the armed conflict (2012-2016); it was devastated by massive flames that erupted on the eastern side of the Great Mosque, causing about 1500 shops to burn down and numerous markets to collapse [17], as well as by random bombing while combat continued in the vicinity. Satellite imagery from 2014 shows the market's eastern end completely destroyed, with one spot where the roofing vaults partially collapsed. The market is currently part of the (Reconstruction and Rehabilitation of the Markets in the Central Commercial Zone) plan, which began in 2018, and it will be restored shortly [18].

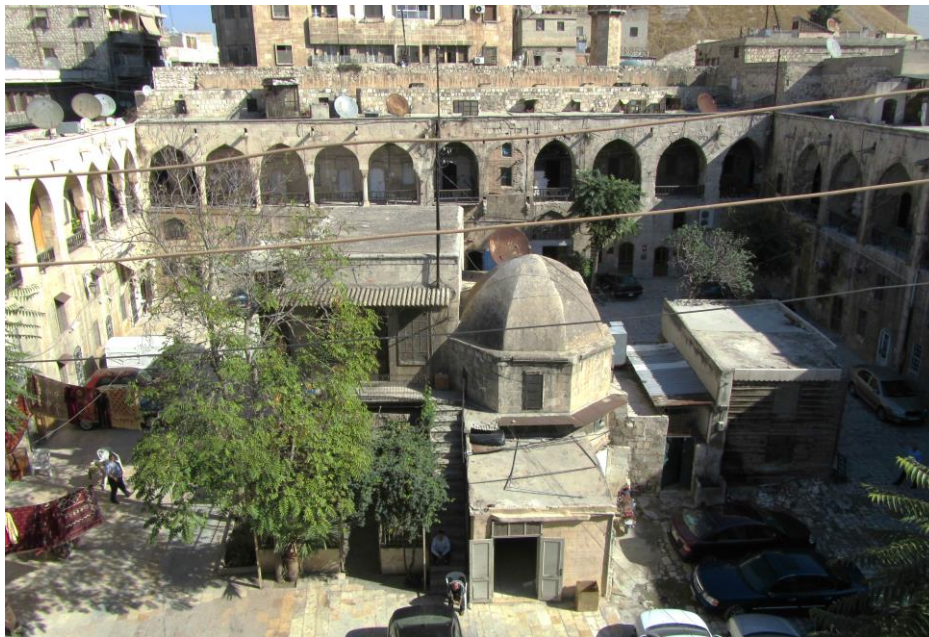
**Figure 9.** A General View of the Khan's Courtyard from West (Kasmo, 2010)

Preceding porticoes along the eastern, northern, and southern sides articulate the upper floor behind which the rooms are set (Figure 9). The preceding porticoes are built in two different types. The wide sections are covered with cross vaults supported by stone piers (Figure 14), while the narrow sections are covered with stone slabs resting on multi-centered arches and polygonal columns with muqarnas capitals (Figure 15). The area above the stable is occupied by a qaysariyya, which consists of a corridor serving two rows of rooms (Figure 16).

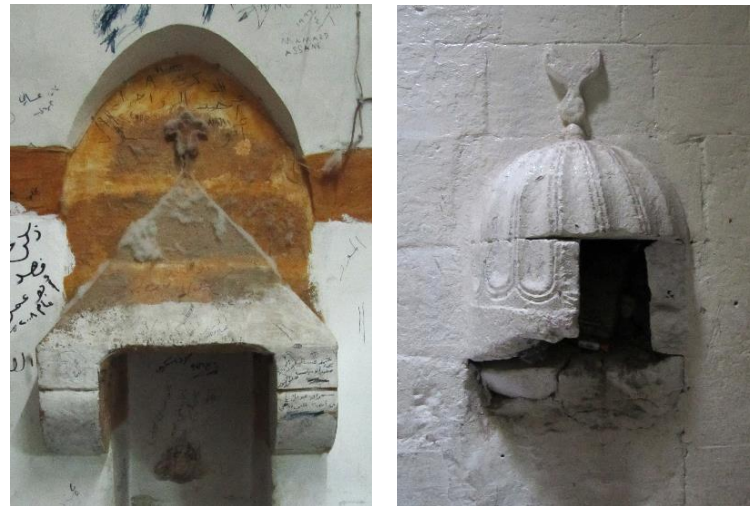
**Figure 10.** Two Types of Fireplaces in the Khan (Kasmo, 2010)

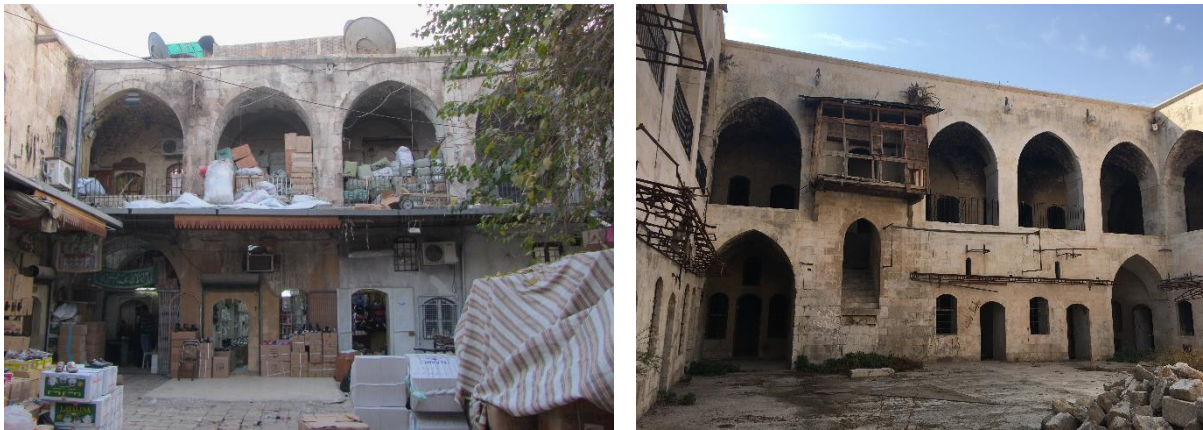
**Figure 11.** General Views of the Courtyards of Khan al-Absi, on the left, (Kasmo, 2011) and Khan al-Haj Musa, on the right, (Grandin, 2020©) showing the absence of preceding porticoes on ground floors.

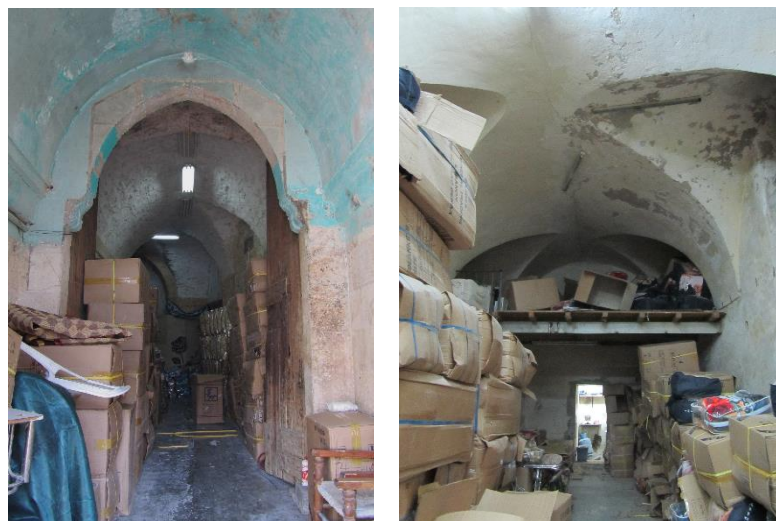
**Figure 12.** The Entrance, on the left, and a General View, on the right, of the Khan's Stable (Kasmo, 2010)

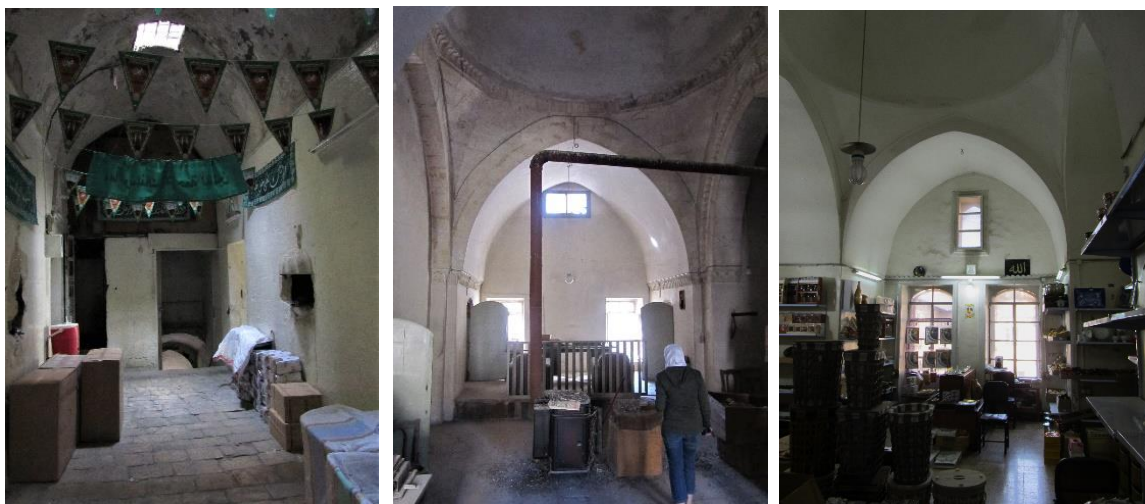
**Figure 20.** The Hallway in the Western Wing of the Khan (Kasmo, 2010)

The upper western wing has no preceding portico. Instead, it consists of two rows of rooms accessed from a central hallway with fireplaces and upper grilled windows (Figure 20). A large hall of a cruciform plan, with a square domed central area and four iwans, punctuates this hallway above the entrance (Figure 21, 17, 20). This type of hall can be found in several 16-century Aleppo's khans, such as Khan al-Gumruk and Khan al-Hibal (1594) (Figure 22). The fact that these halls overlook both the streets and the interior courtyards of the khans makes them strategically placed. Although their original function is unknown, it's possible that they acted as reception spaces for the administrators or prestigious guests. David [20] examined the hall of Khan al-Gumruk and likened it to the grand reception halls found in the domestic architecture of the wealthy.

**Figure 21.** The Cruciform Hall in the Western Wing of the Khan (Kasmo, 2010)

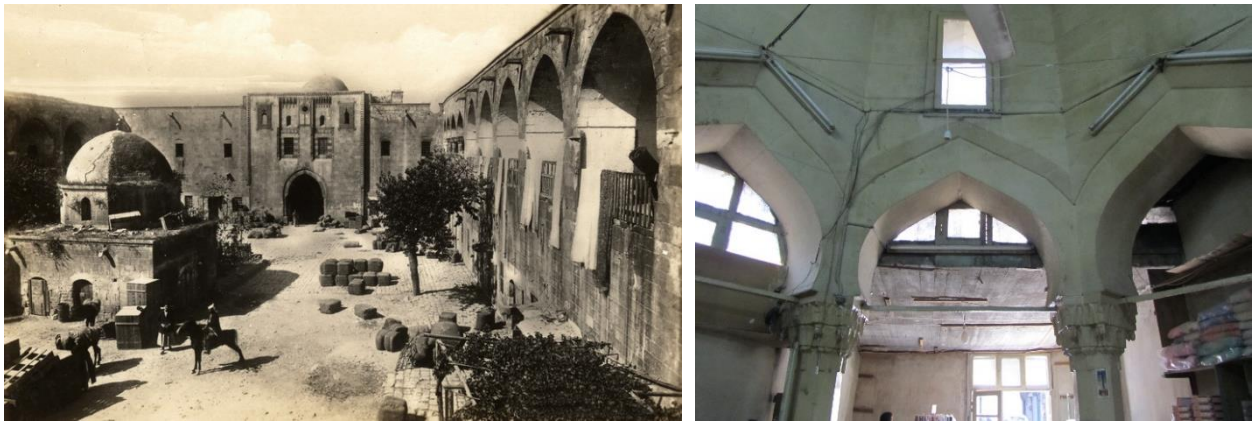
**Figure 23.** A Photo from 1925 Showing the Domed Water Basin before the Later Encroachments [21]

Instead of a mosque, a small domed water basin occupies the courtyard's center, slightly to the north of the entrance axis. Researchers incorrectly assumed that this basin was a small mosque and so the beneficiary of the khan's revenue [5]. However, the deed clearly states that it was a basin supplied with water from the city's main channel system [9]. The basin is covered with a polygonal dome that rests on an octagonal base, within which four small windows are opened (Figure 9, 23). The base in turn rests on the supporting walls except for the western side. At this side, three multi-centered arches and two columns with muqarnas capitals support the base (Figure 24). The columns are tied to the walls with iron bars. The deed also mentions toilets in the northern wing, several wells in the courtyard, and kitchens that no longer exist.

**Figure 24.** The Arches and Columns Supporting the Dome of the Water Basin (Kasmo, 2010)

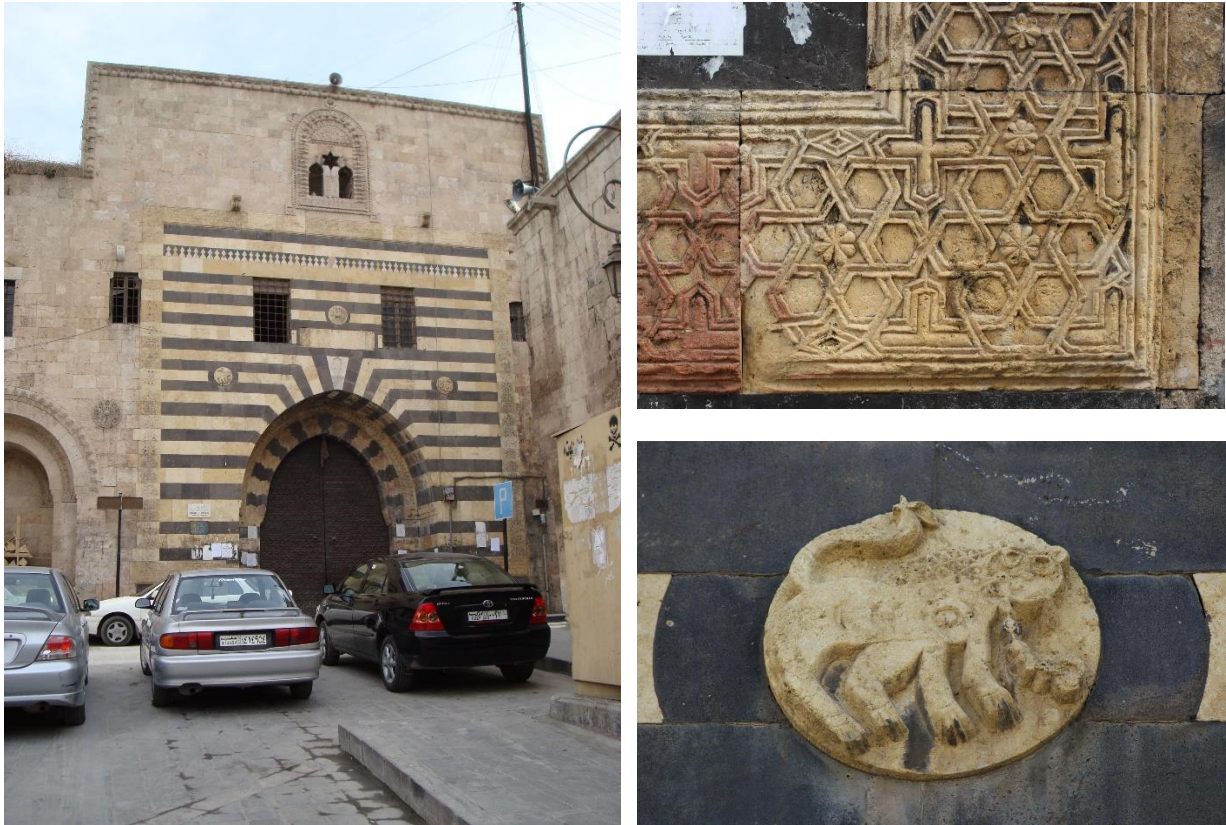
**Figure 25.** The External Façade of Khan al-Wazir's Entrance: A. A General View (Kasmo, 2010), B. The Carved Decorative Band (Kasmo, 2010), C. A Roundel with a Feline Figure (Gussone, 2007©)  
© Museum for Islamic Art in Berlin

The khan's entrance is marked by elaborately decorated façades facing the outer street and the internal courtyard and announcing the importance of the building. These façades evoke the formal conventions of Mamluk commercial architecture in Aleppo in terms of composition, building techniques, and decorative elements. However, instead of duplicating Mamluk norms they adhere to Ottoman modifications of these conventions, which were firmly established throughout the 16th-century khans. They are particularly reminiscent of the entrance's façades of Khan al-Gumruk (1574) (Figure 27). The exterior façade of the entrance is distinguished from the rest of the wall by a higher roofline (Figure 25). The doorway and two upper windows are built with alternate courses of polychromic stones and framed with a broad band carved with geometric ornament. Between the two windows, there is a plain marble plate that may have been intended for an inscription. In the upper section of the façade and just under the cornice, there are two small windows and a star-shape lunette set within a finely carved screen in a form of blind semi-circular arch. Three roundels adorn the façade: one decorative shield above the marble plate and two roundels with feline figures on either side of the doorway. In her discussion of Aleppo's 16th- and 17th-century Ottoman architecture, Watenpaugh [5] analyzed the usage of feline roundels highlighting how they have been re-contextualized from their military-functional context to a new functional and architectural context as “*a visual quotation from the city's architectural history*”. The entrance's lavish facade is boldly contracted by the massive exterior walls of the khan, which are plain and punctuated by small rectangular windows and an upper row of waterspouts.

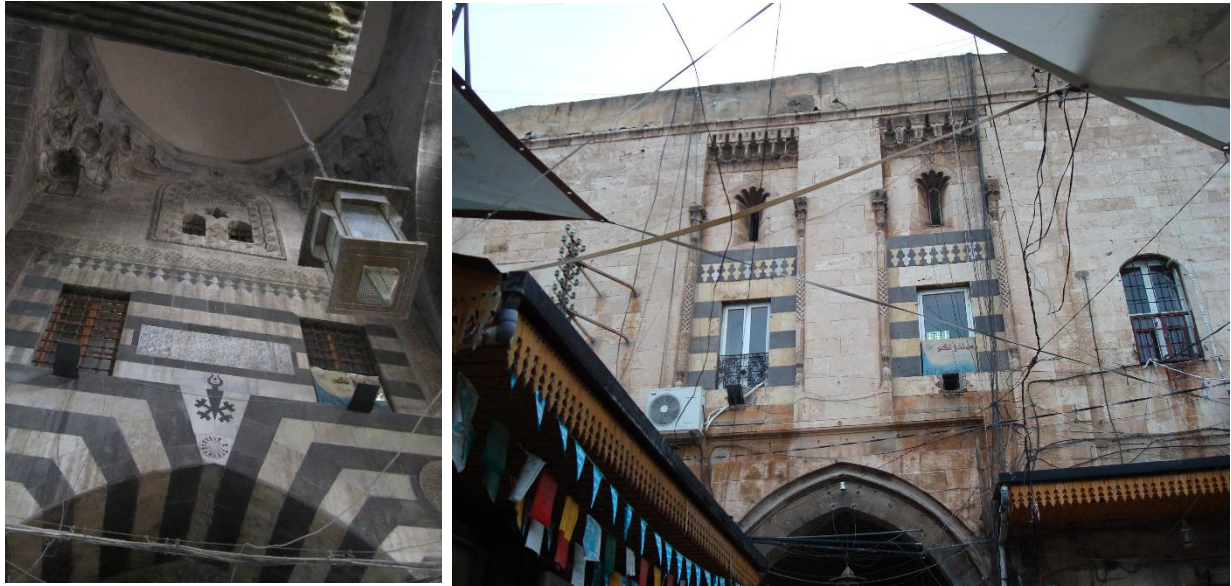
*Figure 27. The External Façade, to the left, and the Courtyard Façade, to the right, of Khan al-Gumruk's Entrance (Kasmo, 2011)*

Above the doorway are two recessed bays that are strikingly similar to those on the internal façade of Khan al-Gumruk (Figure 27). Each bay contains a lower rectangular window framed with polychromatic stones and an upper small window with a multi-centered arch. The bays are decorated with joggled stones, braided colonnettes and muqarnas strips. A small round lunette is placed inside checkerboard frames in the center, and two small windows are set within wide frames of carved geometric ornament and checkerboard bands in the two upper corners of the façade.

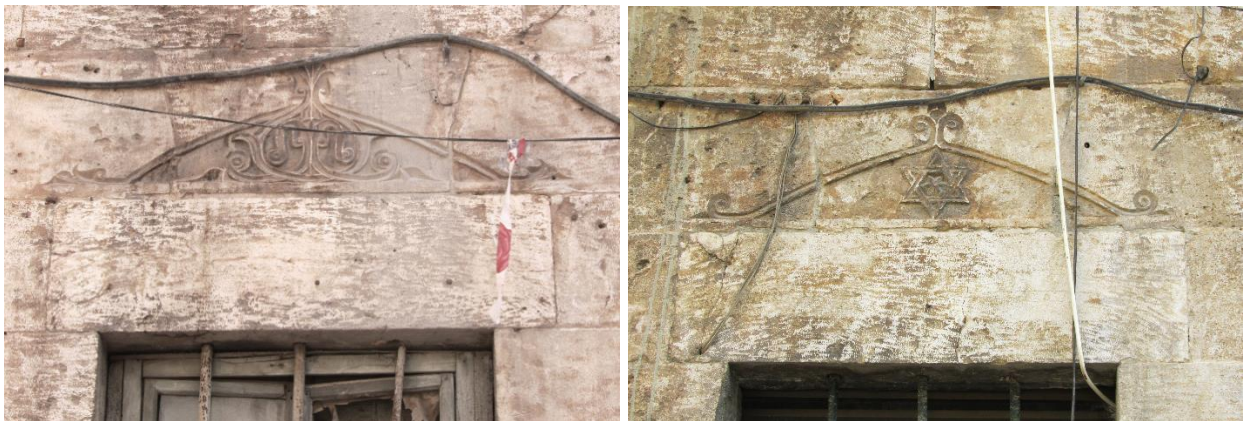
*Figure 28. Carved Ornament above the Openings overlooking the Courtyard (Kasmo, 2010)*

In addition to this façade, the inner atmosphere of the khan is further enriched by the various types of arches in the upper porticoes and columns with their muqarnas capitals, as well as carved vegetal and geometric ornamentation above the windows and doors of the rooms (Figure 28). Because some of the carvings are incomplete, they seem to have been executed on-site after the construction.

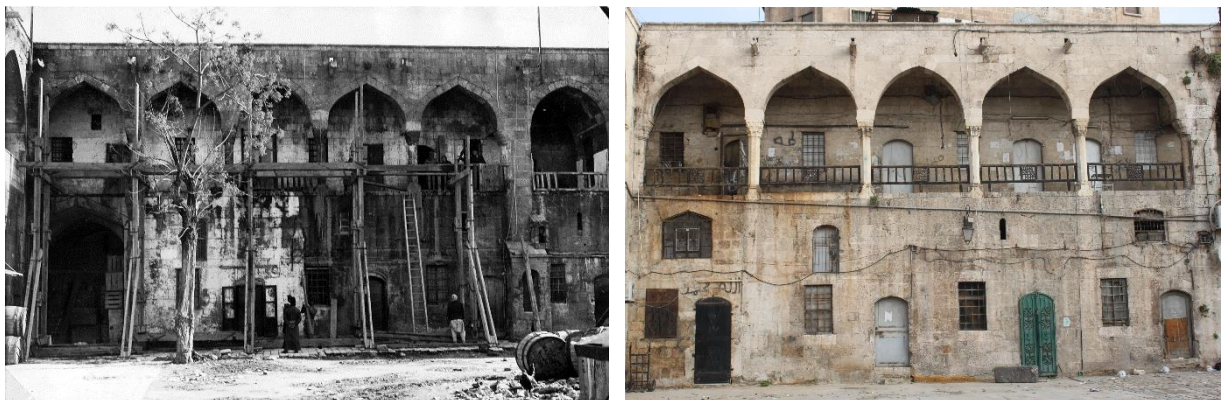
**Figure 29.** The Northern Section of the Eastern Upper Portico during the 1939 Repairs (Michel Ecochard Archive ©) and after (Kasmo, 2010)

Unlike the other major khans in Aleppo, Khan al-Wazir was not involved with the accommodation of European consulates or communities, which helped to retain much of its original architecture and decoration. According to the endowment's accounting books, periodic repairs and maintenance were carried out on a regular basis at least until the early 19<sup>th</sup> century. For example, between 1723 and 1724, 360,000 silver coins (*akçe*) were paid for the repair of the khan [8]. As a result, it appears that the structure did not undergo considerable change until the 20<sup>th</sup> century. A two-story block abutting the northern side of the courtyard's water basin was built in 1913, according to the inscription above its entrance. Although built with traditional materials and techniques, the high block has obscured the basin's, disturbing the original appearance of the courtyard. Its construction has also allowed for additional incompatible encroachments surrounding the basin. During the French Mandate period, the khan was repaired under the direction of French architect Ecochard [22]. These repairs were completed in 1939, according to an inscription on the capital of a column in the eastern wing. According to the available drawings and photographs preserved in the digital collection of Ecochard [22], the repairs were concentrated on the khan's external northwestern corner, the western section of the northern upper portico, and the northern section of the eastern upper portico (Figure 29). The facade and section drawings show that the consolidation works in the upper porticos included replacing deteriorated stones, adding metal ties (Figure 15) and clamps to prevent the disintegration of the masonry system, and replacing the roofing stone slabs in the northern portico with a thin reinforced concrete slab (Figure 32).

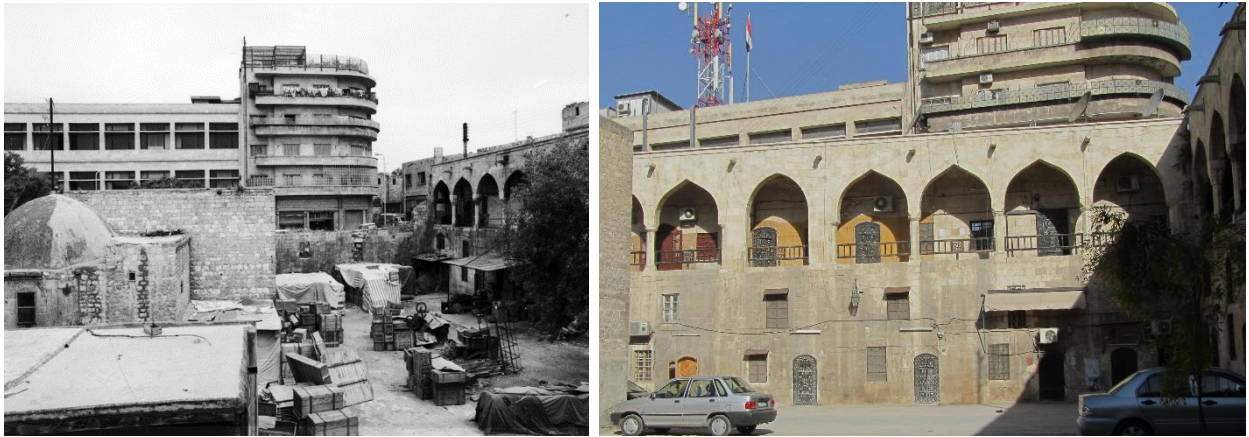
*Figure 30. The Eastern Section of the Northern Wing after its demolition (David, 1982©) and after its reconstruction (Kasmo, 2010) © Museum for Islamic Art in Berlin*

Within the scope of the city's modern master plans, which envisioned opening vehicular routes within the traditional urban fabric of the Old City, the eastern side of the khan's northern wing was demolished in the 1950s to make way for the road through Khan al-Wazir Street that links the citadel's perimeter to the Great Mosque (Figure 30). It was after around 40 years when this section was reconstructed. In terms of mass and

form, the new structure was consistent with the khan's overall layout, preserving its integrity. A secondary entrance was opened on the north-eastern corner of the new section in order to improve access and mobility.

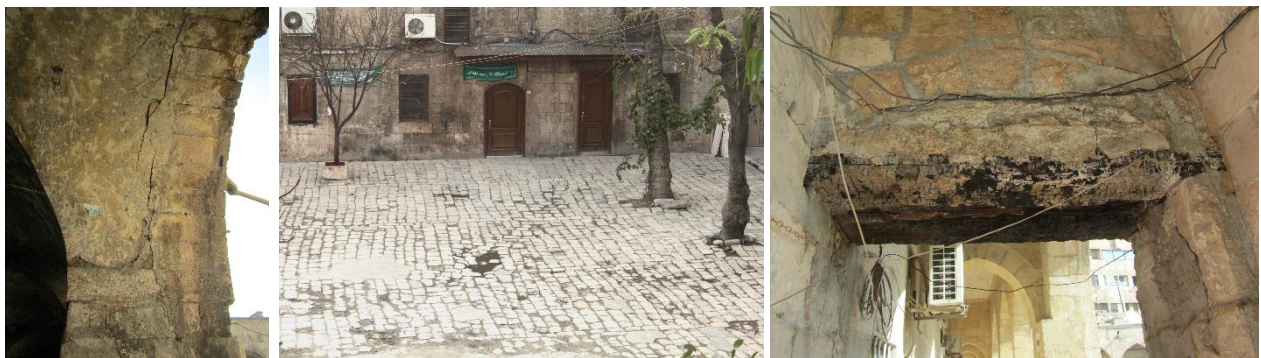
*Figure 31. Some of the Conservation Problems Observed in 2010 (Kasmo, 2010)*

Prior to the armed conflict in the city, the khan's conservation status was affected by two major factors. The first was the incompatible usage and interventions conducted by some shopkeepers. It ranged from poor repairs to detrimental additions and excessive renovations of some units. The second factor, on the other hand, was the lack of necessary periodic maintenance. This was most noticeable in the khan's idle units and common spaces, such as the upper roof, porticos, and courtyard. As a result, a variety of material and structural damages were observed (Figure 31). Many of the stone piers had significant cracks and deteriorated stone blocks. Disintegration between the roofing vaults and the porticos' arches was visible in certain points, and several wooden lintels were very decayed. There was also a noticeable subsidence in the courtyard pavement due to car parking and water leakage, as well as in the upper roof screeds.

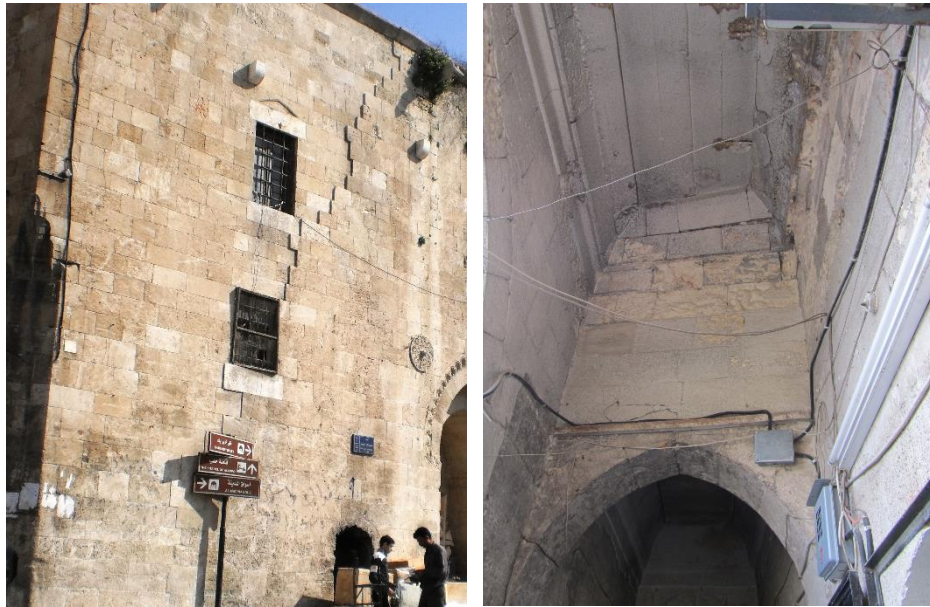
**Figure 32.** *The Structural Problems Observed in the Khan's Northwestern Section (Kasmo, 2010)*

A significant structural deformation was observed in the northwestern section of the khan. A crack, with a slight rotation, ran along the northern side of the khan's external western wall, while from inside, the portico's slab exhibited twisting and partial breakage (Figure 32). This problem may have originated from the use of reinforced concrete in this section within the scope of 1939 repair work, and later from the demolition and reconstruction of the northeastern section, which also incorporated the use of reinforced concrete.

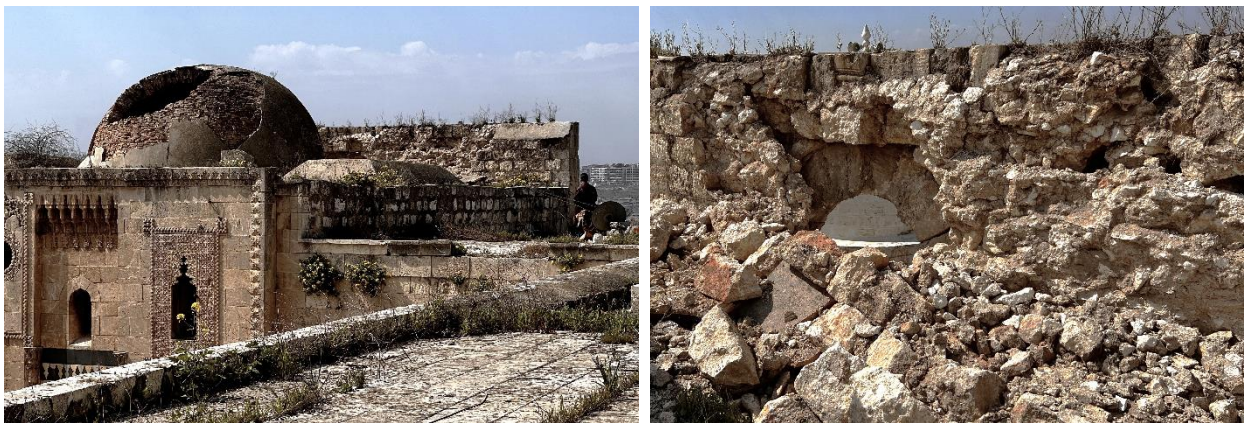
**Figure 33.** *The Partial Destruction of the Dome and the External Façade Wall (Dayoub, 2023©)  
© Museum for Islamic Art in Berlin*

During the years of the armed conflict, the khan was looted and affected by random shelling. Satellite imagery from 2014 to 2016 shows the collapse of the roof at the northeastern corner, where the new entrance is located, the partial collapse of the northern wall of the block abutting the water basin in the courtyard, and the partial collapse of the reception hall's dome in the western wing and the external façade wall (Figure 33). Because the building was not restored, these holes in the roofs have exposed the structure to weathering and internal degradation over the years. The structural flaws magnified the impact of the recent earthquake in February 2023, causing alarming damage in multiple points. The most urgent is the upper section of the unique external façade of the entrance which is at the risk of complete collapse. The façade has been temporarily supported, and efforts to restore it as quickly as feasible are ongoing.
