# Impacts of Recurrent Flooding and Erosion in the Municipality of Mususa (Butembo/Democratic Republic of the Congo) and Some Control Strategies

Deogratias Anguandia Odhipio<sup>1\*</sup>

<sup>1</sup>Department of Geology, Université Officielle de Ruwenzori, Butembo, B.P. 560, Democratic Republic of the Congo

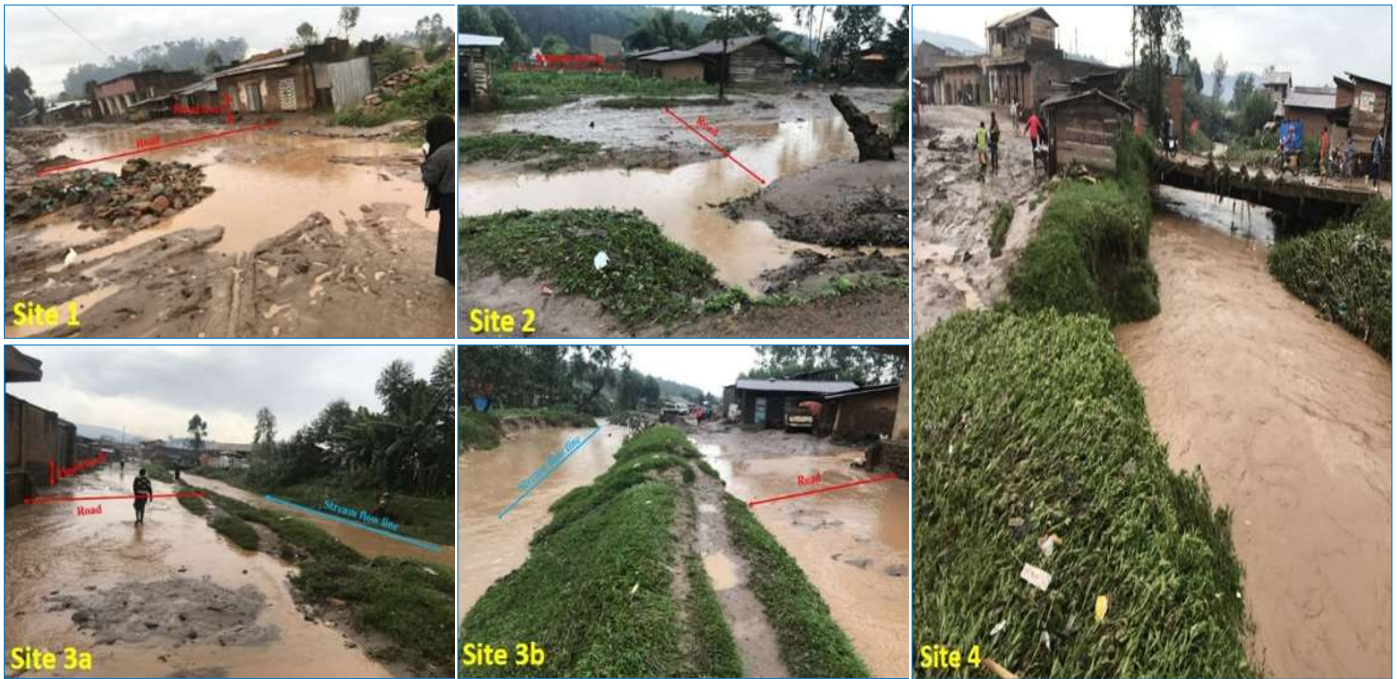
Fig. 3. Flooding of the Kimemi River on the Demobe Bridge and Kabakuli Bridge section (Quartier Vungi)

Being a major collector for the city, the Kimemi River drains a very large area of the region. As a result, sudden floods often occur in the Vungi quarters. After the flood of November 09, 2022, the difficulties for users continued. Some communication axes, notably roads, remained cut off after the rain (Fig. 3).

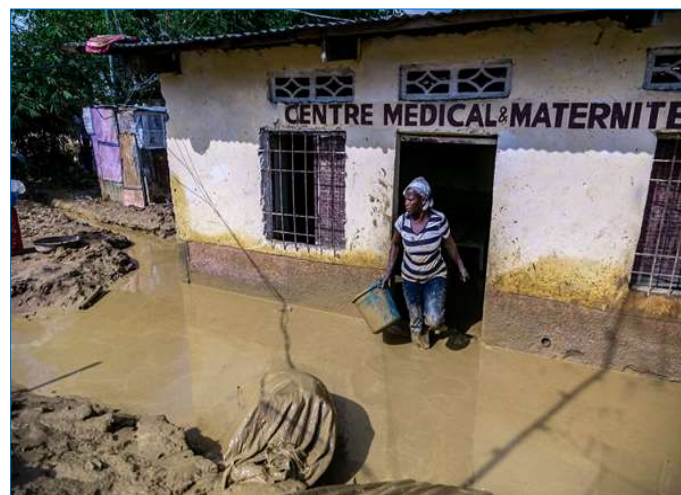
Fig. 4. Mososo quarter flooded after the heavy rains that fell on Kinshasa on April 01, 2023. Image UNDP-DRC

hazardous substances are carried away by the waters, and potentially in contact with people. Moreover, Butembo is not the first Congolese town to experience the problems of flooding. Kinshasa (Fig. 4), the capital of the DRC, is one of the Congolese cities most affected by flooding (Wouters and Wolff, 2010; Lopanza et al., 2020).

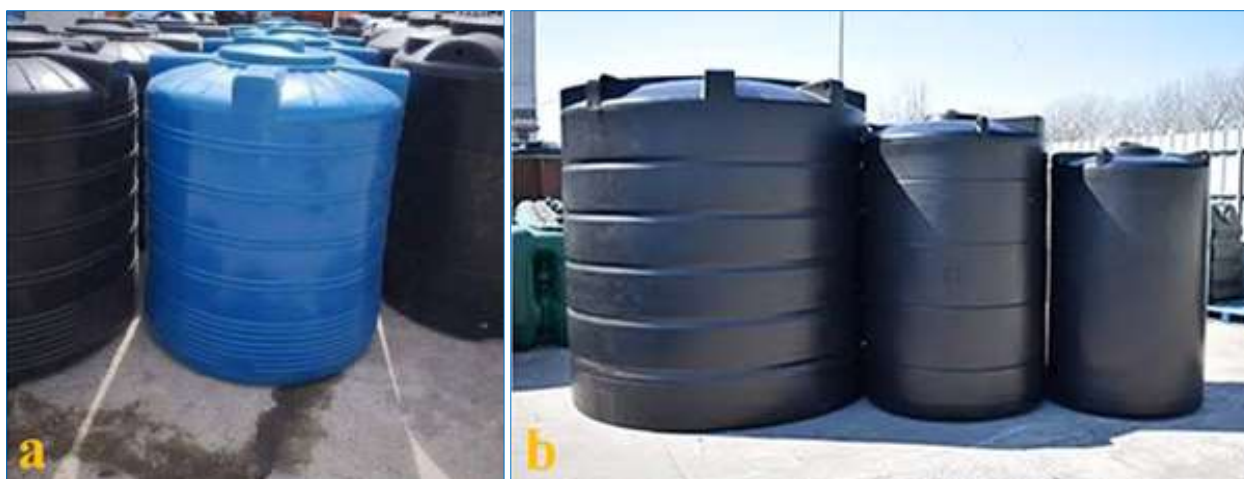
Fig. 6. Images of some tanks for domestic rainwater storage

These solutions are ambitious and require huge resources, which could handicap the implementation of these plans. However, raising public awareness through conferences and workshops seems simple and feasible. And it is the most efficient way, because in Butembo, as in most Congolese cities, waterproofing the entire surface of one's plot of land is a prestige. Changing this philosophy is a direct solution to the problem of flooding. As it is difficult to prevent the population from building and to impose a development model on the plot, the only solution available to effectively combat rainwater is to set up a water storage system on each plot. In this way, the quantity of water that falls on the plot remains stored in the tanks (Fig. 6). This has two advantages. Firstly, this practice helps to combat flooding by reducing runoff flows. Secondly, it combats water shortages, as the population will be supplied with large quantities of rainwater for laundry and household cleaning.

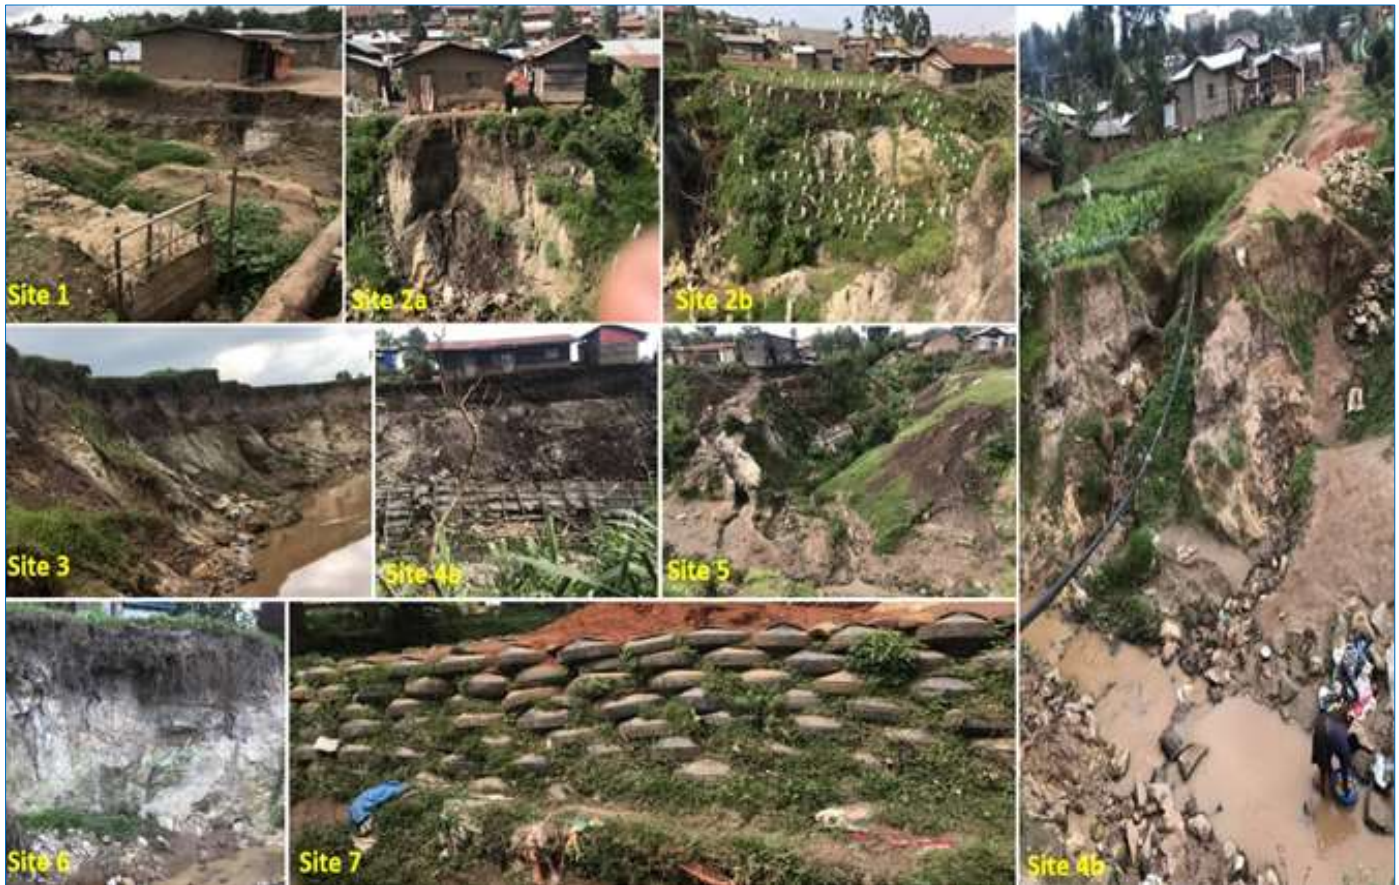
Fig. 7. Images of some eroded areas along the Wayimiria River

In the Municipality of Mususa, in the City of Butembo, for example, erosion of the riverside is observed along the Wayimiria Stream, with direct consequences for houses. Examples in sites 1, 2a, 4b and 5 (Fig. 7). These images (Fig. 7) show the degree of erosion evolution in the few observation sites in the Municipality of Mususa, along the Wayimiria Stream. Their geographic coordinates (Table 2)

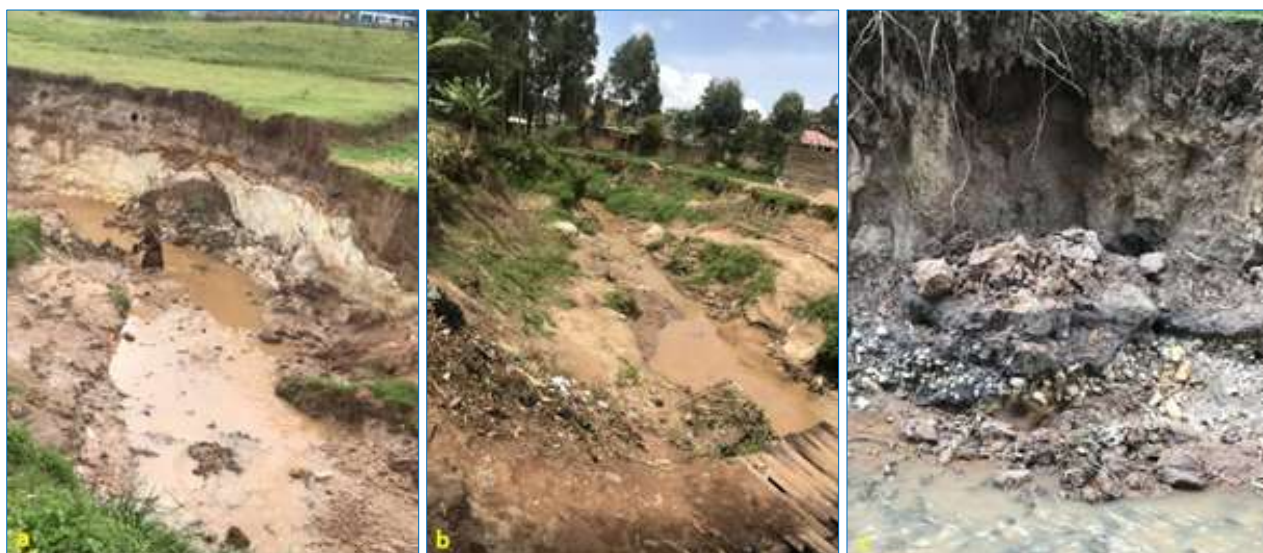
Fig. 9. The main causes of erosion in the Municipality of Mususa in the City of Butembo

However, in the case of the Mususa Municipality, the combination of erosion causes listed by [Lopanja \(2020\)](#) seems to be apparent in some of the observation sites. Notably in the Tarce Primary School valley ([Fig. 9a](#)) and in the Vichai Valley ([Fig. 9b](#)), where the main cause of erosion is the regular mining of sand in the riverbed by the riverside population. In [Fig. 9c](#), the nature of the soil seems to be the cause of erosion.

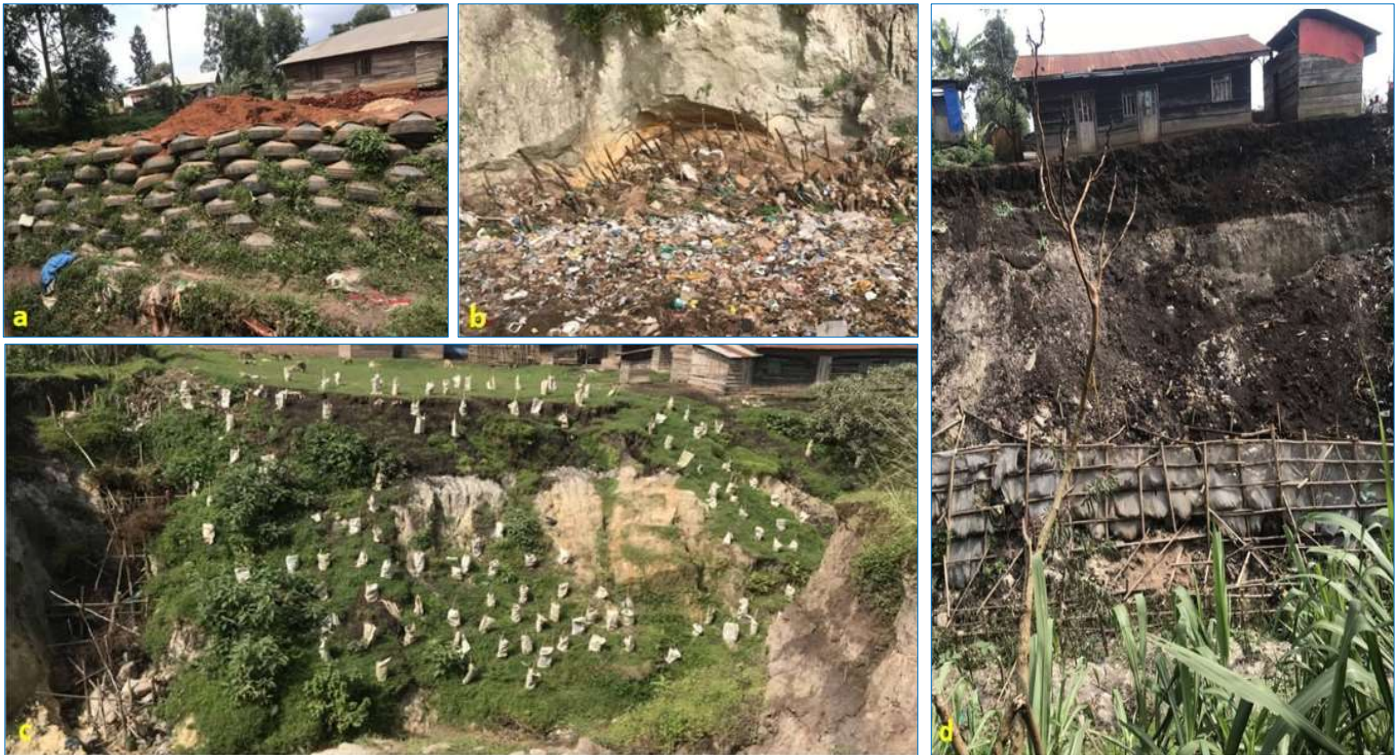
population uses the following techniques and methods. These include the use of vehicle tires as in Vungi near the confluence of the Wayimiria and Kimemi Rivers (Fig. 10a), wooden stakes used in the Vichai Valley (Fig. 10b), wooden stakes wrapped in bags used in the valley near the Vichai Elementary School (Fig. 10c), and mosquito nets supported by wooden stakes in the Vichai Valley (Fig. 10d).

Fig. 10. Some anti-erosion practices already applied to date by the riverside population along the Wayimiria River

Some of these anti-erosion techniques are very simple and are based on the use of affordable materials. The use of tires, for example, seems to be very successful in the Valley of Vungi. However, other erosion control techniques appear to be less

efficient and unsustainable, such as the use of wooden stakes, wooden stakes wrapped in sacks, and mosquito nets supported by wooden stakes, etc. Despite their use, erosion continues to progress. This is why, instead of these, it would

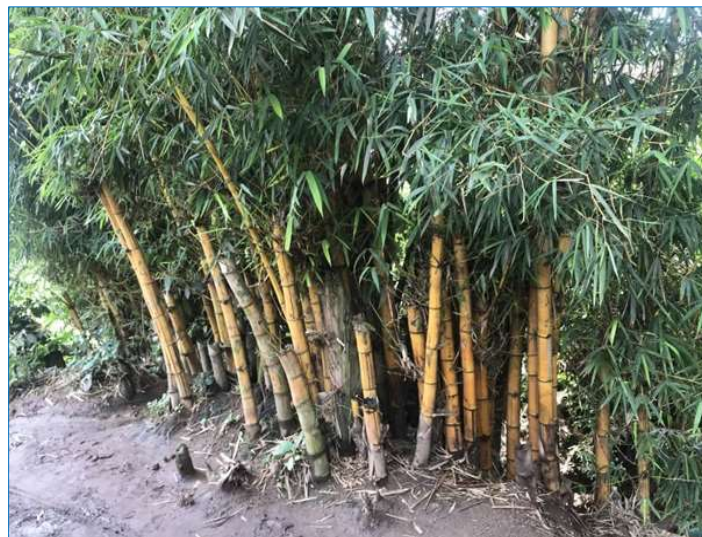
Fig. 11. Images of bamboo to be used to combat erosion along the Wayimiria River in the Municipality of Mususa

be preferable to use plants such as the bamboo, whose roots effectively help to stabilize the soil (Fig. 11).
