THE INFLUENCE OF THE CARBURIZING PROCESS ON THE IMPACT-SLIDING WEAR BEHAVIOR OF 14NiCr14 STEEL

ABSTRACT

Keywords: Barrel extension, Depth of diffusion layer, Surface damage, Surface hardening, Steel.

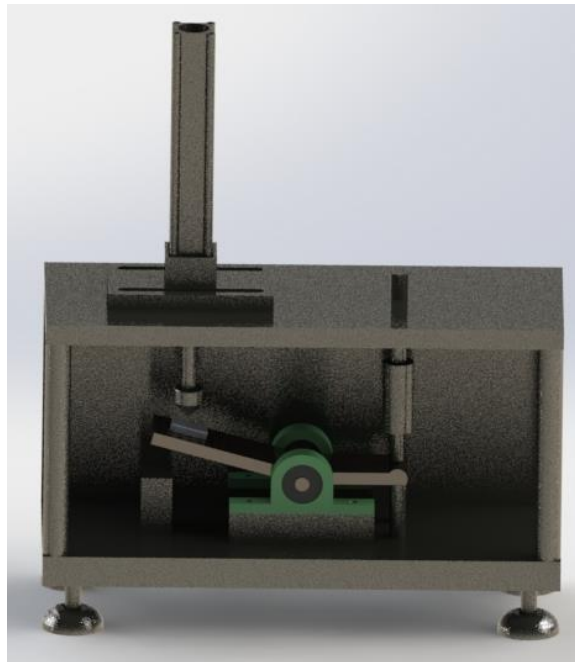
Figure 1. Schematic view of impact-sliding wear tester.

Researchers at Bilecik Seyh Edebali University designed a home-made impact sliding tester, shown in Fig. 1, to evaluate the impact-sliding wear performance of untreated and carburized 14NiCr14 steels. The design of the tester was patented by Chen and Nie [11]. During the experimental procedure, the application of loads onto the surfaces of both untreated and carburized 14NiCr14 steels was regulated by the utilization of a spring and a pneumatic cylinder. Prior to testing, a load cell set the maximum loads that the spring and pneumatic cylinder could provide at 40 N and 240 N, respectively. At ambient temperature (20 ± 5 °C and $40\pm 5\%$ RH), impact-sliding wear tests of untreated and carburized 14NiCr14 steels were conducted against commercially available 10 mm SAE 52100 grade bearing steel balls. Two distinct regions of wear scar (impact and sliding) were examined by a 2-D surface profilometer following the impact-sliding wear test in order to calculate the quantity of wear loss. The wear rates were then calculated by dividing the volumetric wear loss by the number of loading cycles in mm^3/cycle . To ascertain the wear mechanism, LOM examinations were also performed on the worn surfaces of untreated and carburized 14NiCr14 steels. To better understand the wear mechanism in the impact-sliding tests, it was necessary to evaluate the friction coefficient of the sample-counterface system under a sliding motion. In this case, reciprocal sliding tests were carried out under an ambient condition (20 ± 5 °C and $40\pm 5\%$ RH) according to the ASTM G133-05 standard using a 10 mm SAE 52100 steel ball, a sliding speed of 1.9 cm s^{-1} , a sliding distance of 60 m, a track length of 11.5 mm, and a normal load of 30 N.

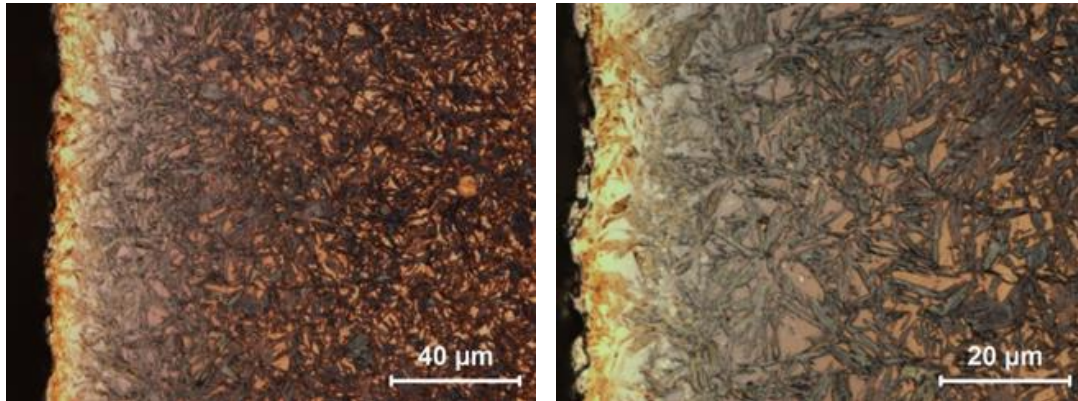
Figure 2. Cross-section LOM microstructures of the carburized 14NiCr14 steel (low and high magnifications).

Figure 2 exhibits the LOM microstructures of a cross-sectioned gas-carburized sample for different magnifications. After the gas carburization process, tempered martensite and sorbite primarily composed the structure of the steel (Fig. 2). The presence of eutectoid and under-eutectoid compositions in the carburized layer of 14NiCr14 steel is evident.

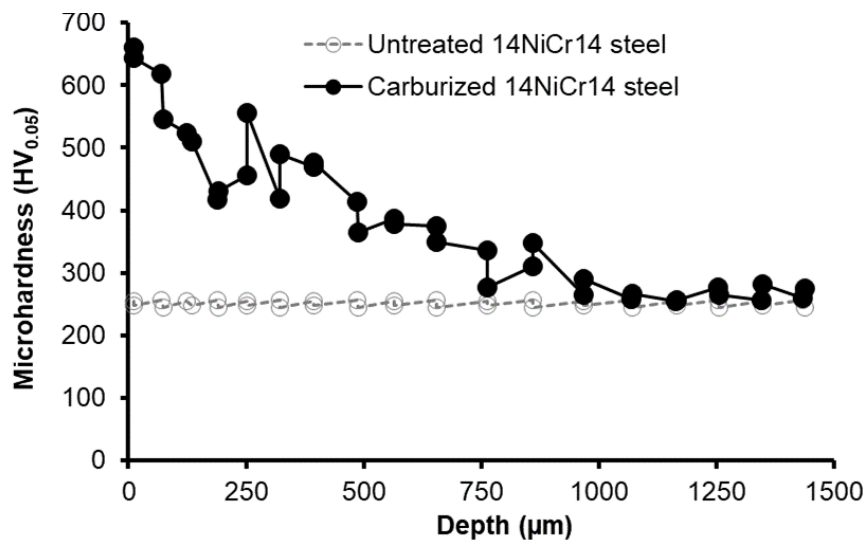
Figure 3. Microhardness values of gas-carburized 14NiCr14 steel from the surface to the core.

The hardness values of untreated and carburized 14NiCr14 steels are plotted from the surface to the core in Figure 3. These values are shown in ascending order. The surface of the untreated 14NiCr14 steel has an average hardness of 250 ± 5 HV_{0.05}. The carburized 14NiCr14 steel has a maximum surface hardness value of 650 ± 10 HV_{0.05}. The carburizing process resulted in a hardness profile that gradually decreased. This drop in hardness demonstrates that the diffusivity of carbon is higher on the surface and gradually decreases toward the core. The surface has a higher concentration of carbon than the core does. Because the value of hardness stays the same after 960 µm have been removed from the surface of carburized steel, this demonstrates that the maximum depth at which carbon diffusion takes place is 960 µm.

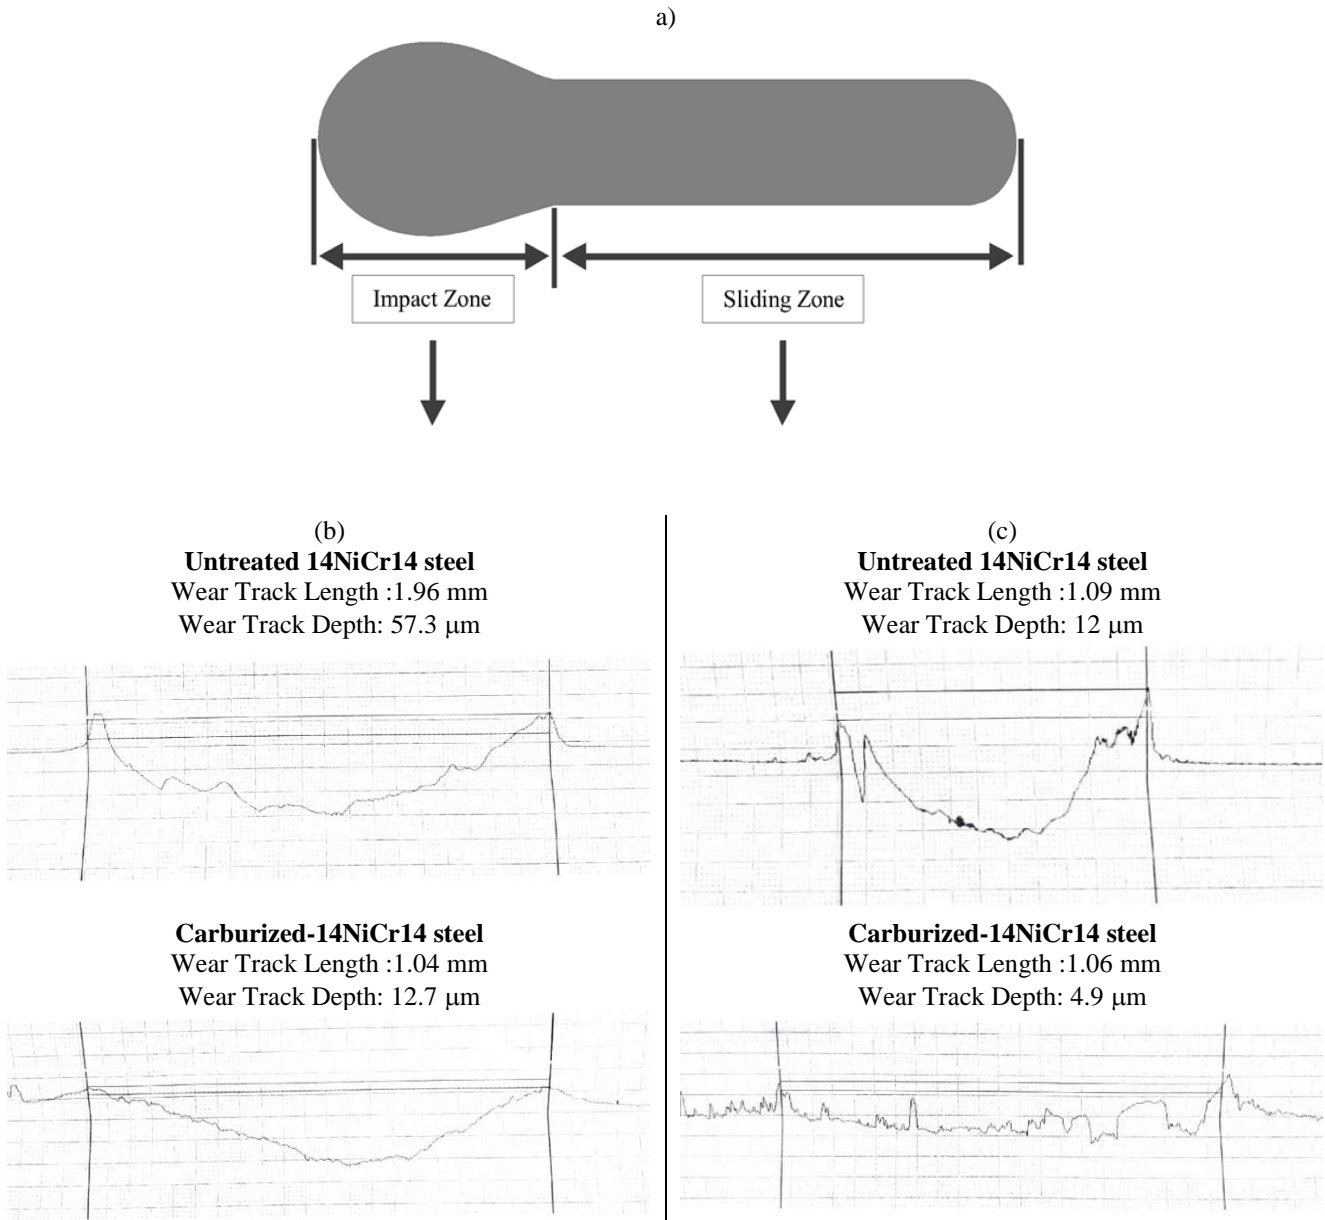
Figure 4. (a) A schematic drawing of the wear track that was made on the samples' surfaces. After impact-sliding wear tests, 2-D profiles of the untreated and carburized 14NiCr14 steels' impact (b) and sliding (c) zones.

Figure 4a illustrates the schematic representation of a wear track, whereas Figs. 4b and c illustrate the 2-D profiles of the impact and sliding zones of the wear tracks for both untreated and carburized 14NiCr14 steels following impact-sliding wear tests. For untreated 14NiCr14 steel, the impact zone has greater depth and width than the sliding zone. However, the gas carburization process imposed shallower and narrower wear tracks in both impact and sliding zones. In the case of carburized 14NiCr14 steel, the depth of the wear track formed by the steel ball in both impact and sliding zones is less than the depth of the carburized layer (960 µm). High-case depth and surface hardness steels are more wear-resistant [12]. The relatively soft,

untreated 14NiCr14 steel was more likely to yield under high cyclic loading conditions. The system's pile-up zones [13] indicated material transfer rather than wear loss. Additionally, pile-up formations were observed in the edges of the impact and sliding zones, indicating that plastic deformation played a role in the progression of wear for untreated 14NiCr14 steel, whereas the carburized layer had a much higher hardness and provided better load support; thus, very limited damage could be observed on carburized 14NiCr14 steel, and pile-up zones were not obvious after the test.

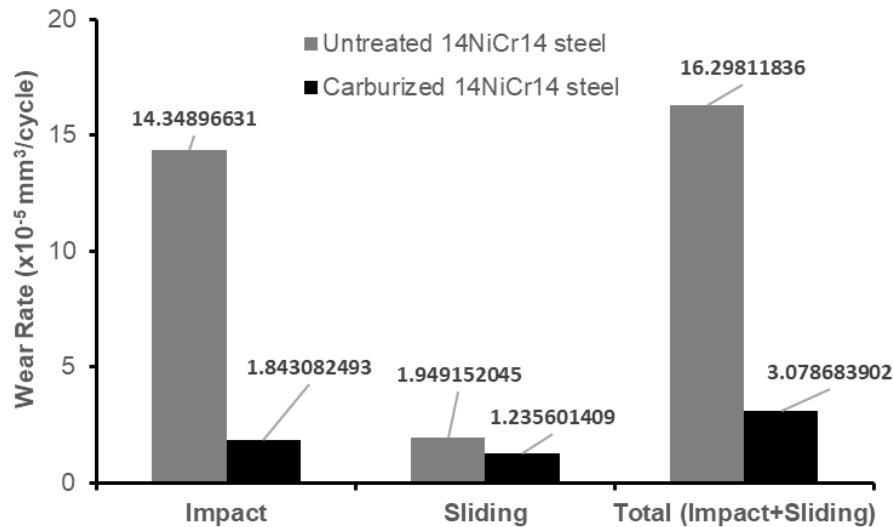
Figure 5. Wear rates of the wear tracks formed on the surfaces of the untreated and carburized 14NiCr14 steels.

Figure 5 depicts the wear rates of the samples' impact and sliding zones. It should be noted that gas carburization reduced the wear rate of the impact zone by 87%, while only 37% of the wear rate of the sliding zone was reduced. Gas carburization, on the other hand, reduced the total wear rate by 81%.

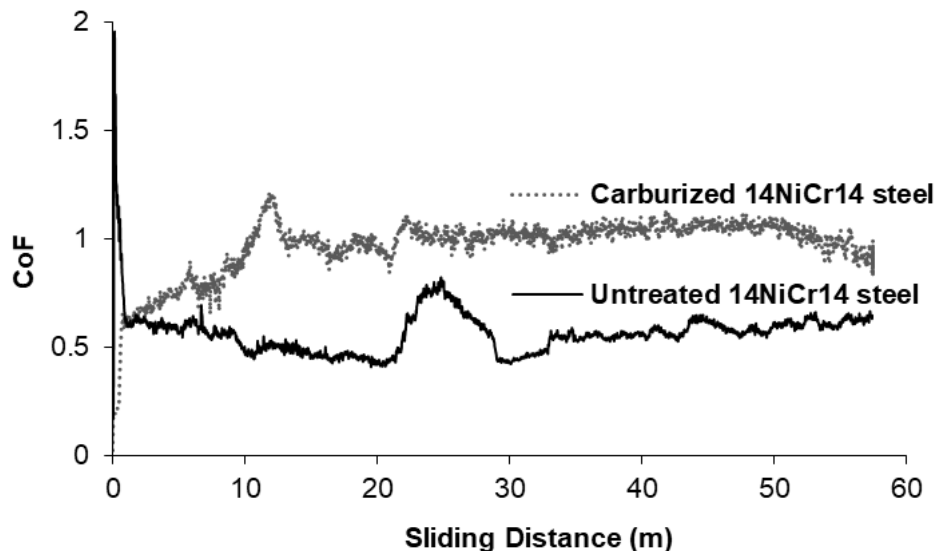
Figure 6. Trend of the CoF under reciprocal sliding tests.

The coefficient of friction (CoF) plot under reciprocal sliding tests is shown in Fig. 6. The initial phase, referred to as the running-in stage, exhibited a notable rise in CoF, whereas the subsequent phase, referred to as the steady-state stage, demonstrated a plateau after varying sliding distances of the two steels. The plateau values of untreated and carburized 14NiCr14 steels were approximately 0.63 and 0.96, respectively. The results of Fig. 6 show an increase in the CoF of the carburized 14NiCr14 steel as reported by Dobrocky et al. [14].

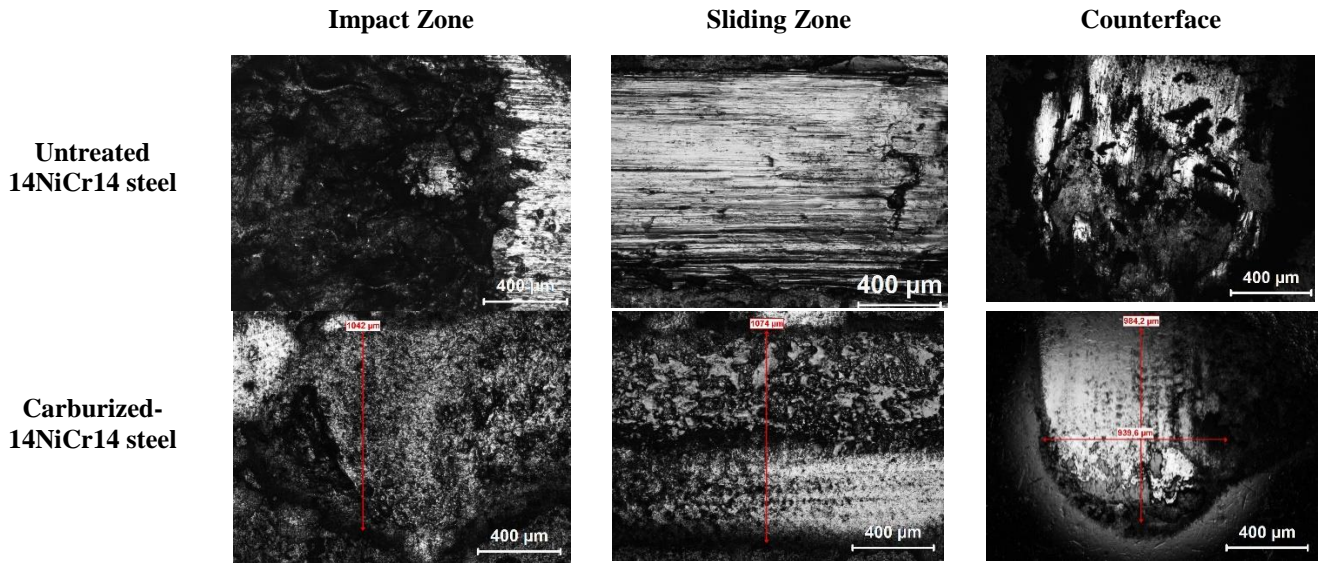
Figure 7. Low magnification LOM images showing the morphology of the wear tracks.

LOM images of the wear tracks formed during the tests are shown in Figs. 7 and 8. The worn surfaces of the untreated 14NiCr14 steel showed severe plastic deformation, with pile-up zones at the edges of the impact and sliding zones (Fig. 2), which were larger in the impact zone than in the sliding zone. High contact pressure causes extreme wear and deep plowing and scratching of the worn surface, resulting in direct metal-to-metal contact [15]. The sliding zone of the untreated 14NiCr14 steel displayed microscale cutting and plowing processes, which were caused by abrasive wear (Figs. 7 and 8). A decrease in the CoF for untreated 14NiCr14 steel will result in an increase in the sliding amplitude, hence causing a greater extent of abrasion wear during the reciprocal sliding test. This observation aligns with the findings depicted in Fig. 6. As carburized 14NiCr14 steel was composed of a hard surface layer on a relatively soft matrix, plastic deformation occurring in the 14NiCr14 steel with high toughness in the core under an impact load could induce surface layer brittle fracture. However, the carburized layer did not detach (Figs. 7 and 8), and the rubbing of the steel ball in the sliding zone caused a combination of adhesive and oxidative

damage to the carburized 14NiCr14 steel (Figs. 7 and 8). The production of the hard layer, which consisted of the carburized layer and the carbon diffusion zone beneath it, as a result of gas carburization had a significant hardening impact, as was anticipated by this formation. The carburized layer exhibited hardness values of $650 \pm 10 \text{ HV}_{0.05}$, whereas untreated 14NiCr14 steel exhibited softer hardness values of $250 \pm 5 \text{ HV}_{0.05}$. During impact-sliding wear tests, it was observed that the steel balls also experienced wear, as depicted in Figs. 7 and 8. The wear scars observed on the contact surfaces of balls have a direct relationship with the size of the wear tracks observed on both untreated and carburized 14NiCr14 steels. This correlation suggests that the wear of the ball is influenced by the dimensions of the contact regions. It is important to acknowledge that the quantity of wear debris that adheres to the surface of the steel ball in contact with untreated 14NiCr14 steel is significantly higher compared to the surface of the steel ball in contact with carburized 14NiCr14 steel during impact-sliding wear tests.

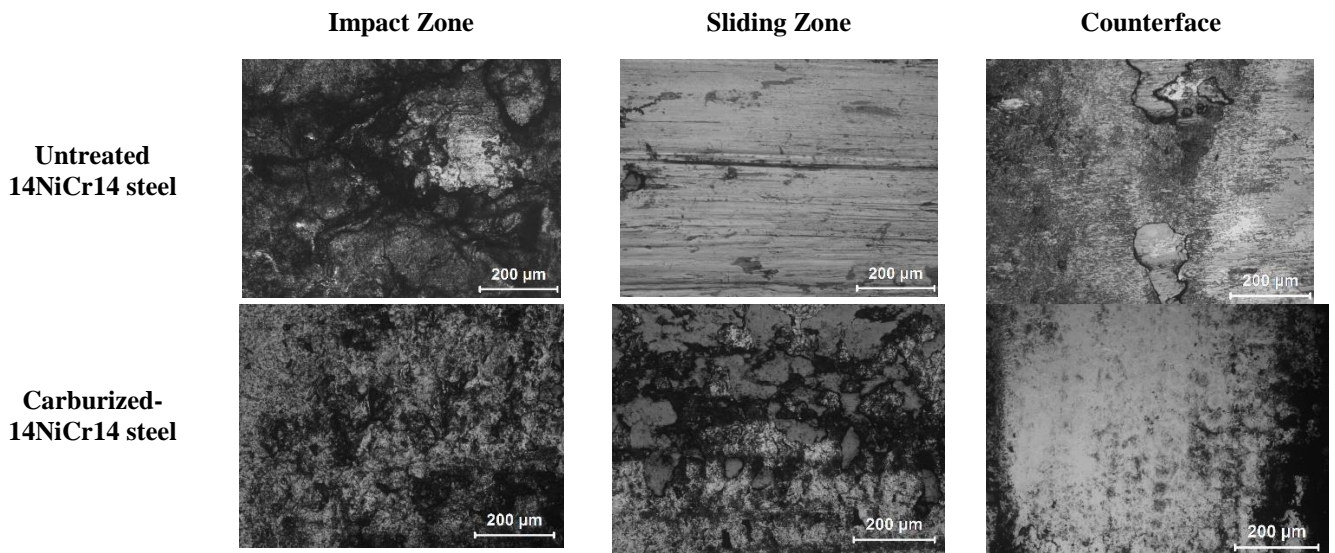
Figure 8. High magnification LOM images showing the morphology of the wear tracks.
