Examination of the Design Competence of Superstructures and Outdoor Facilities in the Dilek Peninsula Büyük Menderes Delta National Park

Citation: Eşlik, B. & Göktuğ, T. H. (2024). Examination of the design competence of superstructures and outdoor facilities in the Dilek Peninsula Büyük Menderes Delta National Park. *Journal of Architectural Sciences and Applications*, 9 (1), 350-367.

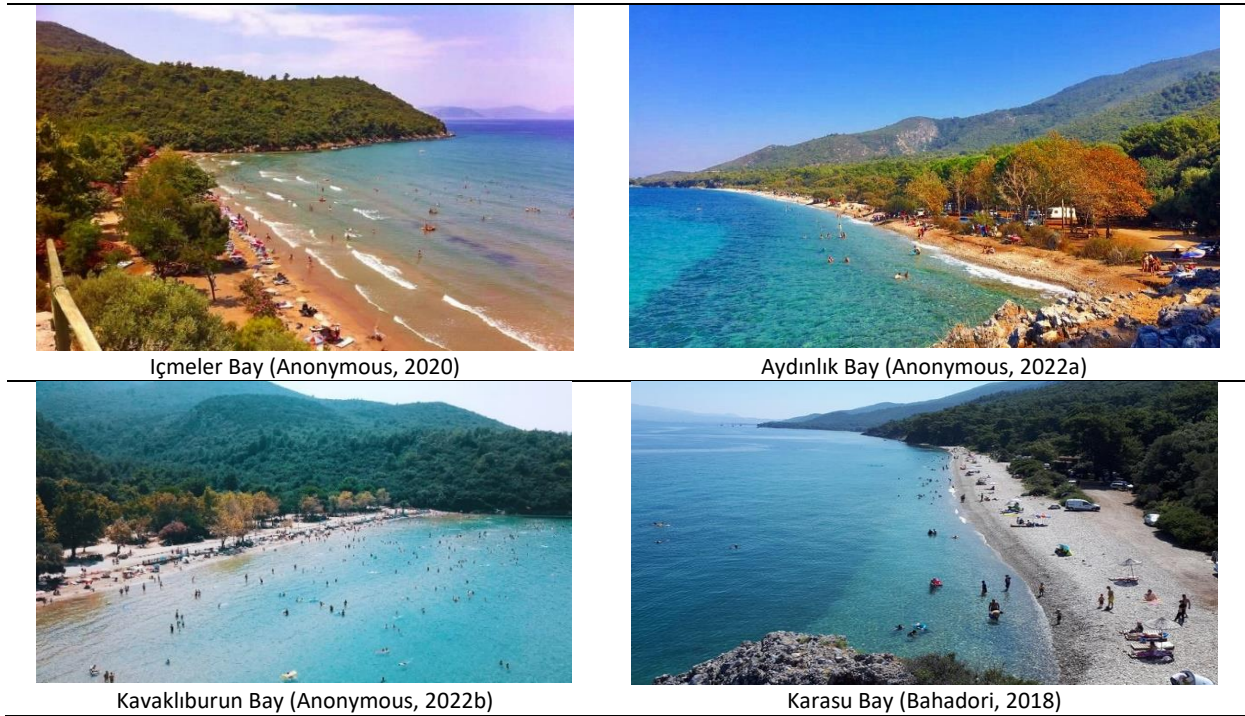
Figure 3. Kalamaki Bays

In this study, an examination was conducted on the superstructures and outdoor facilities situated along the Kalamaki Bays and the primary road axis connecting these bays to the entrance gate of the National Park (Figure 3). The overall physical attributes of the locations, as well as the superstructures and outdoor facilities scrutinized, along with their respective quantities, are detailed in Table 1.

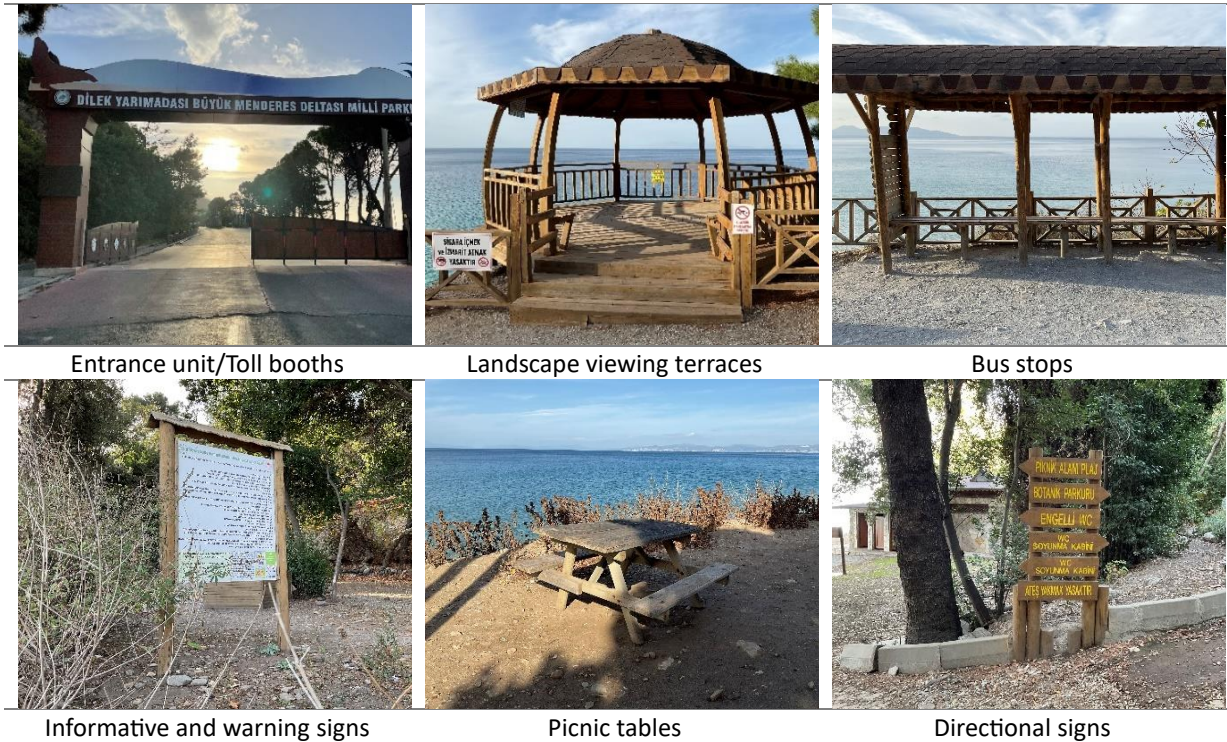
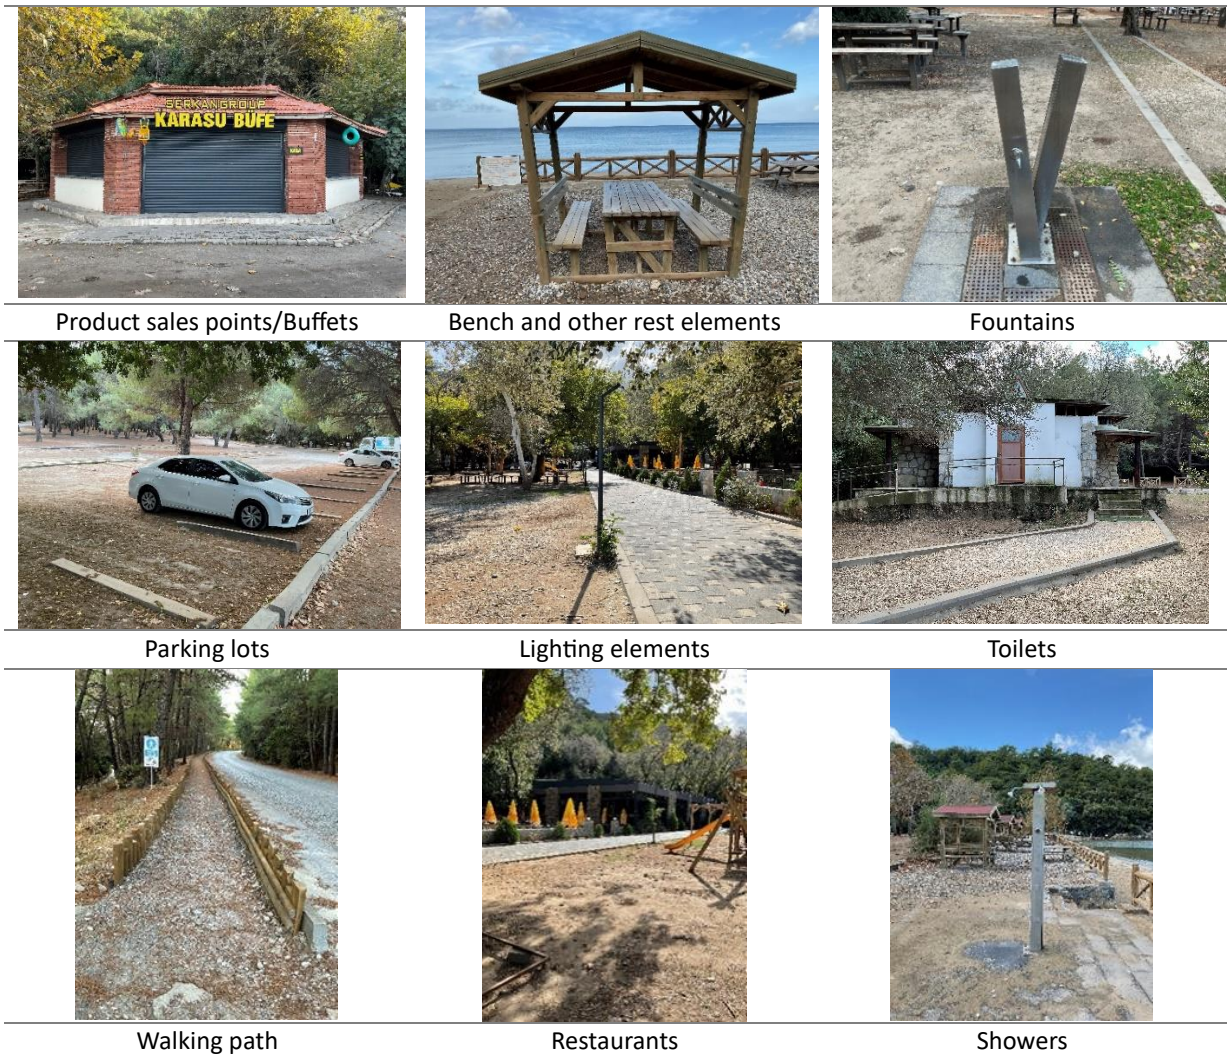
Figure 4. Some outdoor facilities in the National Park (Eşlik & Göktuğ, 2023a)

The photographs of the outdoor facilities observed in Dilek Peninsula Büyük Menderes Delta National Park are provided in Figure 4.

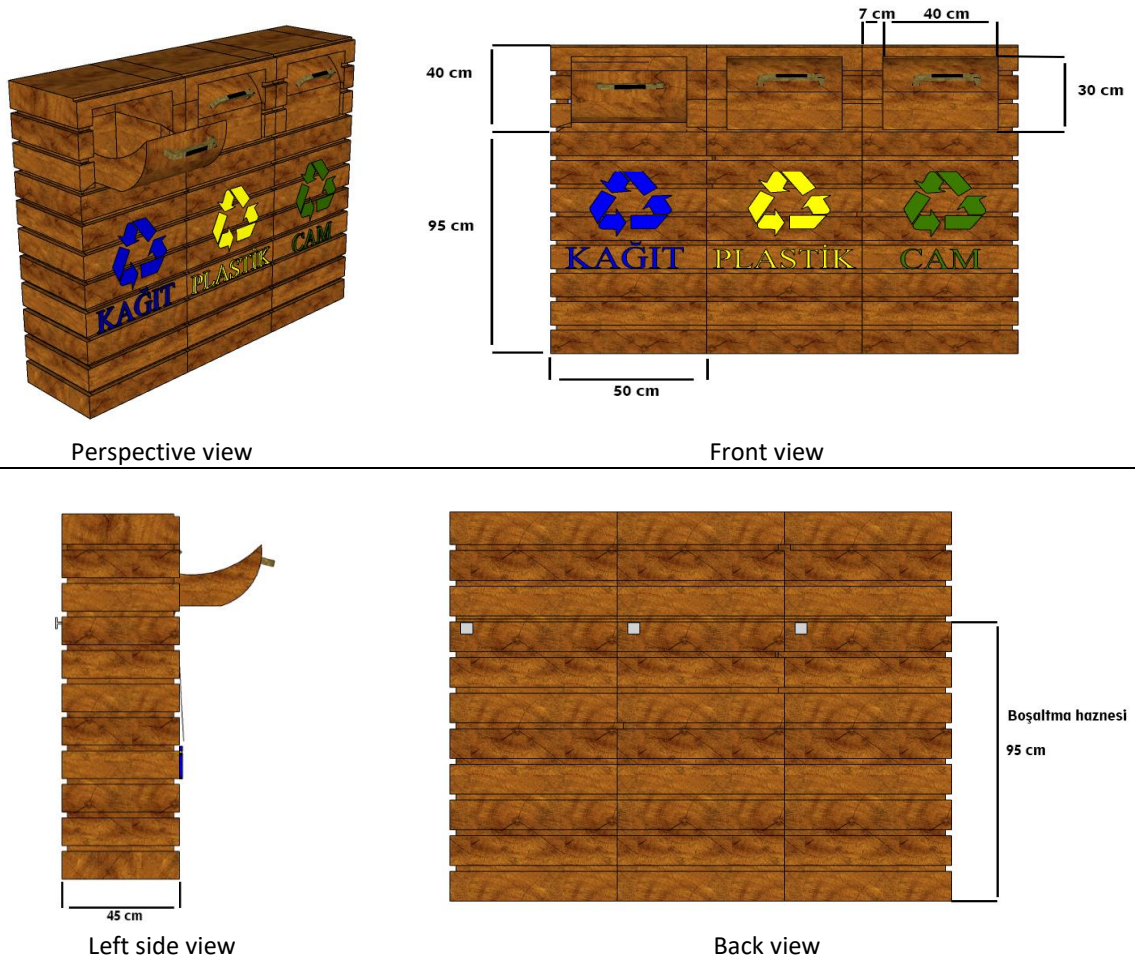
Figure 5. Trash can design (Eşlik & Göktuğ, 2023b)

A design proposal for garbage bins has been developed and illustrated in Figure 5. In this design suggestion, the trash can lid is opened by pulling it forward and the garbage is placed inside this lid. In this way, wild animals cannot enter the trash can. The accumulated garbage can be emptied by unlocking the discharge door located on the side of the trash can. Impregnated pine was selected as the primary material for the main body in this design.

One of the primary challenges arising from the dense visitor masses is the issue of solid waste. On crowded days, garbage is indiscriminately discarded as bins reach full capacity. Leaking water from

these waste containers not only contaminates the ground but also attracts wild animals to the vicinity. While foraging through garbage cans to meet their nutritional needs, garbage bins may inadvertently topple or wild animals become trapped inside the bins, resulting in potential injury or even fatality.

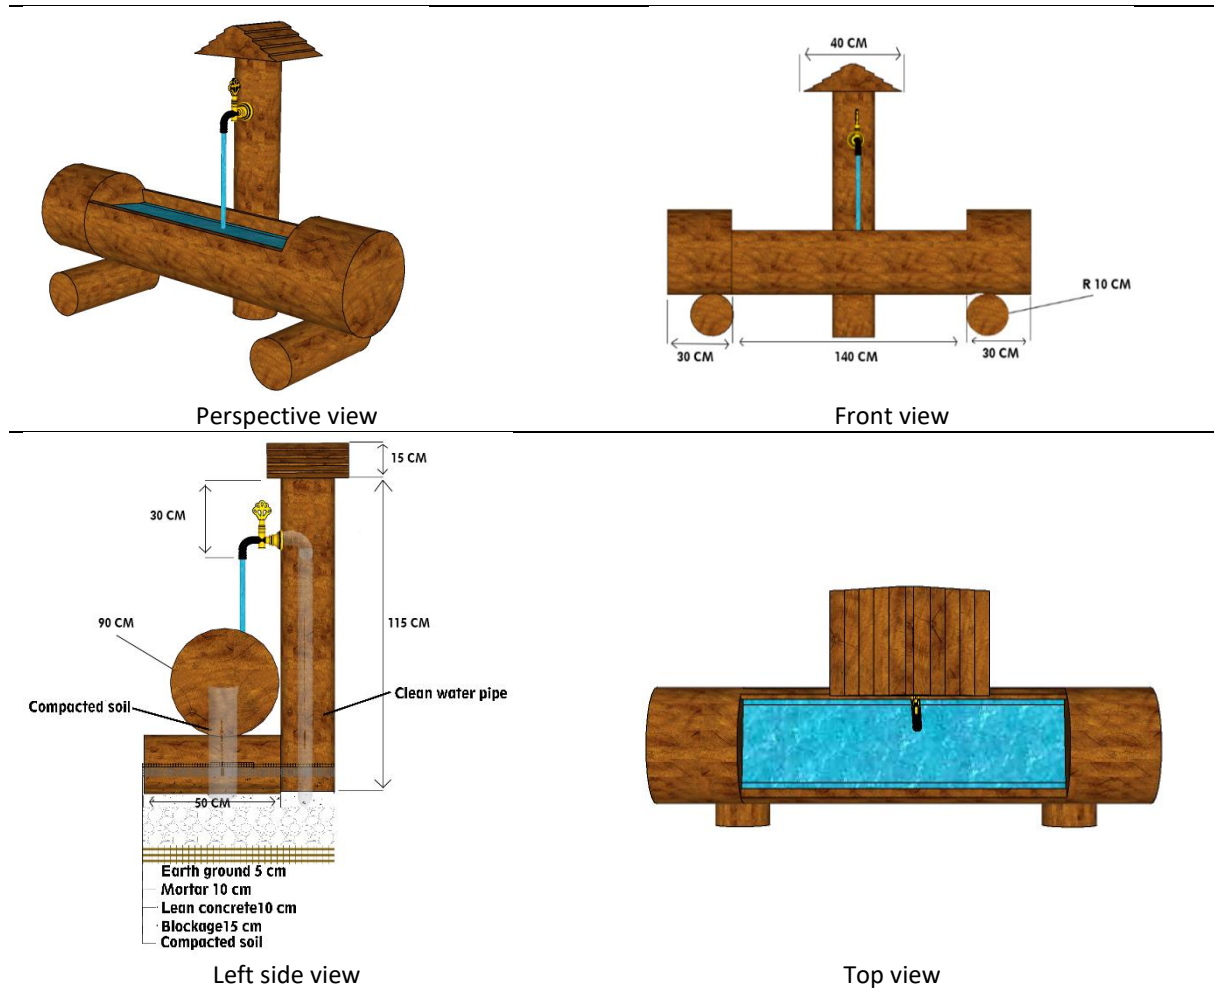
Figure 6. Fountain design (Eşlik & Göktuğ, 2023b)

It is crucial to acknowledge that the perception of aesthetic appearance in national parks significantly differs from that in open and green urban areas. Therefore, the chosen materials for designs must be durable and harmonize with nature. Although the fountains designed in İcmeler Bay are constructed from metal, a durable material, they appear incongruent with nature. The fountains in other bays exhibit partial compatibility with nature but suffer from poor maintenance, low functionality, and aesthetic appeal. As an alternative to these fountains, a design utilizing natural wood material is presented in Figure 6. In this fountain design, the interior of an impregnated pine tree is carved, housing a clean water pipe that allows water to flow into the fountain. The reservoir, through which the water flows, retains water up to a certain level. When the water reaches the discharge pipe's level, it is released. This designed fountain effectively caters to wildlife's water needs by accumulating water in its reservoir up to a specified level.

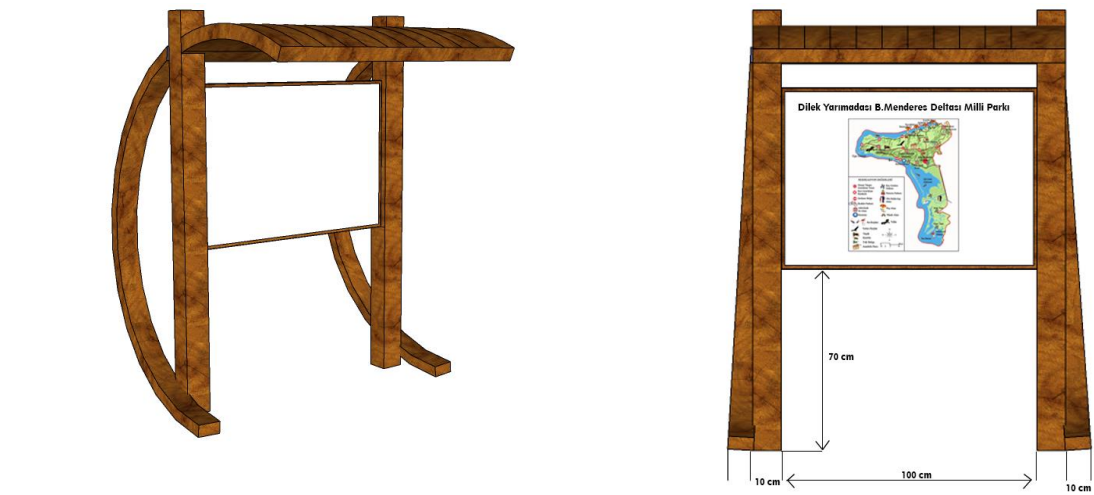
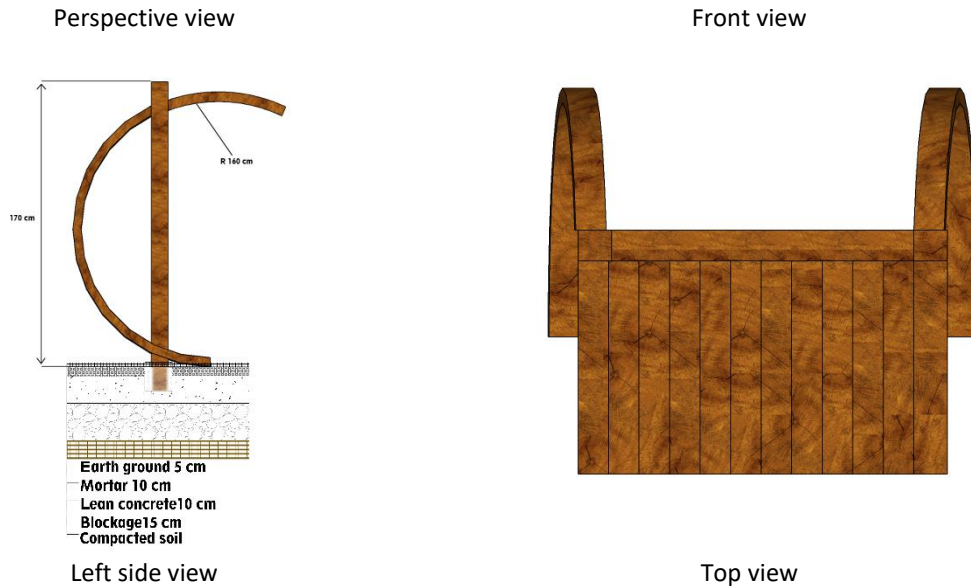
Figure 8. Informative sign sample design (Eşlik & Göktuğ, 2023b)

One of the essential elements in national parks includes information boards and warning signs. Information boards play a crucial role in explaining the natural and cultural wealth of the National Park, offering insights into recreational activities, and thereby providing visitors with valuable information. Warning signs are pivotal for visually communicating visitor rules, designated areas, and behaviors, emphasizing situations that require visitor sensitivity. Therefore, it is imperative that these panels and signs are visually striking, appropriately positioned, and easily readable. During the inspections, it was observed that many of these elements had lost their functionality due to faded and unreadable inscriptions. An alternative design has been developed, incorporating a roof system to mitigate the impact of adverse weather conditions on informative and warning signs used in the National Park, as presented in Figure 8. The design utilizes impregnated pine for the construction of the sign's poles and roof, with mica serving as the protective material for the written content on the sign.

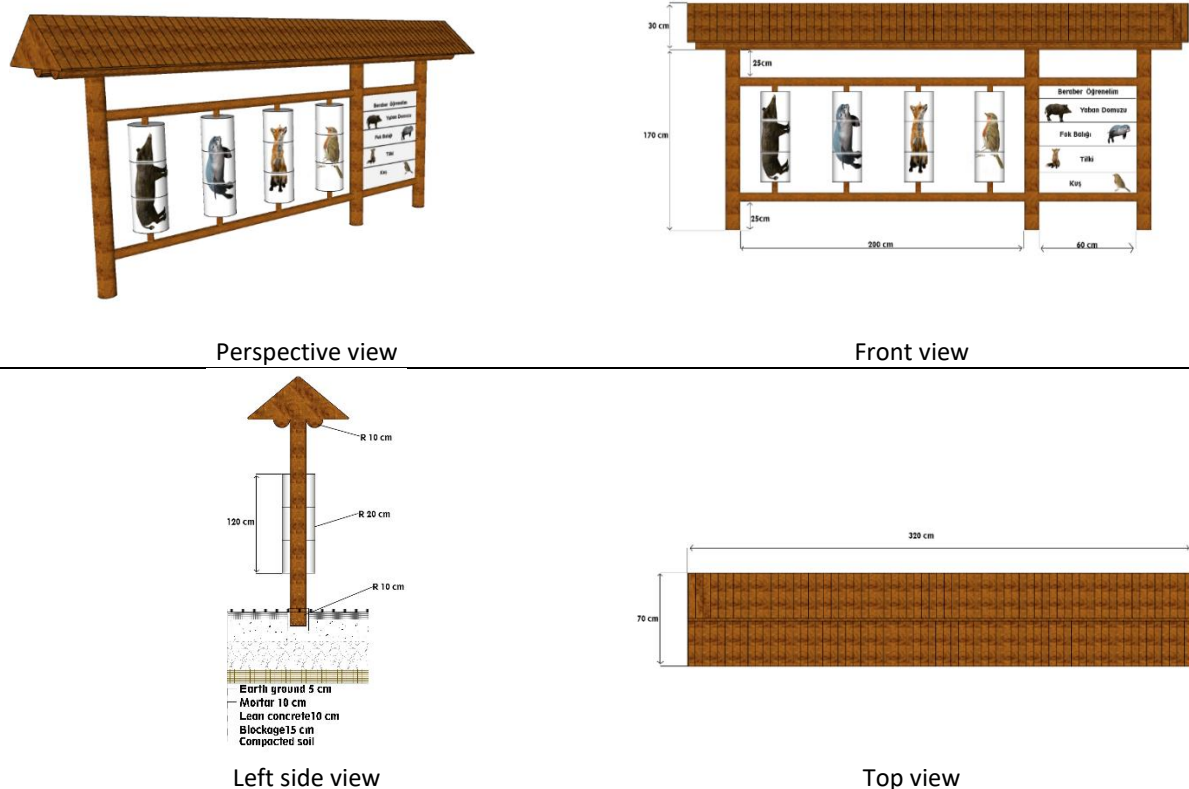
Figure 9. Design of a fauna activity game called "Beraber Öğrenelim" (Eşlik & Göktuğ, 2023b)

As a result of the evaluations conducted on the design criteria of the children's playgrounds in the National Park, it can be concluded that it achieved a success rate of 71.25%, indicating a commendable success. Nevertheless, children's play elements in the National Park exhibit similar features and functions as those found in urban areas. Instead of conventional children's play elements in national parks, there is an opportunity to incorporate educational designs where children can learn various aspects of the national park, such as flora and fauna, through play. To illustrate this concept, a game element was designed in which the image of a wild animal native to the National Park is completed when pieces are rotated and aligned, as depicted in Figure 9. The main frame and roof of the design utilize impregnated pine wood, circular PVC is employed in the rotation mechanism, and mica material serves as a protector on the informative game board.
