Düzce University Journal of Science & Technology

Research Article

The effect of Centrifuged Hot-Dip Galvanisation (SHDG) Process on the Corrosion on Nuts

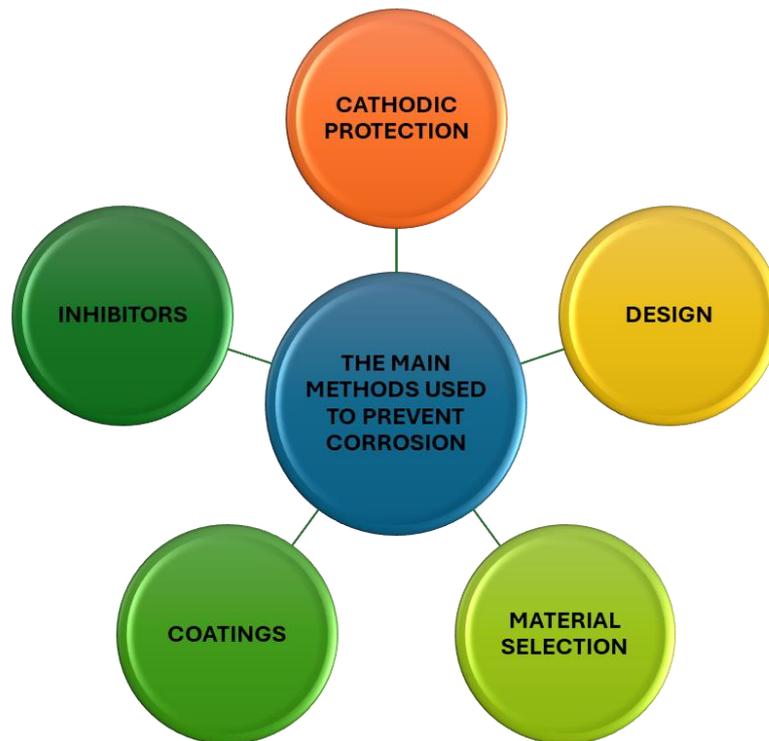
Figure 1. The main methods used to prevent corrosion

There are five primary methods of corrosion control that play a vital role in mitigating the detrimental effects of corrosion: material selection, coatings, inhibitors, cathodic protection and design. Material selection involves selecting materials that are inherently resistant to corrosion or that can be treated to increase their resistance. Coatings, such as paints and metallic coatings, create barriers between the metal surface and the corrosive environment, preventing direct contact and corrosion initiation. Inhibitors are chemicals that can be added to the environment or applied directly to the metal surface to inhibit corrosion reactions. Cathodic protection involves the application of an external electrical current or sacrificial anode to shift the corrosion potential of the metal to a more passive state. Finally, design considerations such as proper drainage, ventilation and avoidance of crevices can minimize corrosion by reducing the accumulation of moisture and corrosive agents. Each of these methods is critical to effective corrosion management and will be further explored in subsequent chapters to provide a comprehensive understanding of corrosion control strategies (Figure 1).

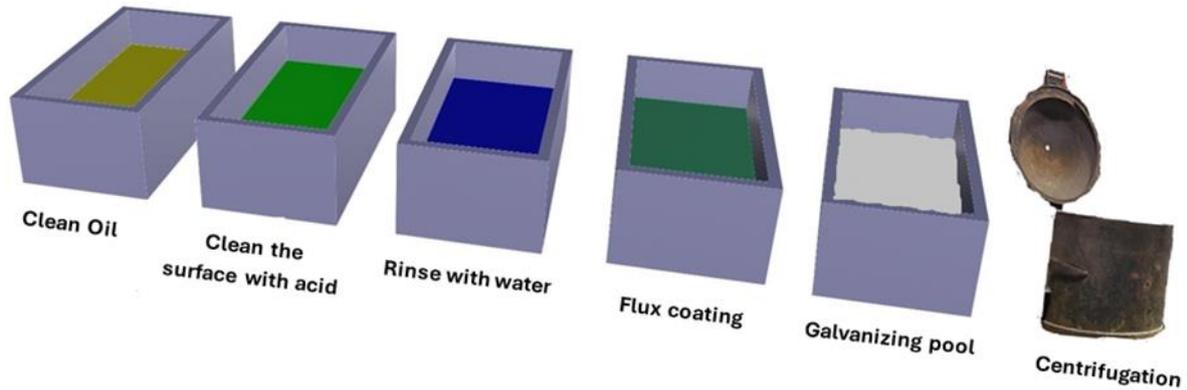
Figure 2. The SHDG process

The hot-dip galvanizing process offers a unique combination of superior properties such as high strength, formability, light weight, corrosion resistance, low cost and recyclability. In the hot dip galvanizing process, a steel sample is cleaned, fluxed and then immersed in a molten zinc bath at a temperature of approximately 450 °C [7]. Hot dip galvanized steels have been extensively used in industrial sectors such as automobiles, household appliances or construction due to their excellent corrosion resistance properties [8], [9]. While the hot-dip galvanizing process is successfully applied to large metal parts, the centrifugal hot-dip galvanizing process (SHDG) is applied to small metal parts. Centrifugation is employed to achieve a homogeneous coating by removing excess zinc from the surface. In this process, the steel product is rotated in a crucible to facilitate the removal of excess zinc through centrifugal force. Consequently, a more uniform and thinner zinc coating is achieved, enhancing the quality of the coating and providing more durable protection (Figure 2).

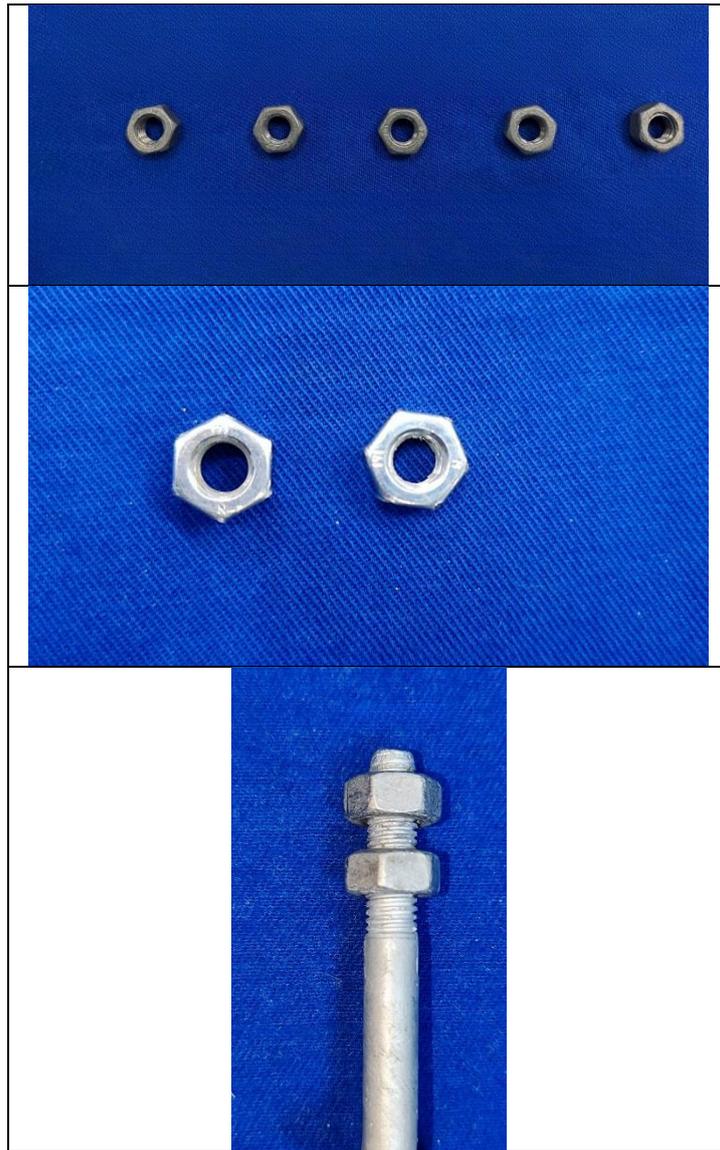
A salt spray test (ASTM B117) provided relative corrosion resistance values for SHDG coated nuts in a standardised corrosive environment. The experimental results presented in this study were obtained using 5% NaCl at 35 °C with 50% humidity for 13 days. Figure 3 shows images of bolts and nuts coated by the SHDG process prior to salt spray testing. Before the salt spray test, the surfaces of the bolts and nuts appear to be bright and intact appearance.

Figure 3. Visual inspection before the salt spray test

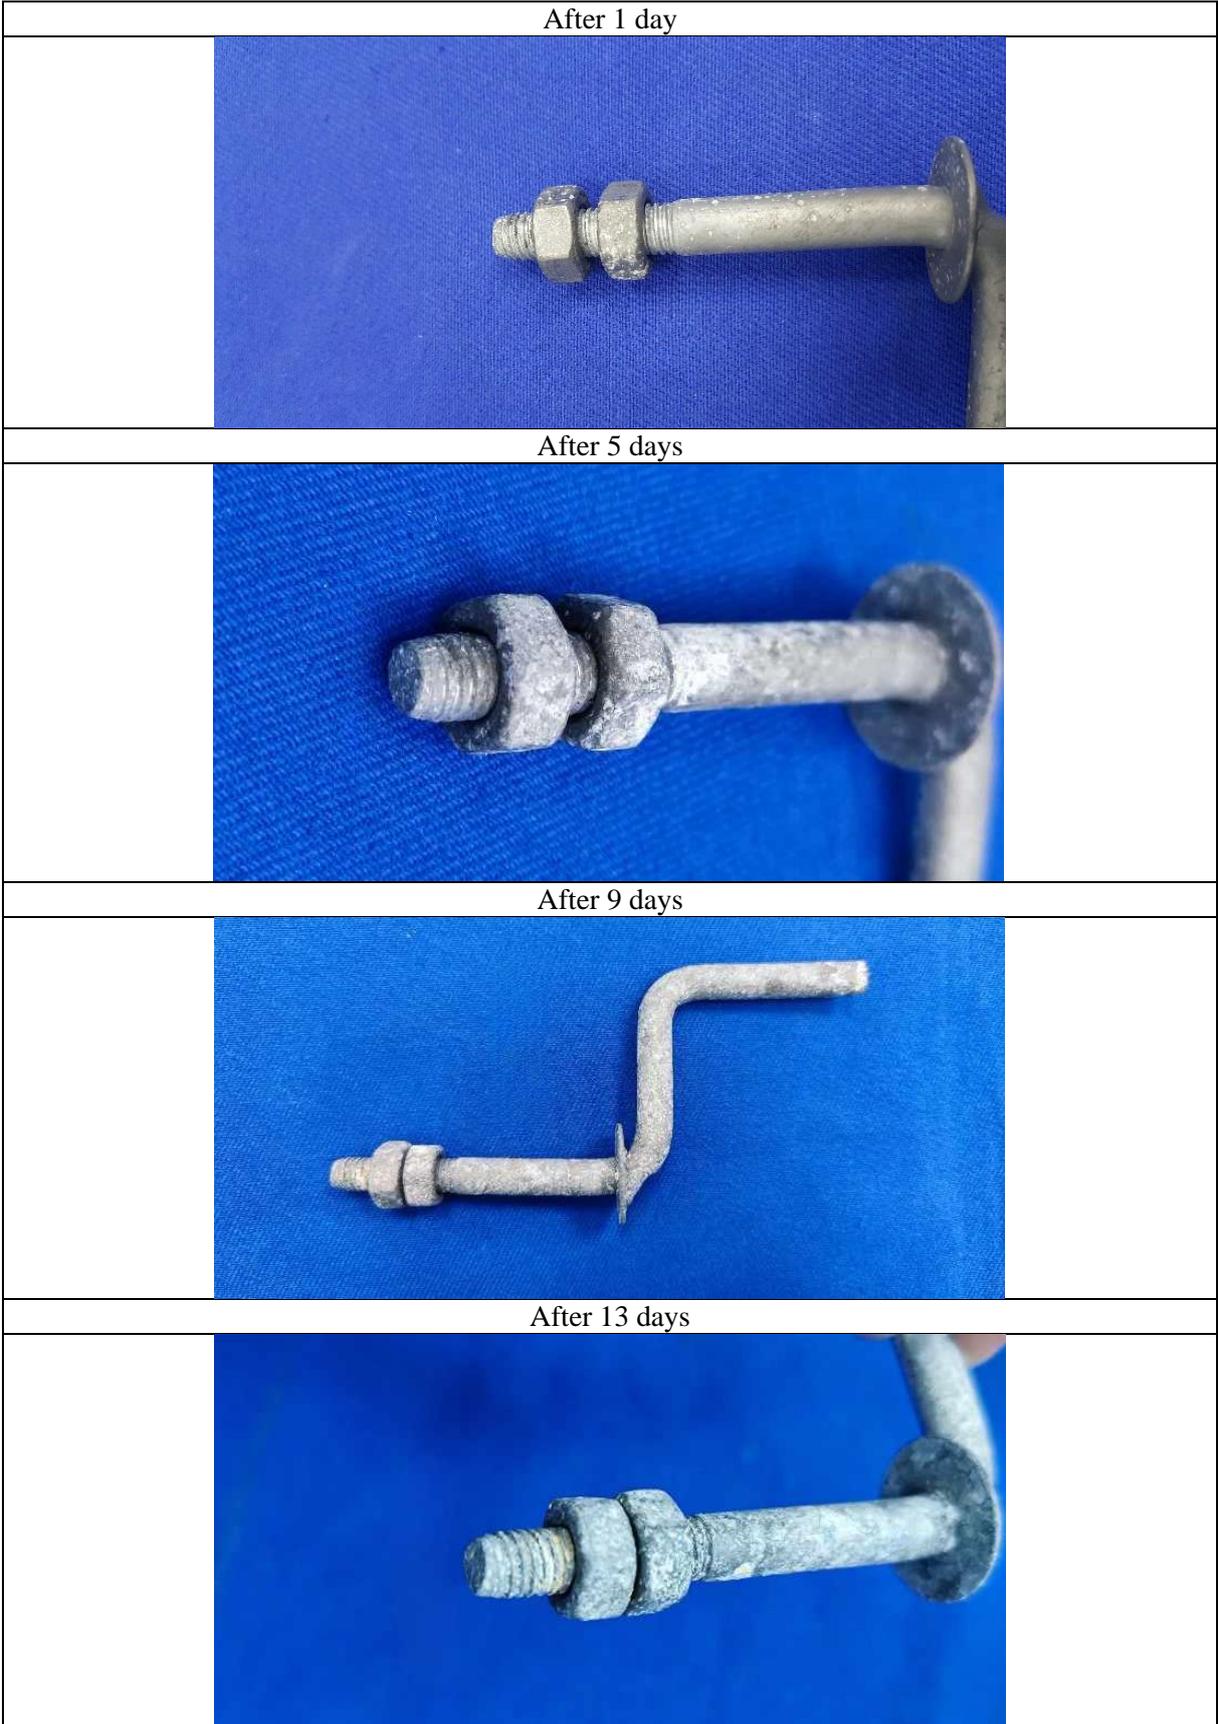
The specimens placed in the salt cabinet were removed at the end of the 1st, 5th, 9th and 13th days respectively and examined visually (Figure 4). After 1 day of salt spray testing, it was observed that the lustre of the coating had diminished and the zinc coating had begun to corrode, resulting in the appearance of white patches. It can be seen that the degree of corrosion increases with the duration of exposure. At the end of the 13th day, white corrosion products were observed prominently covering the surfaces of both the bolt and nut samples. This observation indicates that the zinc coating applied to these components has undergone uniform corrosion. No brown colour formation was observed on the surface of the bolt and nut at the end of the specified periods. The continued presence of the protective zinc coating, indicated by the absence of brown rust, demonstrates that the underlying matrix material remains protected from corrosive elements and potential degradation. The coating thickness of the nut removed from the test chamber on the 13th day of the salt spray test was 224 μm . The increase in coating thickness may be due to the formation of possible oxide layers such as ZnO , $\text{Zn}_5(\text{OH})_8\text{Cl}_2 \cdot \text{H}_2\text{O}$ or $\text{Zn}_5(\text{CO}_3)_2(\text{OH})_6$ formed on the surface of the nut [12].

Figure 4. Visual inspection after the salt spray test

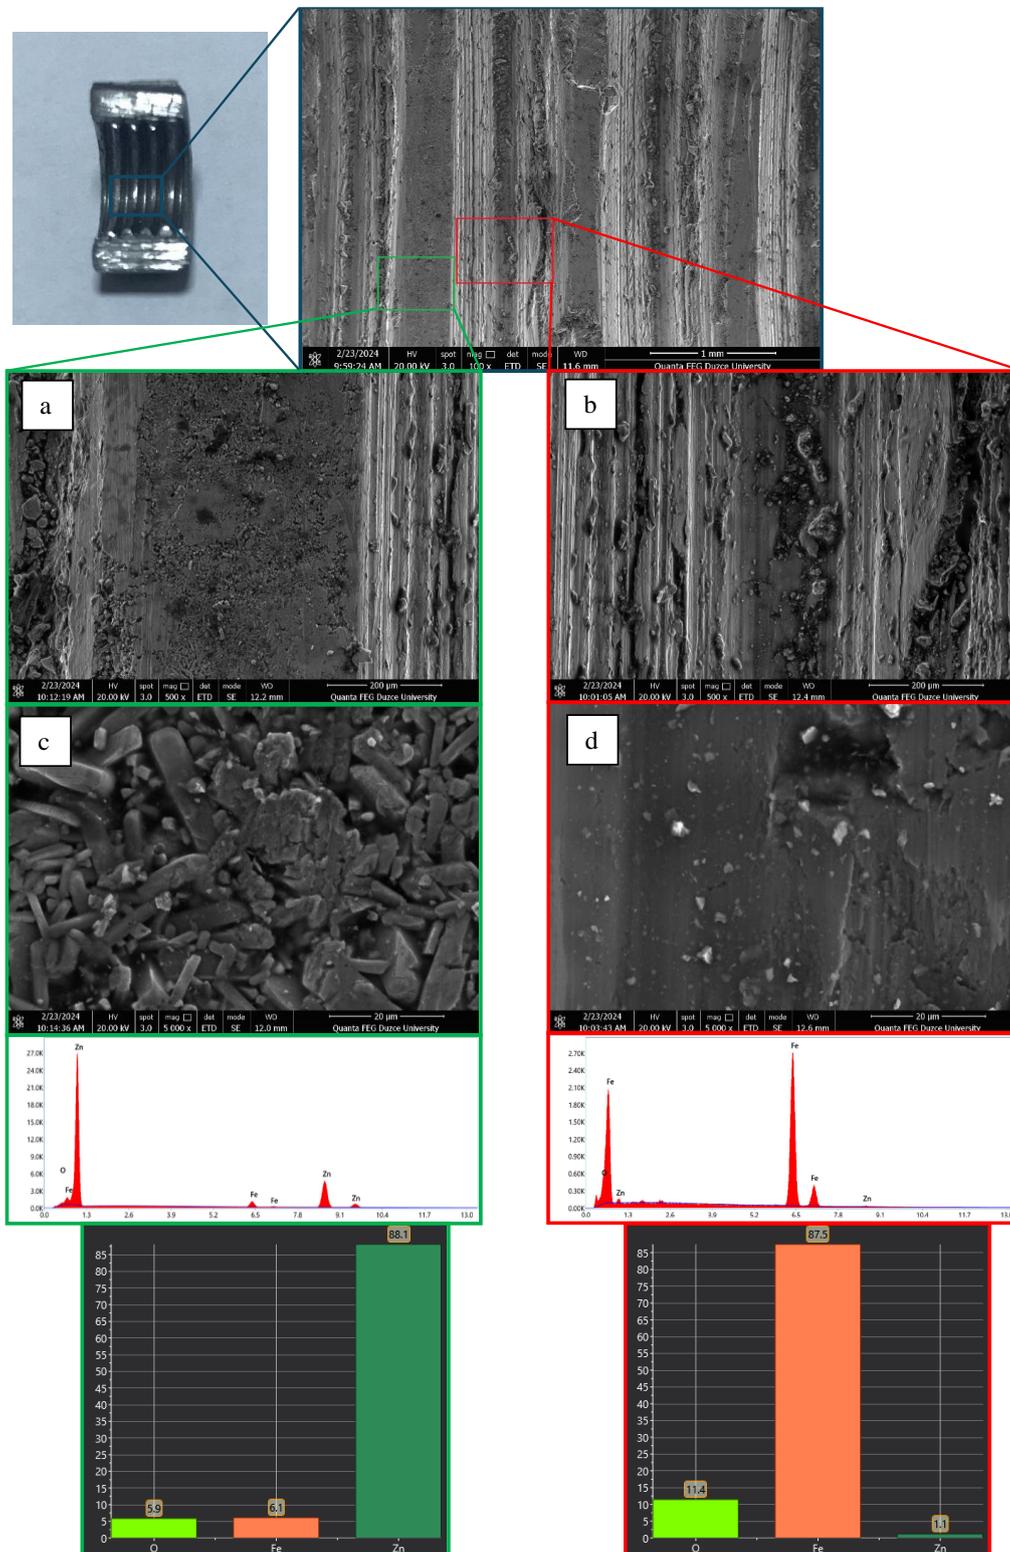
Figure 5. SEM images of galvanized nuts before corrosion (a and c: 500x and 5000x of top regions; b and d: 500x and 5000x of hollow regions)

In Figure 5, the red area shows the hollow area and the green area shows the top area in the galvanized nut sample. It can be seen that the surface is rough as a result of coating the nut with Zn. As a result of EDS analysis, Zn, Fe and O were detected on the surface of the nut. Zn, used as the main coating element, functions in two capacities, both as a barrier against corrosion and as a matrix element protector [13]. As a result of EDS taken from the tops in the thread area, 88% Zn was detected, while 1% Zn (87.5% Fe) was detected in the hollow areas. This indicates that the top areas are better covered with Zn, while the hollow areas are less covered. Similarly, in the EDS element mapping results, it can be seen in Figure 6 that the Zn element is concentrated in the top regions and Fe is dominant in the hollow regions.

SEM-EDS analysis was performed to investigate the surface morphologies of galvanized nuts cut in half before corrosion and exposed to a corrosive environment for 13 days. Figure 5 shows SEM images taken from the thread area of galvanized nuts before exposure to corrosion.

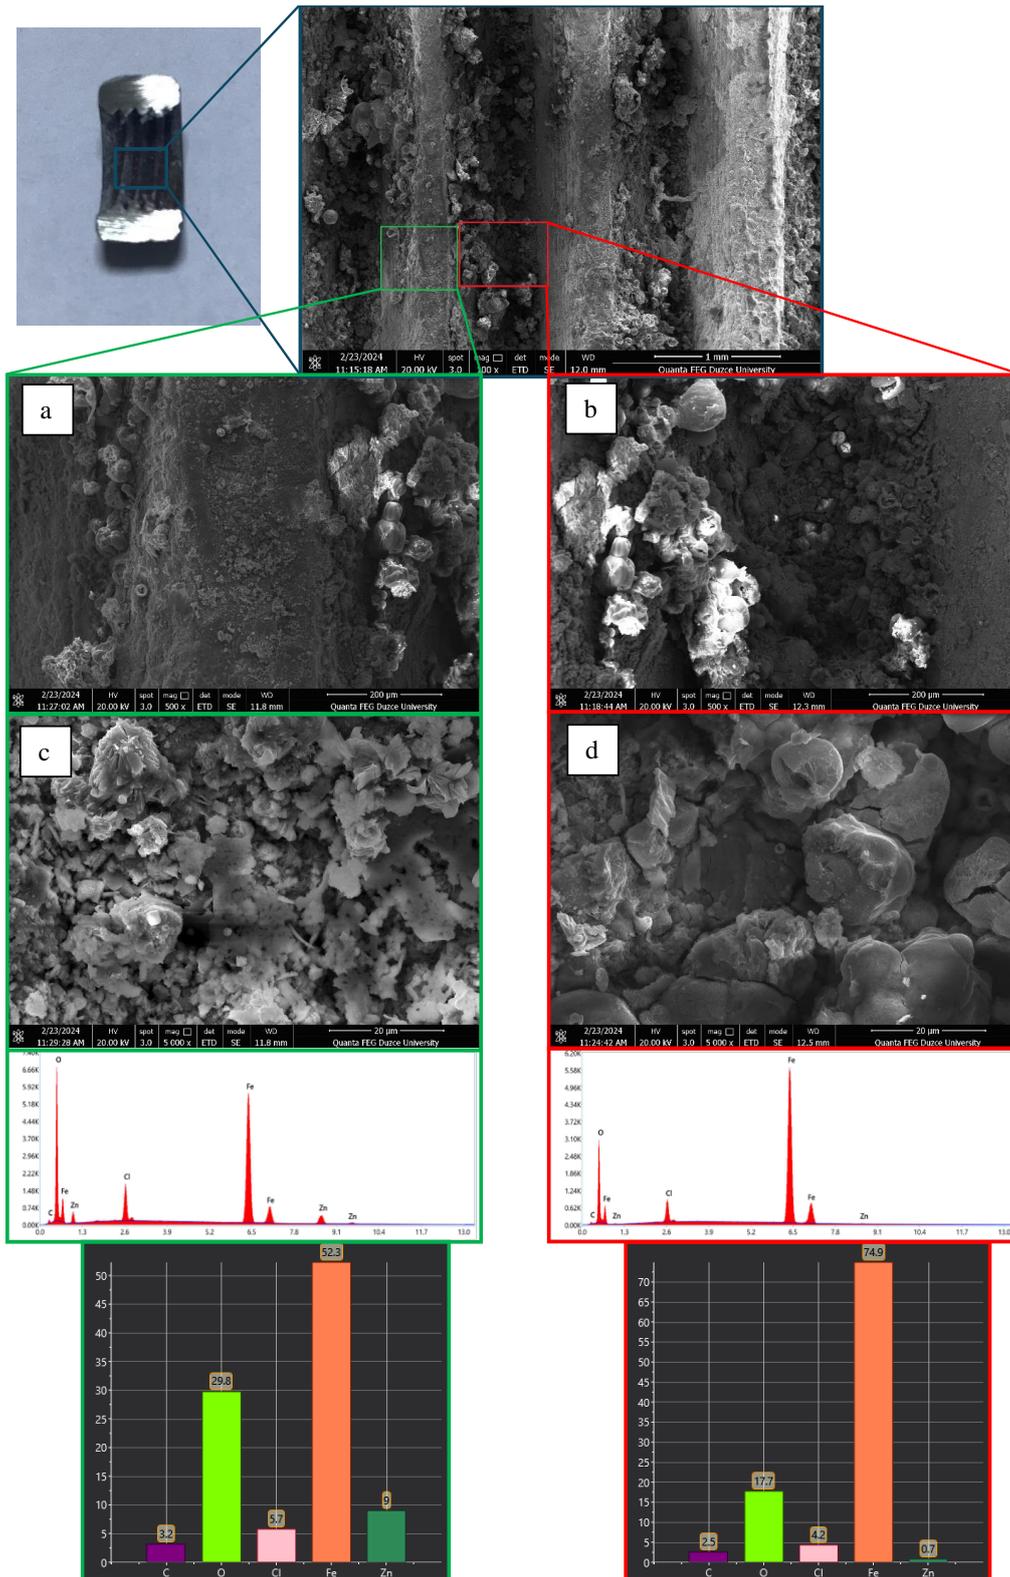
Figure 7. SEM images of galvanized nuts exposed to corrosive environment after 13 days (a and c: 500x and 5000x of top regions; b and d: 500x and 5000x of hollow regions)

In the SEM images of the galvanized nut after corrosion, it is seen that corrosion products occur in both hollow and top regions (Figure 7). After 13 days, it is seen that different corrosion products are formed in different parts of the surface. EDS data show that Zn, Fe and O are the main components of corrosion products. The presence of Cl ions on the surface was observed upon exposure to the salt test. Zn, the

main component in the coating layer, decreased with the intensification of corrosion after 13 days of exposure. It was determined that the Zn rate was lower in the hollow regions compared to the top regions. While the Fe content was 52.3% in the top region, it was found to be 75% in the hollow region. Since it is difficult for the electrolyte to reach the thread area during the first exposure period in bolt-nut samples, the area is dry and corrosion is less. However, when it enters the electrolyte over time, it keeps the thread area wet and the deterioration of zinc accelerates the formation of Fe-based corrosion products on the surface [13]. Figure 8 shows the EDS element mapping images of galvanized nut samples after corrosion. According to the EDS mapping result, the presence of corrosion products in the thread area of the galvanized nut was detected. It has been determined that corrosion products are associated with regions richer in Fe.

Figure 7 shows SEM images and EDS results of galvanized nuts exposed to a corrosive environment for 13 days.

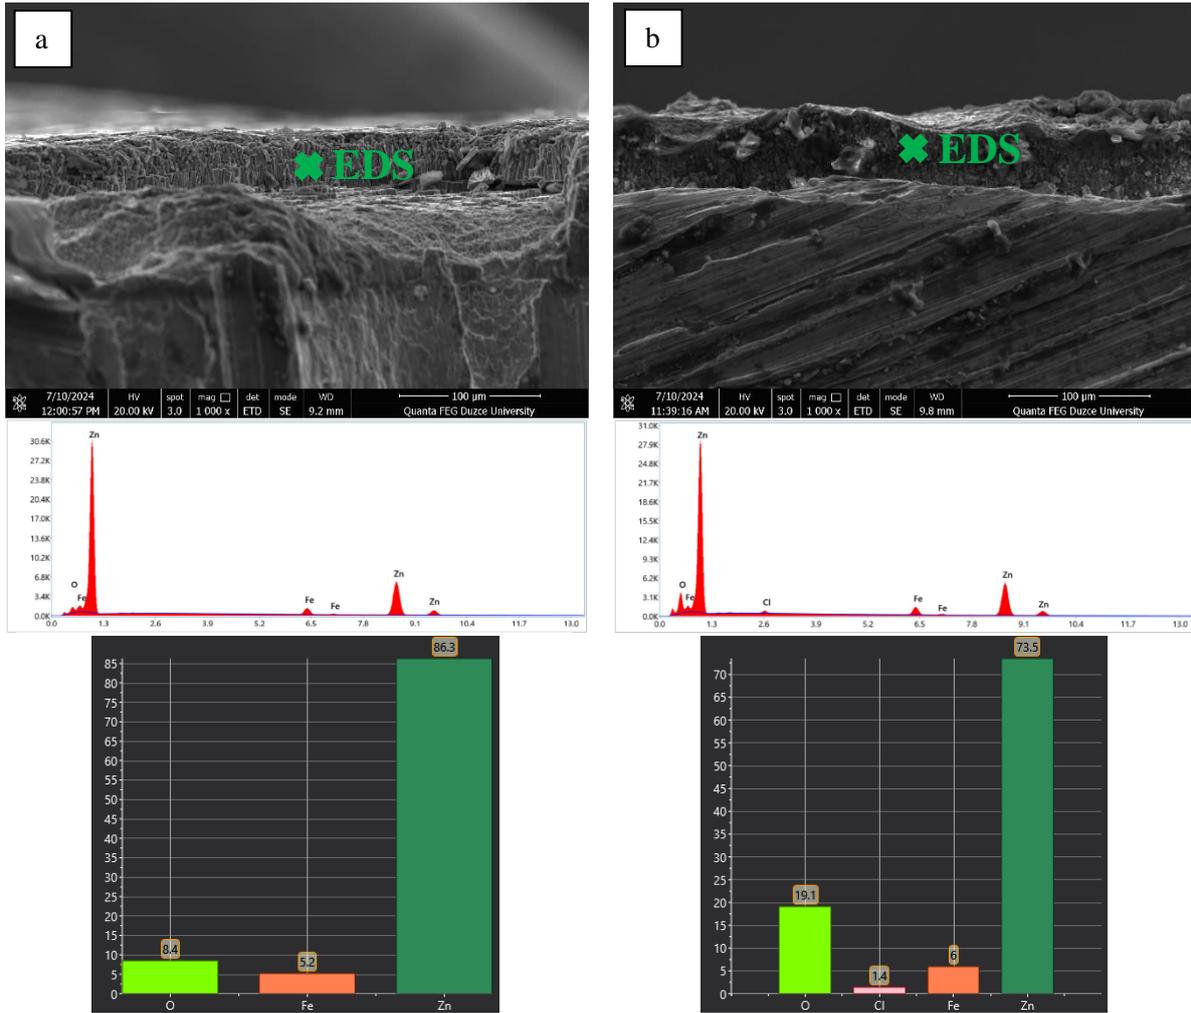
Figure 9. The cross-sectional images and EDS spectrum of the nut: (a) Before corrosion and (b) After the salt spray test.

It can be seen from the cross-sectional morphologies shown in Figure 9 that the layer thickness on the surface increases when galvanised nuts are exposed to corrosion. As mentioned in the salt spray test results section, the increase in thickness of the Zn layer after 13 days is due to the formation of oxide layers on the surface. The EDS results for the elements O, Fe and Zn in the coating layer before the corrosion tests were 8.4%, 5.2% and 86.3% respectively. After being subjected to the salt spray test for 13 days, the EDS results showed that the O and Fe ratio increased to 19.1% and 6%, respectively, while the Zn ratio exhibited a decrease to 73.5%. Additionally, the presence of 1.4% Cl from the environment was also observed.

The cross-sectional images of galvanized nut specimens before and after 13 days of exposure to the salt spray test were observed using SEM-EDS, as shown in Figure 9.

4. The cross-sectional SEM images showed that the thickness of the coating layer deposited on the nuts by the SHDG process increased after the salt spray test for 13 days. The EDS results of the coating layer showed an increase in the O and Fe ratios, a decrease in the Zn ratio and the presence of the Cl element on the surface.
