# Seismic Risk Evaluation of Existing Reinforced Concrete Buildings: A Case Study for Çanakkale-Türkiye

**Abstract** – Türkiye is in an important earthquake zone, and most of the population is under seismic hazard. The high loss of lives in the past earthquakes indicates that our existing building stock is vulnerable. In this study, a field survey was carried out to determine the existing earthquake risks of reinforced concrete buildings in İsmetpaşa, Barbaros, Cevatpaşa, Kemalpaşa, Namikkemal, Esenler, and Fevzipaşa Neighborhoods of Çanakkale city center. This study was conducted to specify the regional distribution of risky buildings to be examined by the street survey method called "Simplified methods that can be used to determine the regional risk distribution of buildings" in the implementation regulation of Law No. 6306. For this purpose, 585 reinforced concrete buildings were examined with this method, and the earthquake performance scores of these buildings were determined. The performance scores calculated as a result of reflecting the number of stories, earthquake hazard zone, type of structural system, and structural irregularities of the buildings were evaluated based

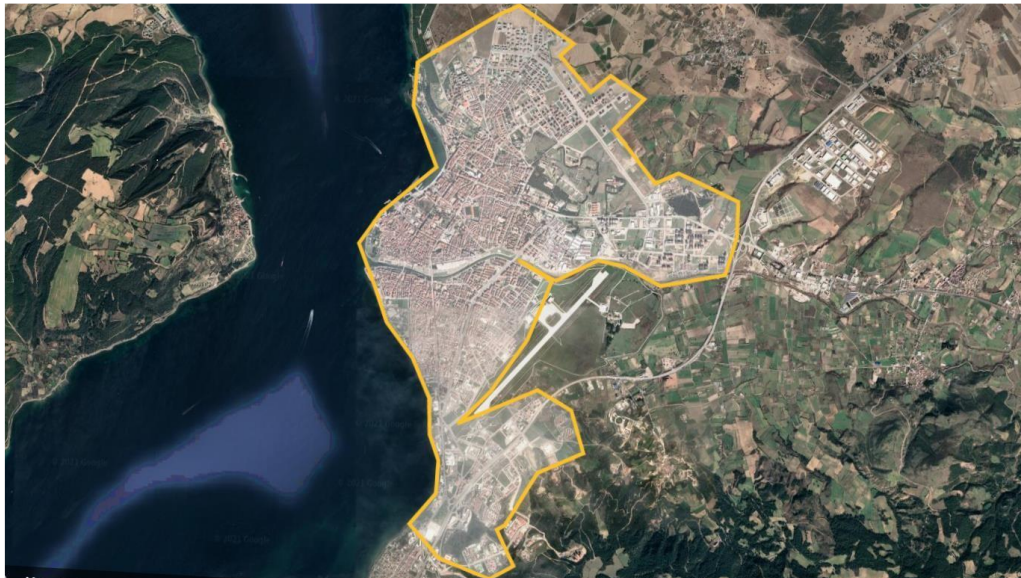
**Figure 2.** Satellite image of the study area [31]

The surface area of the central district of Çanakkale is about 94900 hectares. Figure 2 specifies the borders of the study area.

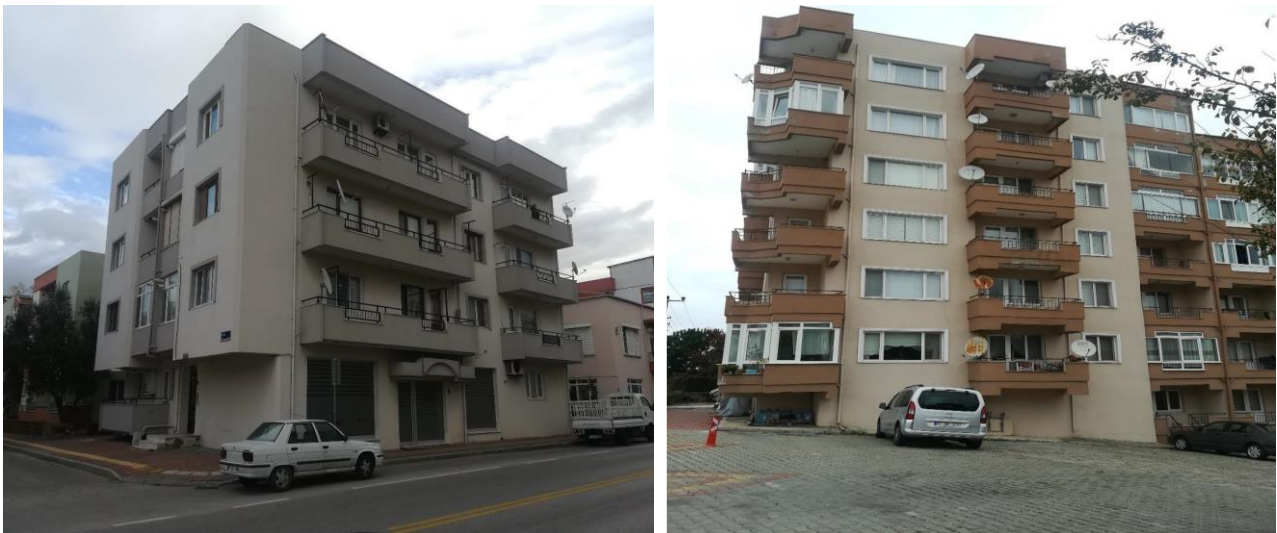
**Figure 5.** Building examples

Using these parameters, 585 RC buildings in all the neighborhoods in Çanakkale city center were selected randomly and recorded in data collection forms. While making these selections, care was taken to reflect a certain distribution. Figure 4 indicates the distribution of building locations in the study. Figure 5 shows two building examples from the study.

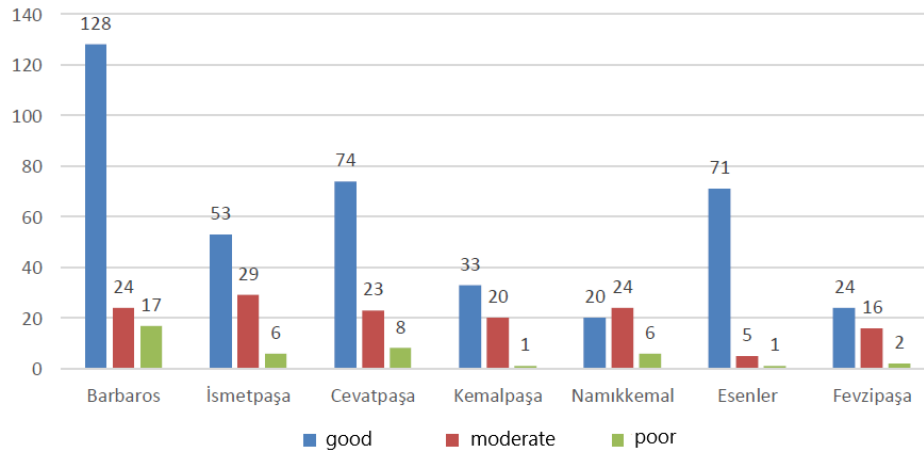
**Figure 9.** Building apparent quality according to neighborhoods

Figure 9 indicates the apparent quality distribution according to neighborhoods. When the results are evaluated as a percentage, the percentage with good apparent quality was calculated as 92% in Esenler, 76% in Barbaros, 70% in Cevatpaşa, 67% in İsmetpaşa, 61% in Kemalpaşa, 57% in Fevzipaşa and 40% in Namikkemal. This ranking was largely accurate regarding the construction process for Çanakkale city center.

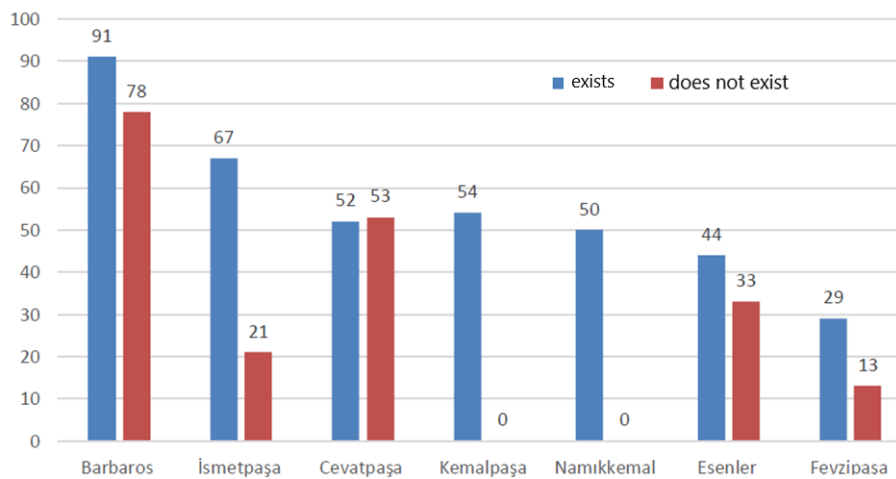
**Figure 10.** Soft/Weak story based on neighborhoods

The distribution of soft or weak stories according to neighborhoods is seen in Figure 10. The soft or weak story rate was calculated as 100% in Kemalpaşa and Namikkemal, 76% in İsmetpaşa, 69% in Fevzipaşa, 57% in Esenler, 54% in Barbaros and 50% in Cevatpaşa. Looking at these ratios, it is possible to say that a soft or weak story is the type of irregularity that is generally the most common. In the Kemalpaşa and Namikkemal Neighborhoods, shops and stores are on the ground floors of all buildings, as seen in Figure 10.

Our study found soft stories with values ranging from 50% to 100% and heavy overhangs ranging from 37% to 63% were the most common irregularities in existing buildings according to neighborhoods. Soft story, especially with significantly higher story heights, may cause sudden collapse during an earthquake. Buildings with both low-performance scores and also soft stories can be prioritized.

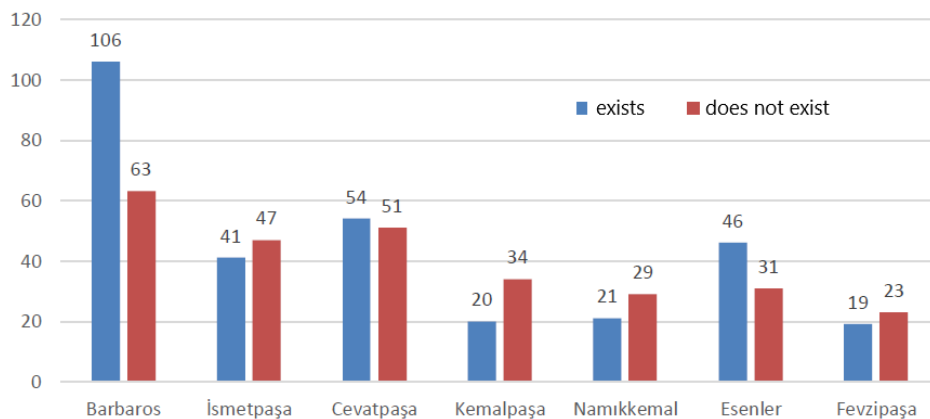
**Figure 11.** Heavy overhangs, according to neighborhoods

Figure 11 shows the distribution of heavy overhangs according to neighborhoods. The percentage of buildings with heavy overhangs was calculated as 63% in Barbaros, 60% in Esenler, 51% in Cevatpaşa, 47% in İsmetpaşa, 45% in Fevzipaşa, 42% in Namikkemal and 37% in Kemalpaşa Neighborhoods. Based on the ratios, heavy overhang irregularity is the most common irregularity after a soft or weak story.

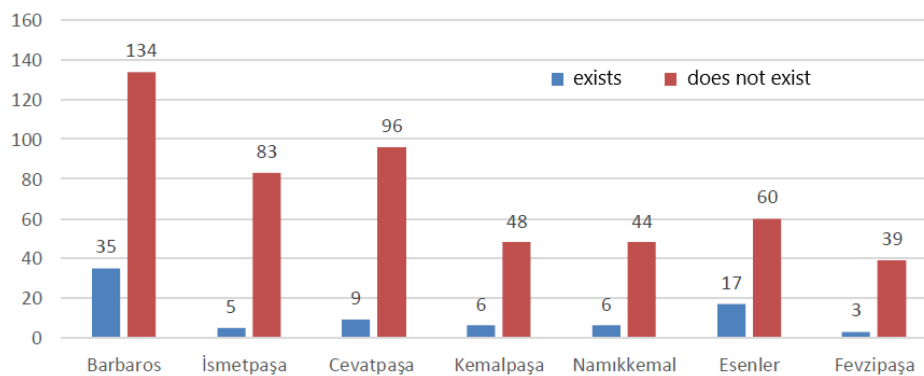
**Figure 12.** Irregularity in plan torsion according to neighborhoods

The distribution of irregularities in plan torsion according to neighborhoods is seen in Figure 12. There is an irregularity in the plan at a rate of 22% in Esenler, 21% in Barbaros, 12% in Namıkkemal, 11% in Kemalpaşa, 9% in Cevatpaşa, 7% in Fevzipaşa and 6% in İsmetpaşa Neighborhoods. Compared to other irregularities, it is seen that the rates of irregularity in the plan torsion are low.
