Atalan, Ö., Özer Baş, G., Gölükçü, İ., Tatlıhayat, E. and Çamlı, A. Y. (2025). "Ottoman Period of Commercial Urban Areas: Research of Manisa-Kula Conservation Area", *Pamukkale University Journal of Social Sciences Institute*, issue 66, pp. 1-16.

OTTOMAN PERIOD OF COMMERCIAL URBAN AREAS: RESEARCH OF MANİSA-KULA CONSERVATION AREA *

*This article is derived from the Scientific Research Project titled "Development of a Method for the Investigation and Protection of Historical Commercial Buildings in Kula Urban Site", Project no: 2021-042, Completion date: 2022.

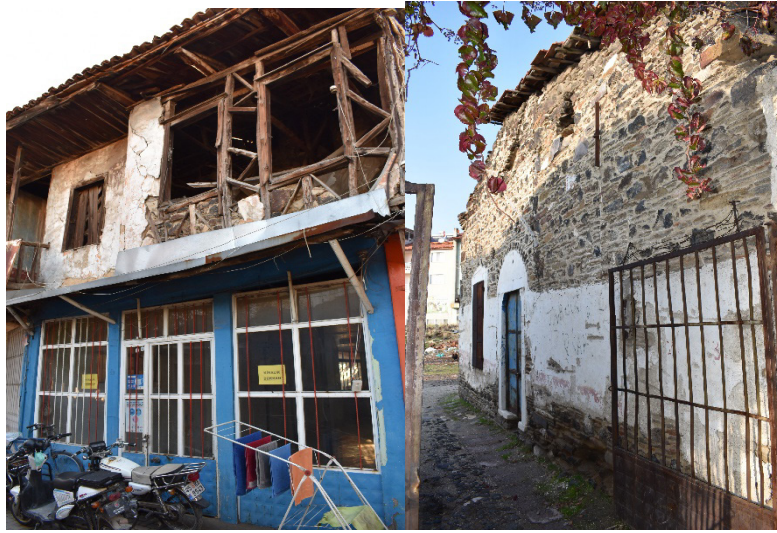
Figure 2. Veliöğlü Inn and Şapçı Inn (Personal archive)

Şapçı Inn is located on Hamdullah Street, within the urban conservation area. It is a single-storey building with a courtyard, built of masonry stone. Şapçı Inn plan scheme was shaped on a rectangular-trapezoidal form as a result of the land situation. Some of the spaces within the inn can be accessed from the street. The units in the main section are located around the courtyard. Some of these units are located back to back, while one is accessed from the street and the other from the courtyard.

Veliöğlü Inn is located within the urban conservation area, at the intersection of Hamdullah Street and 1st Street. It was built with a wooden frame construction system. While the lower floor is partially used, the upper floor is unusable due to structural problems. In the inscription of the building, it is written that it was built in H (1311) AD 1894. The building is a two-storey building with a gable roof and covered with Turkish style tiles. The lower floor of the surviving parts was built with rubble stone material. In the plan scheme, there is a courtyard in the middle and two-storey rooms around the courtyard. The single-storey shops attached to the inn are covered with vaults. It can be said that the plan of the building, which has two entrances, has changed significantly in the process.

It has been observed that Velioğlu and Şapçı Inn, among the 1st Group cultural heritage buildings located in the Kula Urban Conservation Area, have survived to the present day. Ciğeroğlu and Zincirli Inns, whose existence is mentioned in the sources, have disappeared. According to the documents, the location of the Ciğeroğlu Inn, which has not survived to the present day, has been determined. Velioğlu Inn was built in 1894 with a two-storey, reed-filled wooden frame technique. While some of the units on the ground floor of the inn are usable, the second floor is completely unusable.

Şapçı Inn, whose construction date is unknown, consists of single-storey shop units arranged around a courtyard in the masonry system. Most of Şapçı Inn's shops facing Hamdullah Street are in use. The shops overlooking the inner courtyard are unusable. Velioğlu and Şapçı Inn, which have survived to the present day and are partially in ruins, face the threat of collapse day by day. With this; As a result of the studies carried out in the research area, 47 buildings should be preserved in their current state, 124 (80 historical buildings + 44 buildings from the republic period and after) should be preserved after simple repairs, 108 buildings should be used after major repairs, and 19 buildings should be completely demolished. It has also been concluded that the added illegal floors will be demolished.

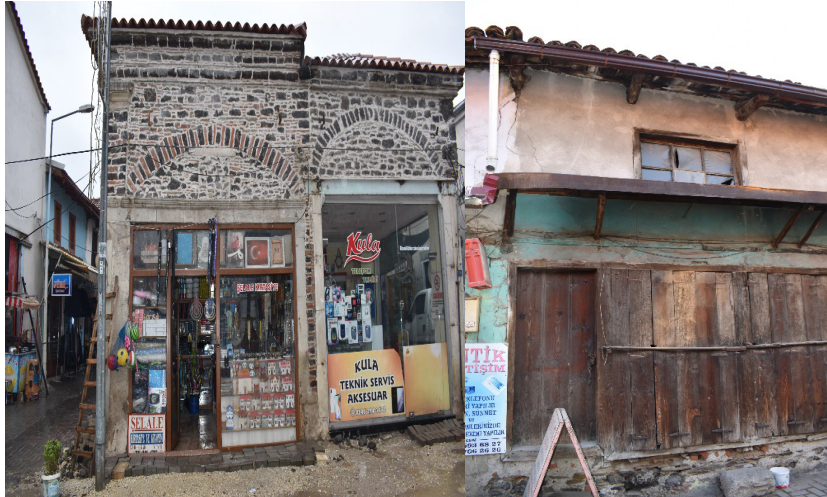
Figure 4. Masonry building example and wood frame structure example

Shops with masonry construction systems predominate in the area. There are many stone masonry walls built from volcanic “black stone” which is the local stone of the region, as well as stone/brick masonry alternating walls. Facade elements such as jambs around openings in masonry buildings, moldings at eaves or floor levels, and relief arches are also made of stone or brick.

Shops with wooden frame construction systems are generally shops whose front walls are made of carcass. The main walls adjacent to other shops must have been built with a masonry system to take precautions against fire, according to the regulations that came into force in the 19th century. The carcass walls in the area were made with post and pane filling, not lathing. It is understood from the spilled plaster parts that the inside of the load-bearing wooden frame was made of stone or brick filling. In shops with carcass walls, it is seen that the moldings around the opening, shutters, and moldings at the eaves or floor levels are also made of wood.

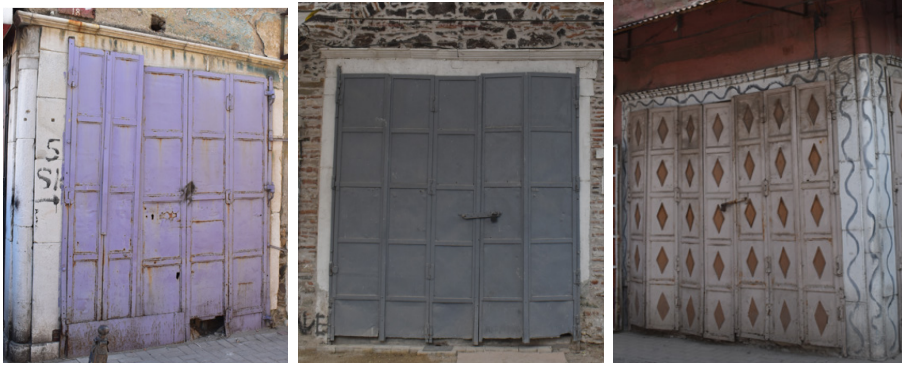
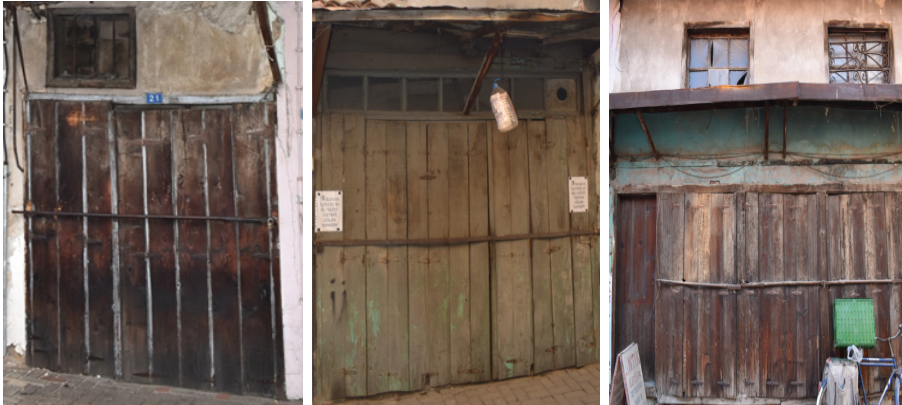
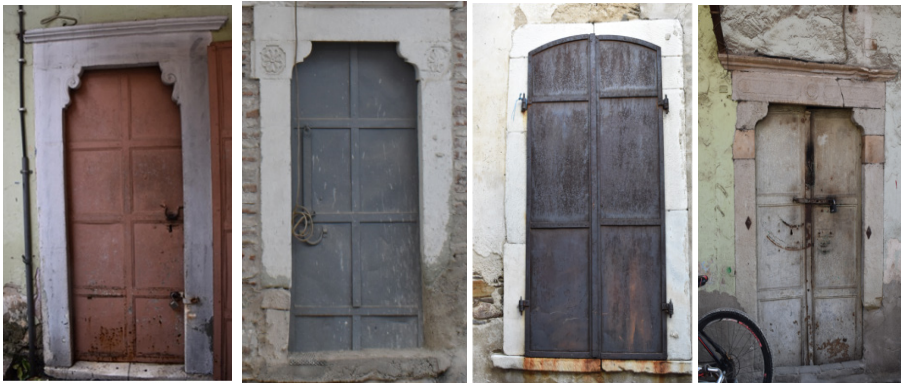
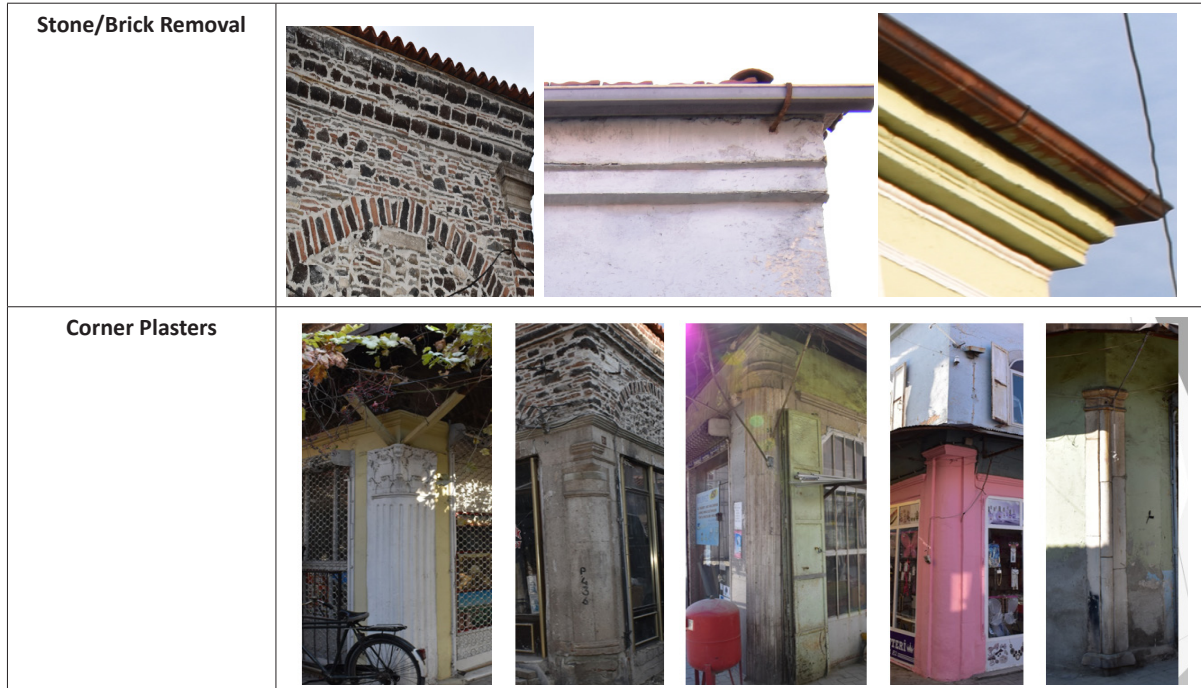
Tablo 2. Facade elements seen in shops in Kula traditional bazaar

Facade Elements	Photos
Metal Shutter

Wooden Shutter

Doors/Windows

Arched Doors/Windows	 
Eye Window	 
Iron Fence	 
Triangle Pediment	 
Wooden Porch

Although the building elements on the facades vary depending on the number of floors, typologies and construction systems of the shops, the shops in the Kula traditional trade area have a common architectural language. The recurring architectural elements on the facades that form this common architectural language are; wooden/metal shutters, doors/windows with jambs, triangular pediments, eye windows, iron railings, sheet metal covered wooden porches, stone/brick/wood moldings and corner plasters. Some shops are decorated with floral motifs such as flowers, acanthus leaves, or religious symbols on the jambs and corner plasters. In addition to these recurring facade elements, it has been observed that iron, sheet metal doors and wooden joinery have largely survived to the present day in shops whose originality has been preserved.

The structural elements on the facades vary depending on the number of floors, typologies and construction systems of the shops. The shops in the Kula traditional trade area have a common architectural language. The elements that make up this common architectural language are: Wooden and metal shutters, doors and windows, triangular pediments, eye windows, iron railings, sheet metal covered wooden porches, stone/brick/wood moldings and corner plasters. Some shops are decorated with floral motifs or religious symbols such as flowers and leaves on corner placards. In addition to these facade elements, it has been observed that iron and sheet metal doors and wooden joinery have largely survived to the present day in shops whose originality has been preserved.

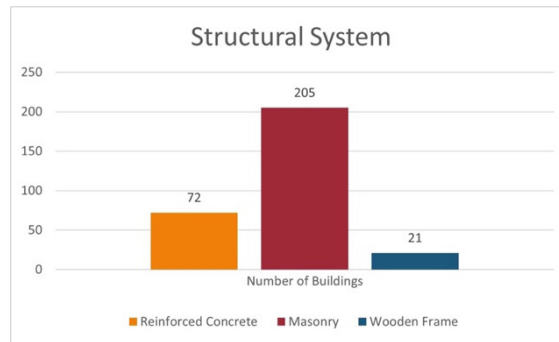
Table 3. Structural systems of buildings

When the load-bearing system properties of 298 buildings within the boundaries of the study area were examined, the number of reinforced concrete structures was found to be 72, the number of masonry structures was 205, and the number of wooden frame structures was 21. It was determined that 10 of these buildings were built with a mixed masonry system on the ground floor and a carcass system on the upper floor.

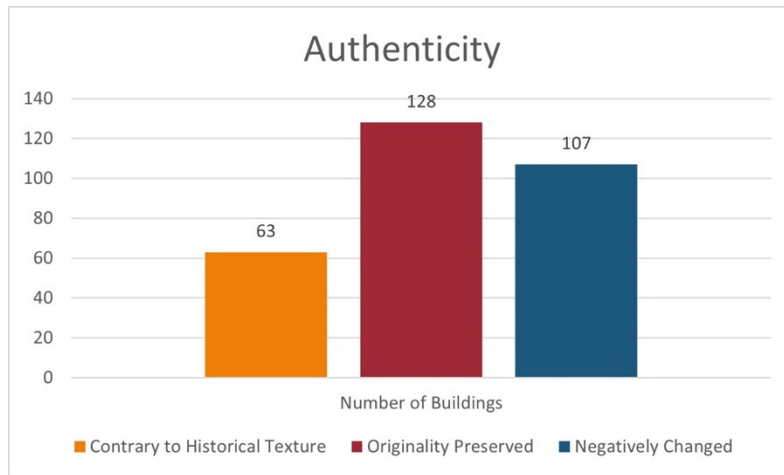
Table 8. Authenticity of buildings

When the originality status of 298 buildings in the study area was examined, the number of buildings contrary to the historical texture was determined as 63, the number of historical buildings with preserved originality was 128, and the number of qualified historical buildings that had undergone negative changes was 107.
