Determining the Efficiency of Rapid Damage Assessment Studies after the 6 February Kahramanmaraş Earthquakes

6 Şubat Kahramanmaraş Depremlerinden Sonra Hızlı Hasar Tespit Çalışmalarının Etkinliklerinin Belirlenmesi

Citation: Karataş, G. & Demirkan, Ö. (2024). Determining the efficiency of rapid damage assessment studies after the 6 February Kahramanmaraş Earthquakes. *Journal of Architectural Sciences and Applications*, 9 (1), 407-421.

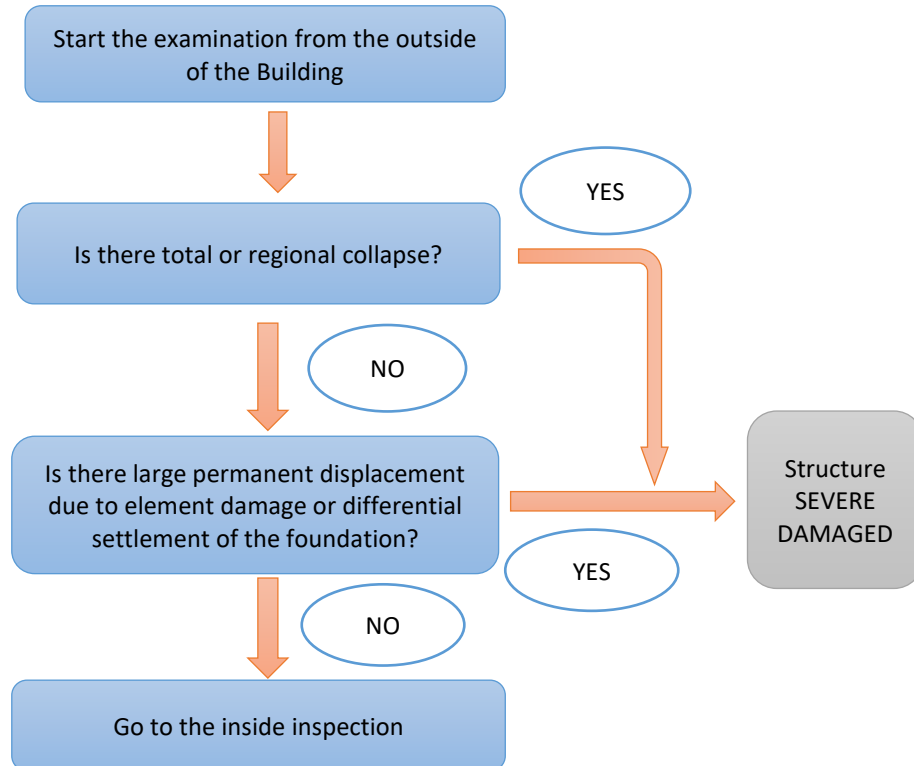
Figure 2. Schematic sequencing of external review steps (İlki et al., 2019)

According to the RYTEİE damage detection method, the limits of external and internal inspection steps in reinforced concrete structures have been determined. Damage detection in buildings is evaluated according to the parameters in the examination steps given in Figure 2 and Figure 3. When the structures examined from the outside are considered to be heavily damaged, the inspection is terminated and the internal inspection is not carried out. In buildings that are not considered to be heavily damaged, the internal inspection step is started and the evaluation is made by starting from the lower floors of the building and examining it up to the damaged floors (İlki, Demir, Cömert & Halıcı, 2019).

1. Investigation step: Regional or complete collapse

If a complete or regional collapse has been observed in the building, the structure is determined as severely damaged the process is terminated and no other stages are examined.

2. Inspection step: Checking permanent horizontal displacement between floors

The following step includes examination for permanent displacements in the floors and the relative drift ratio must be determined. If this ratio is greater than 0.01, the building is classified as severely damaged and the process is terminated.

3. Inspection step: Checking the rotation of the building from ground collapse

At this stage, movements in the ground and foundations and their effects on the structure are evaluated. If there is a proper fit without rotation, the examination continues, however, if a bending of more than 3rd degree is detected, the examination is terminated (Figure 4). If the rotation amount is less than 1 degree, it is determined as minor damage, whereas a bending between 1 and 3 degrees is classified as moderate damage where the examination has been continued (Kaplan, 2018). Settlement and collapse damages on the ground that occur in buildings due to the effect of ground movement and liquefaction are shown in Figure-4.

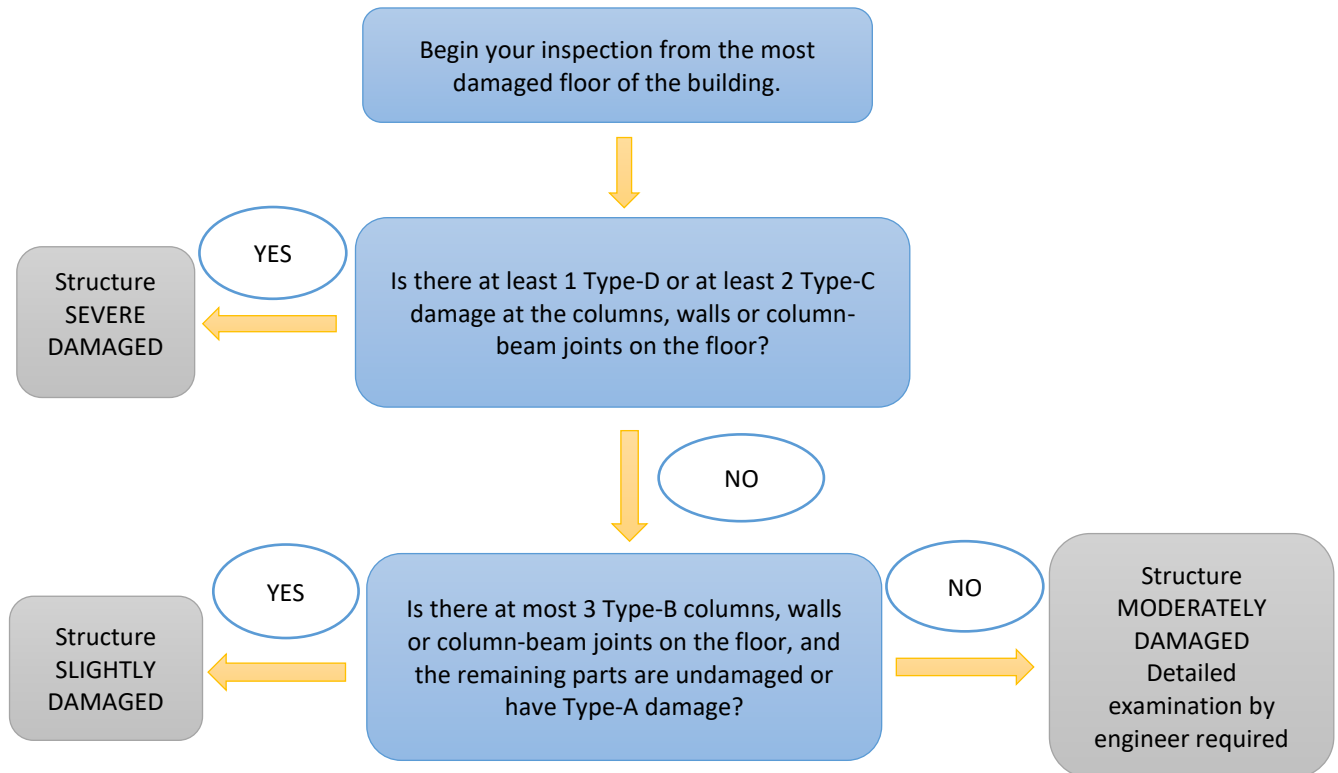
Figure 3. Schematic sequencing of internal review steps (Ilki et al., 2019)

If the structure is not classified as severely damaged after the external observation, experts are allowed to enter the building to examine the horizontal and vertical load-bearing elements of the damaged building, starting from the lowest floors to the most damaged floors. If there are different levels of damage to the load-bearing elements of the building on different floors, the most severely damaged floor is chosen to classify the damage rates on the floors. In reinforced concrete structures, damage to the infill walls is not taken into account, even if the damage is very advanced or severe. On the other hand, the damage to the load-bearing elements of the structure; bending, shear cracks, the width of these cracks, and crushing in the concrete are important and should be taken into account (Kaplan, 2018).

- If there are no cracks or pressure damage in the load-bearing elements of the structure, the element is classified as "**NO DAMAGE**",
- If there are bending or shear cracks not wider than 0.5 mm without any pressure damage, the element is classified as "**SLIGHTLY DAMAGED**",

- If there are bending cracks wider than 0.5 mm, shear cracks between 0.5 mm and 2 mm, or crushing in the concrete shell (cover, concrete cover), the element is classified as "**MODERATELY DAMAGED**",

- If the width of the shear crack is between 2 and 10 mm or if there is peeling (the width of the bending crack is not important), the element is classified as "**SEVERELY DAMAGED**"

- If the width of the shear crack is more than 10 mm or if there is buckling of longitudinal reinforcement or crushing of the core concrete (the width of the flexural crack is not important), the element is considered as "**VERY SEVERE DAMAGED**". If there is damage at the column-beam joints that is more serious than the damage seen in the columns, these are considered as column damage. Damage types, classification and dimensions of load-bearing elements are given in Table 1 (Kaplan, 2018).

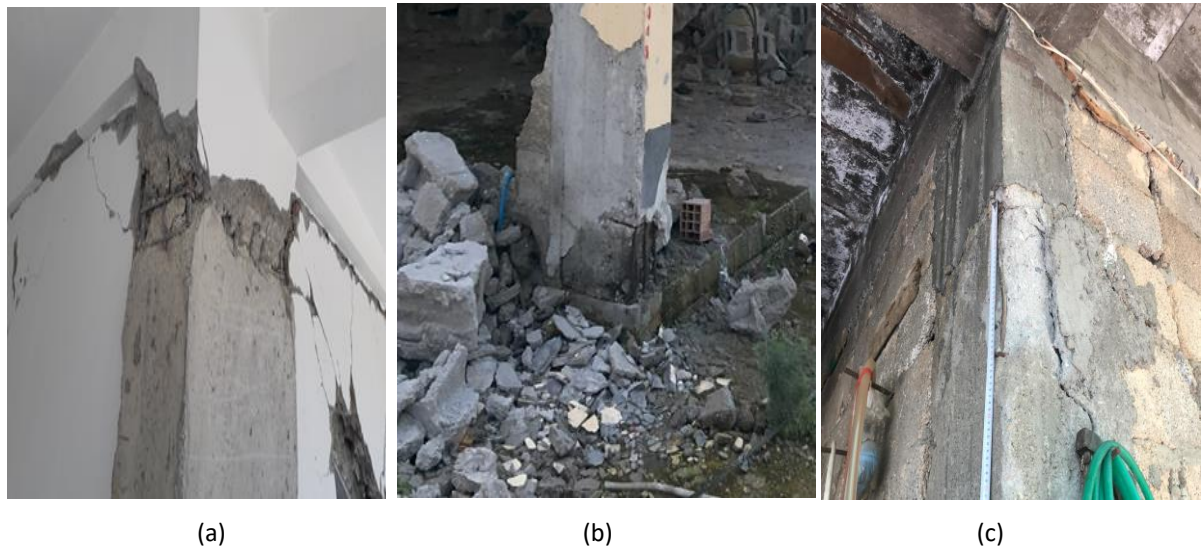
In reinforced concrete structures, earthquakes apply very large forces to the column-beam joints, which are the elements of the load-bearing system, and structural damage occurs as a result of the strain on these joints. During field studies in the selected region, it was observed that severe damage occurred at the column-beam joints in many buildings (Figure 5).

In order to prevent buckling of longitudinal reinforcement in reinforced concrete structures, installing transverse reinforcement in accordance with the regulations increases the durability of the core concrete under pressure. In the field studies, the reinforced concrete buildings in the earthquake zone

were severely damaged as a result of the crushing and crusting of the core concrete, which has been categorized as C and D type damages according to the evaluation criteria explained in the RYTEIE method (Figure 5).

Figure 5. Structural damage types (a), (b) core crushing, shell crushing, shell crushing, reinforcement buckling, (c) insufficient transverse reinforcement - Malatya; (Karataş, 2023)

- **Shell Crushing:** The concrete layer outside the stirrup is called the Shell, while Shell crushing is defined as crushes occurring in the concrete outside the stirrup (Figure 5).
- **Shell Casting:** It is the pouring of concrete outside the stirrup (Figure 5).
- **Reinforcement Buckling:** These are bucklings in longitudinal reinforcements, stirrups or horizontal reinforcements within the load-bearing structural element (Figure 5).
- **Core Crushing:** The concrete and/or concrete layer inside the stirrup is called the core. Core crushing is defined as the crushing of the concrete inside the stirrup (Figure 5) (Kaplan, 2018).

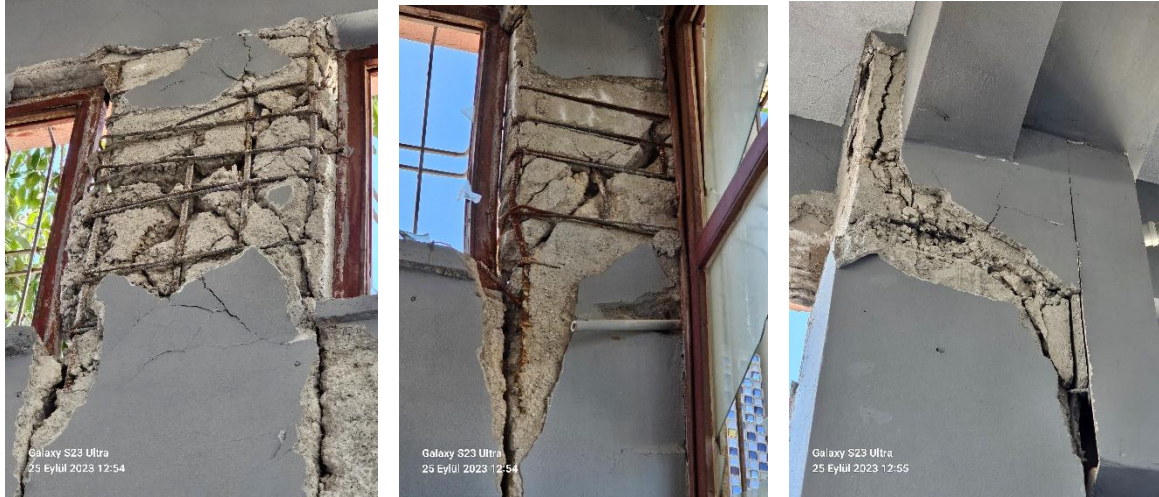
Even if the load-bearing system of the building is designed in accordance with the regulations, concrete spills in columns and beams due to mistakes made during on-site application cause damage to the load-bearing system. Damages resulting from manufacturing errors in the load-bearing structural system of the observed building, in addition to the effect of the earthquake load, caused the rusting iron concrete to crack and the structure to be severely damaged due to not leaving enough cover on the columns (Figure 7).

Figure 7. Damages resulting from manufacturing errors - Malatya (Karataş, 2023)

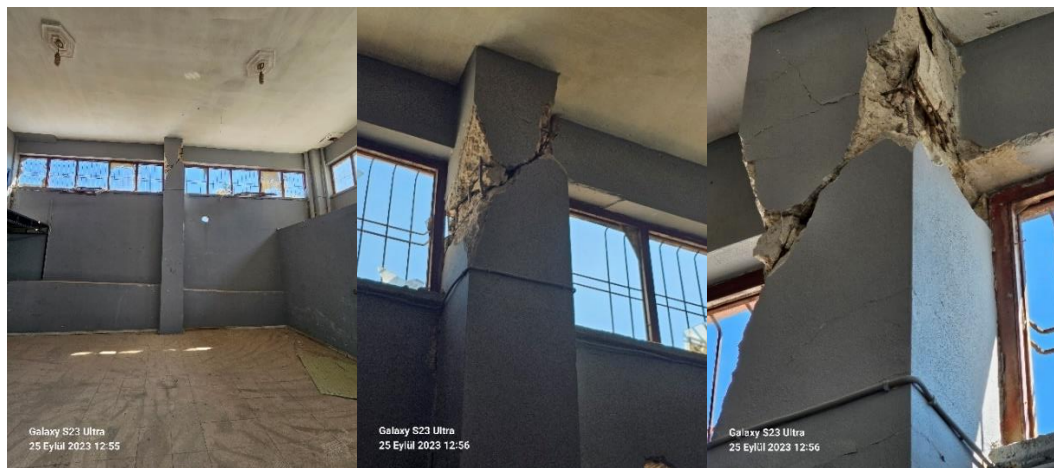
During the design phase, horizontal windows planned on the exterior walls for illumination and ventilation purposes in the basement and ground floors play an important role in the formation of the short column effect. Other reasons for the formation of short columns include gradual foundations made to suit the land structure, mezzanine floor solutions, and different floor alignments in adjacent buildings due to the slope of the land. It has been observed that column damage on the lower floors of such buildings is higher than on the ground floors, as a result of the earthquake effect not distributing the load from the ground to the beams. Examples of the short colon effect giving rise to different types of severe damage in buildings can be seen Figure 8.

Figure 8. Short colon effect damages – Malatya (Karataş, 2023)

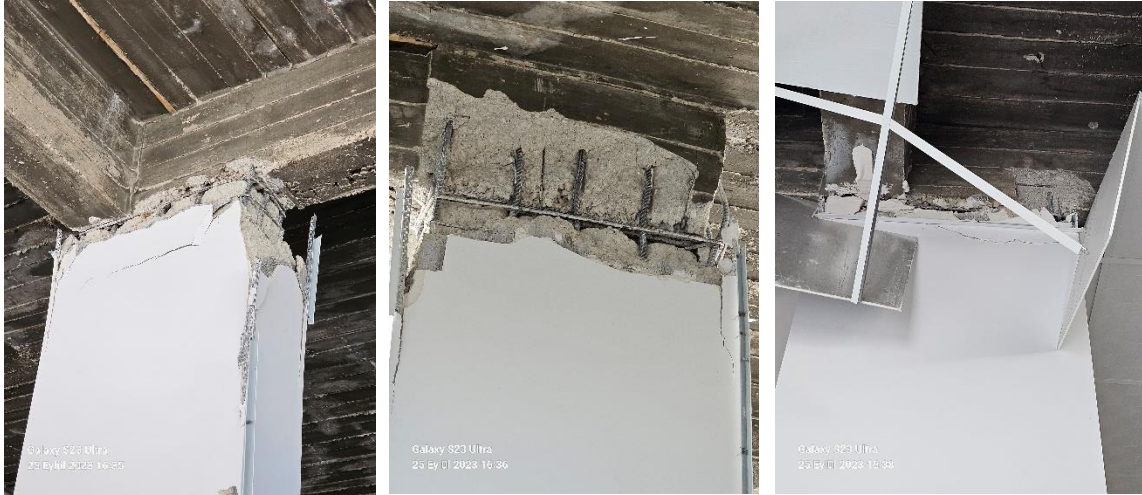
Columns and beams in the load-bearing system of the building should be strictly dimensioned according to the regulations. In the load-bearing system of reinforced concrete structures, the column-beam dimensions should have a harmonious relationship in order to transfer the load to the ground appropriately. In order to create wide space in rooms, columns were constructed thinner and/or weaker than beams, which cause serious damage in the columns due to loss of bearing capacity during earthquakes. It has been observed that weak column gives rise to damages in the load-bearing system of the building resulting in severe damaged structure as seen in Figure 9.

Figure 9. Weak column and strong beam damage - Malatya (Karataş, 2023)

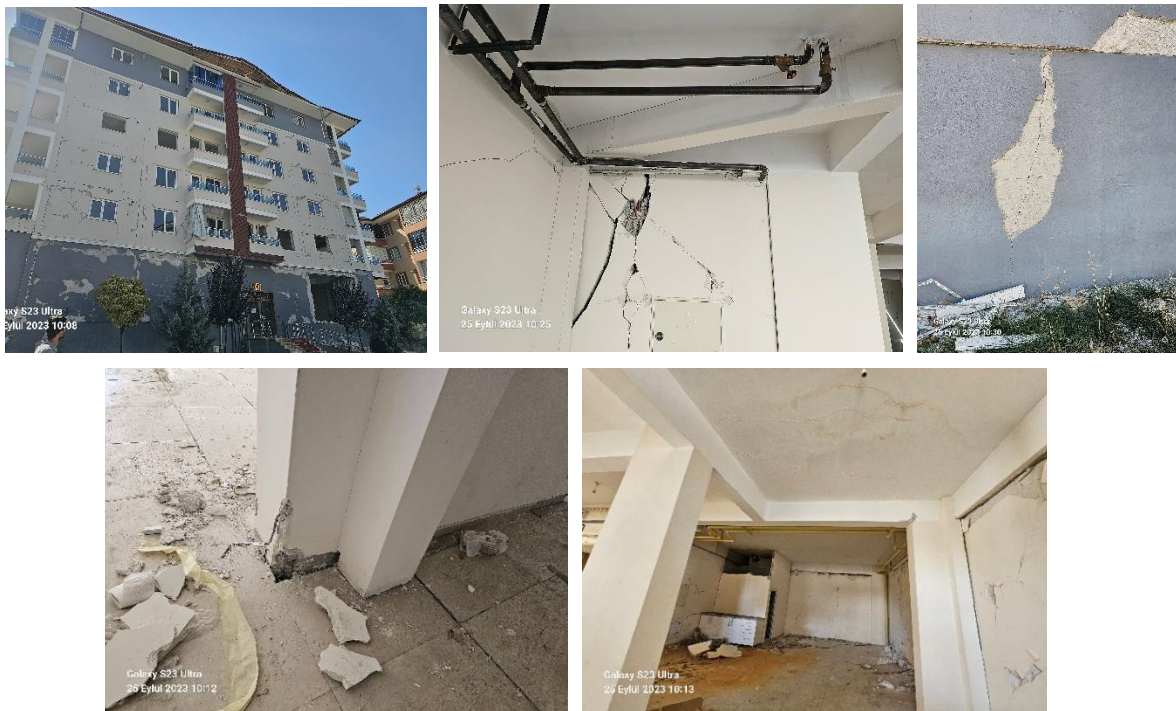
Especially reinforced concrete structures are expected to be resistant to earthquake loads, however, the ground floors are sometimes planned as workspaces for commercial with a greater height than the other floors, resulting in a soft floor. “Soft floor” is defined as the situation when shear walls on the upper floors do not continue on the ground floor, the height is more compared to the upper floors and the stiffness is less than the upper floors. This situation caused structural irregularities in the building and damage to the structure against the earthquake load (Figure 10.).

Figure 10. Soft Floor Effect Damage - Malatya (Karataş, 2023)
