Traditional Houses in Materials Analysis; Konuralp, Düzce Example

Büşra Sabuncu^a, Özlem Sallı Bideci^b

In this study, mortar and plaster samples taken from a traditional house (1799 parcel) located in the neighborhood Konuralp, Düzce Province, were subjected to acid loss, ignition loss, loss of aggregates sieve analysis after acid, protein, and fat tests, tests of salt, as well as Petrographic and SEM-EDX analyses. Brick samples underwent physical examinations microscopic analyses and mechanical in addition to SEM-EDX analyses. For wood samples, macroscopic and microscopic analyses were conducted to determine their types. Based on these analyses, recommendations have been made to contribute to the repair and reuse of the material properties of the selection processes of traditional structures.

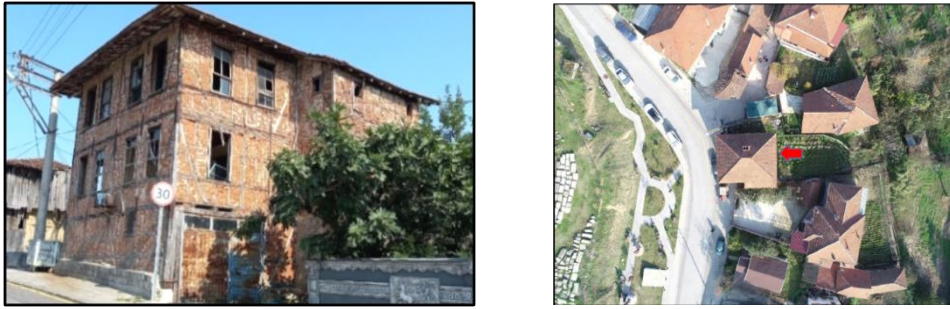
Figure 1. Structure of electric vehicle types

The building with parcel number 1799, located in the Konuralp District of Düzce province, is located approximately 60 meters south of the ancient theater known as 40 Steps, dating from the Roman Period. It is located within the borders that have been declared as a 2nd-degree archaeological site by the decision of the Kocaeli Cultural Heritage Preservation Regional Board dated 13.03.2013 and numbered 889. The building was registered as a 2nd Group cultural asset by the same board's decision dated 30.09.2015 and numbered 2221. A general perspective and bird's eye view of the location of the parcel in question is shown in Figure 1.

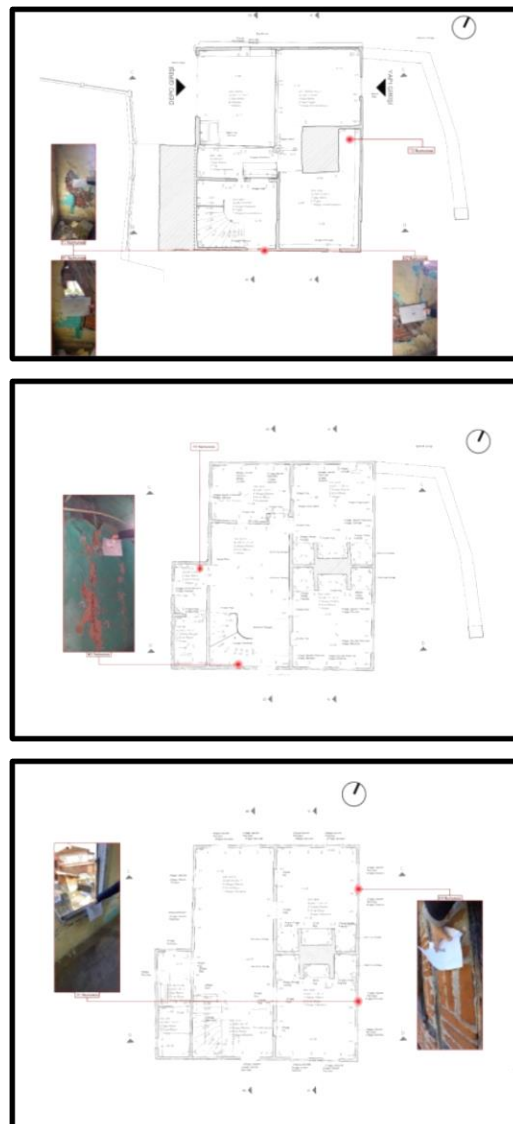
Figure 2. 1799 parcels numbered floor, first floor, and II. sampling sheet of a plan

Before taking samples from the buildings, the building materials that determine the character of the building were identified and the bricks, mortar, plaster, and wood of the buildings were analyzed observationally. In order to proceed systematically during the sample collection and to record the locations of the samples taken, survey drawings of the building obtained from Düzce Municipality [5] were used. Figure 2 shows the ground, first-floor, and second-floor sampling sheets.

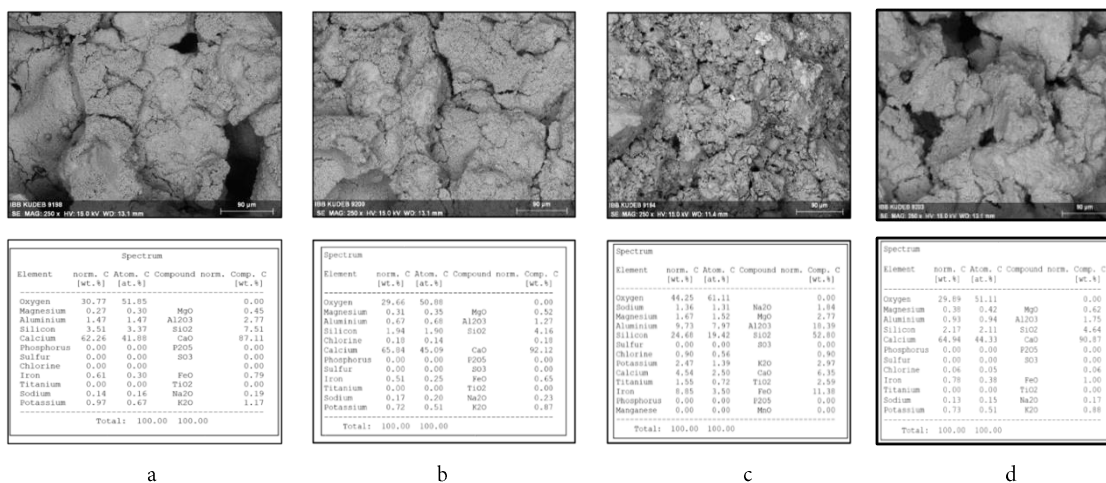
Figure 12. (a) H1, (b) H2, (c) H3 and (d) H4 SEM image and EDX Elemental analysis and oxide ratios of samples

With SEM-EDX analyses, SEM images were taken from the binding parts of the mortar samples and EDX analyzes were performed on the marked areas on these images. SEM images and EDX analysis element and

oxide ratios of H1, H2, H3, H4 samples are given in Figure 12.

As shown in Figure 12, the binder of the H1 mesh mortar sample is lime-derived calcium carbonate, which contains clay formed by the decomposition of feldspars in the range of approximately 10-12%. While the sample contained 87.11% calcium originating from lime, it was determined that this element contained much smaller amounts of silicon, aluminum, potassium, iron, magnesium, and sodium. The binder of the H2 plaster mortar sample is lime-derived calcium carbonate, which contains clay formed by the decomposition of feldspars in the range of approximately 5-6%. It was determined that the sample contained 92.12% calcium, originating from lime, and much less of this element, silicon, aluminum, potassium, iron, magnesium, sodium, and chlorine. H3 plaster mortar sample; The binder is approximately 8-10% lime-derived calcium carbonate, and the remainder is clay formed by the decomposition of potassium and sodium-based feldspars. It was determined that the sample contained 52.80% silicon, originating from clay, and smaller amounts of this element, aluminum, iron, calcium, potassium, magnesium, titanium, sodium, and chlorine. The binder of the H4 mesh mortar sample is lime-derived calcium carbonate, which contains clay formed by the decomposition of feldspars in the range of approximately 10-12%. It was determined that the sample contained 90.87% calcium, originating from lime, and much less of this element, silicon, aluminum, iron, potassium, magnesium, sodium, and chlorine.

According to the SEM-EDX results of the mortar samples, it is understood that the binder parts of the mortars numbered H1, H2, and H4 contain a very high amount of calcium originating from lime, while the amount of silica in the H3 mortar is quite high due to the high clay it contains. It was determined that the wood of the window frame taken from the second floor of building number 1799 was chestnut (*Castanea sativa* Mill.). It was envisaged that the same type of wood as the tree species specific to the region could be used during the repair phase.

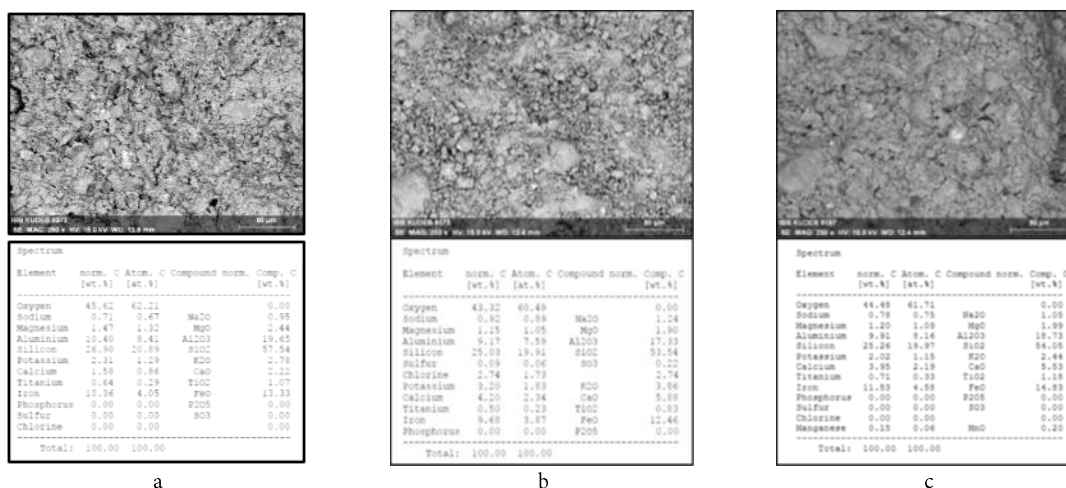
Figure 13. (a) T1, (b) T2 and (c) T3, SEM image and EDX Elemental analysis and oxide ratios of samples

SEM images and EDX analysis of element and oxide ratios of T1, T2 and T3 samples are given in Figure 13.

Calcium carbonate was detected in the range of 2-3% in the content of the T1 brick sample, and it was observed that there were silt and clay-sized particles in the area determined as clay in the sample examination area. It was determined that the sample contained 57.54% silicon, and smaller amounts of this element, aluminum, iron, potassium, magnesium, calcium, titanium and sodium. Calcium carbonate was detected in the range of 5-6% in the T2 brick sample, and it was observed that there were silt and clay-sized particles in the area determined as clay in the sample examination area. It was determined that the sample contained 53.54% silicon, and smaller amounts of this element, aluminum, iron, calcium, potassium, chlorine, magnesium, sodium, titanium and sulfur. T3 brick sample; It was determined that the sample contained 54.05% silicon, and smaller amounts of this element, aluminum, iron, calcium, potassium, magnesium, titanium, sodium and manganese. The most suitable soils for brick making are clay soils. Generally, clays include illite, montmorillonite, kaolinite, quartz, limestone and iron minerals. When these minerals are fired between 800-1200 °C, they have the strength required for bricks. Illite and kaolinite clays are the most suitable for brick and tile making [16]. $\text{SiO}_2/\text{Al}_2\text{O}_3$ ratio of kaolin type minerals is 2/1; In montmorillonite, illite and chlorite type minerals, it is 3/1 [17]. Since these ratios are more than 3/1 in the brick samples taken from the building, it can be concluded that the bricks are not kaolinite in structure.
